SERVICE BULLETIN

CESSNA / CITATION II

SB550-57-2

AILERON FENCE REPLACEMENT

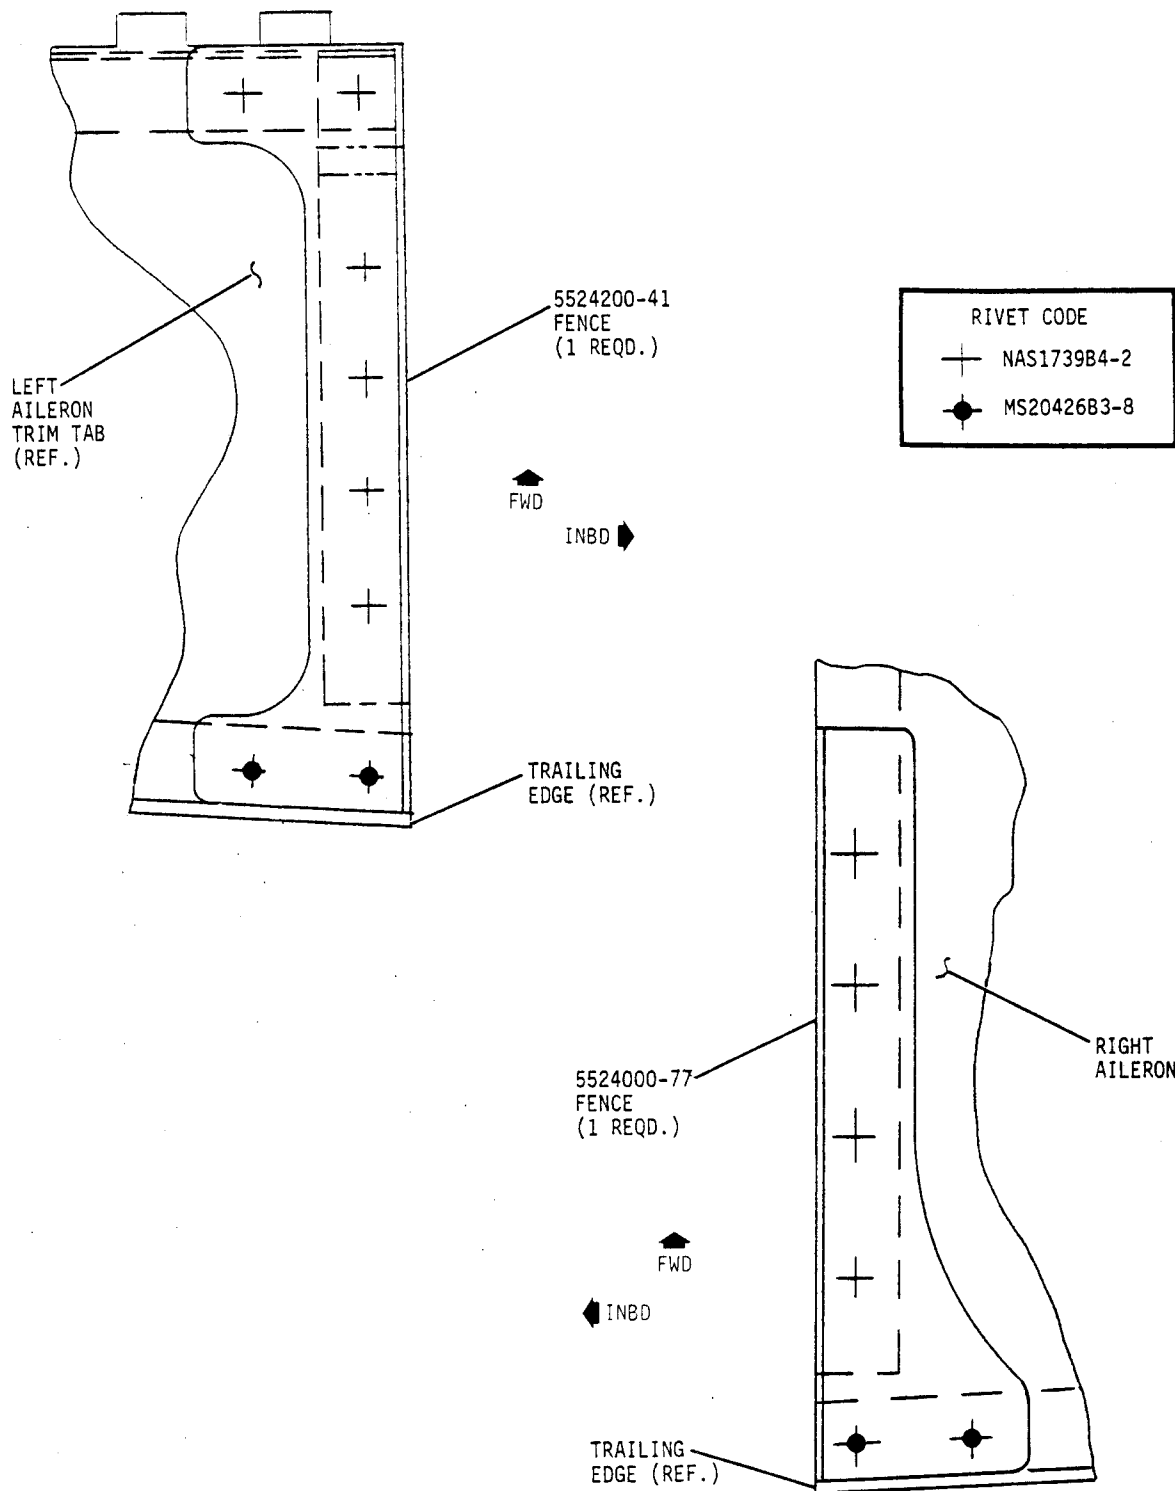
VIEW LOOKING DOWN
 Aileron Fence Replacement
 Figure 1

To provide additional static lateral stability below approach speeds.

3. (See Figure 1) Place and clamp the 5524000-77 Fence in position and back drill (.098) diameter holes thru the fence (2 places) using the existing holes in the aileron trailing edge. Use temporary sheet metal fasteners at these two locations.

4. Using a hole finder, locate the other four (4) holes and drill (.140) diameter thru the fence (4 places). Deburr all holes in the fence.
5. Repeat Steps 2 thru 4 for the left aileron trim tab and the 5524200-41 Fence.

7. Apply a thin coating of sealer from the MIL-S-8802 Semkit to the faying surfaces and install the 5524000-77 Fence (LH Aileron Trim Tab) and 5524200-41 Fence (RH Aileron) using MS20426B3-8 and NAS1739B4-2 Rivets as shown.
