Service Bulletin

SEB01-2

MAIN LANDING GEAR ACTUATOR INSPECTION

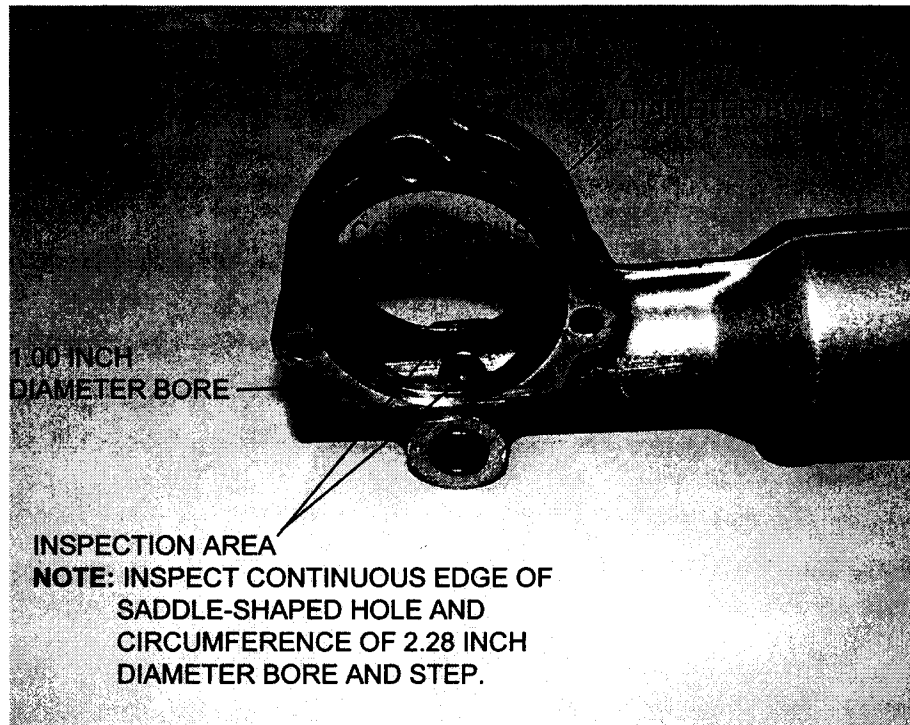
FIGURE 1. MAIN LANDING GEAR ACTUATOR INSPECTION

To provide notification that an inspection is required of the main landing gear actuators for the presence of cracks. Cracked actuators and actuator bodies shall be replaced. If no cracks are found, the part number 1281000-1, 1281000-2, 9882000-1, 9882000-2, 9882015-1 and 9882015-2 actuators and 1281001-1, 1281001-2 or 1281001-3 actuator bodies shall be modified and subsequently reinspected as specified in this service bulletin; part number 1281000-3, 1281000-4, 9882000-4, 9882000-5 and 9882015-4 actuators and 1281001-4, 1281001-5 or 1281001-6 actuator bodies do not need to be modified but will require subsequent inspection. Non-compliance with this service bulletin could result in failure of the main landing gear actuator.

- C. (Refer to Figure 1.) Perform a fluorescent penetrant inspection in location indicated by Figure 1 on both sides of each main landing gear actuator body.

- (5) Examine the areas under black light. An 8X to 10X magnifying glass should be used in the examination as some cracks are difficult to see with the naked eye.

- D. If a crack or cracks are detected, the actuator or actuator body must be replaced.
- E. If no cracks are detected on part number 1281000-1, 1281000-2, 9882000-1, 9882000-2, 9882015-1 or 9882015-2 Actuator Assemblies and 1281001-1, 1281001-2 or 1281001-3 Actuator Bodies, proceed to Step 2.

2. Polish edge of hole intersection of main landing gear actuator.
 - A. (Refer to Figure 1.) Using fine grit emery cloth (600 grit), or equivalent, polish edge of hole intersection as shown in Figure 1.
 - (1) Smooth continuous edge of saddle-shaped oval hole where 1.00 inch diameter bore transitions 2.28 inch diameter bore, so that no sharp edges or tool marks can be felt by finger tip.
 - (2) Smooth circumference of 2.28 inch diameter bore and step so that no sharp edges or tool marks can be felt by finger tip.
 - (3) Flush actuator body with solvent to remove any metal shavings, fluorescent penetrant solution or other foreign matter.
3. (Refer to applicable Service Manual.) Assemble and install Main Landing Gear Actuator.
