Service Bulletin

SEB95-3

FLAP SUPPORT INSPECTION AND ROLLER WASHER INSTALLATION

TITLE FLAP SUPPORT AND ROLLER BEARING INSPECTION/FLAP ROLLER WASHER
INSTALLATION

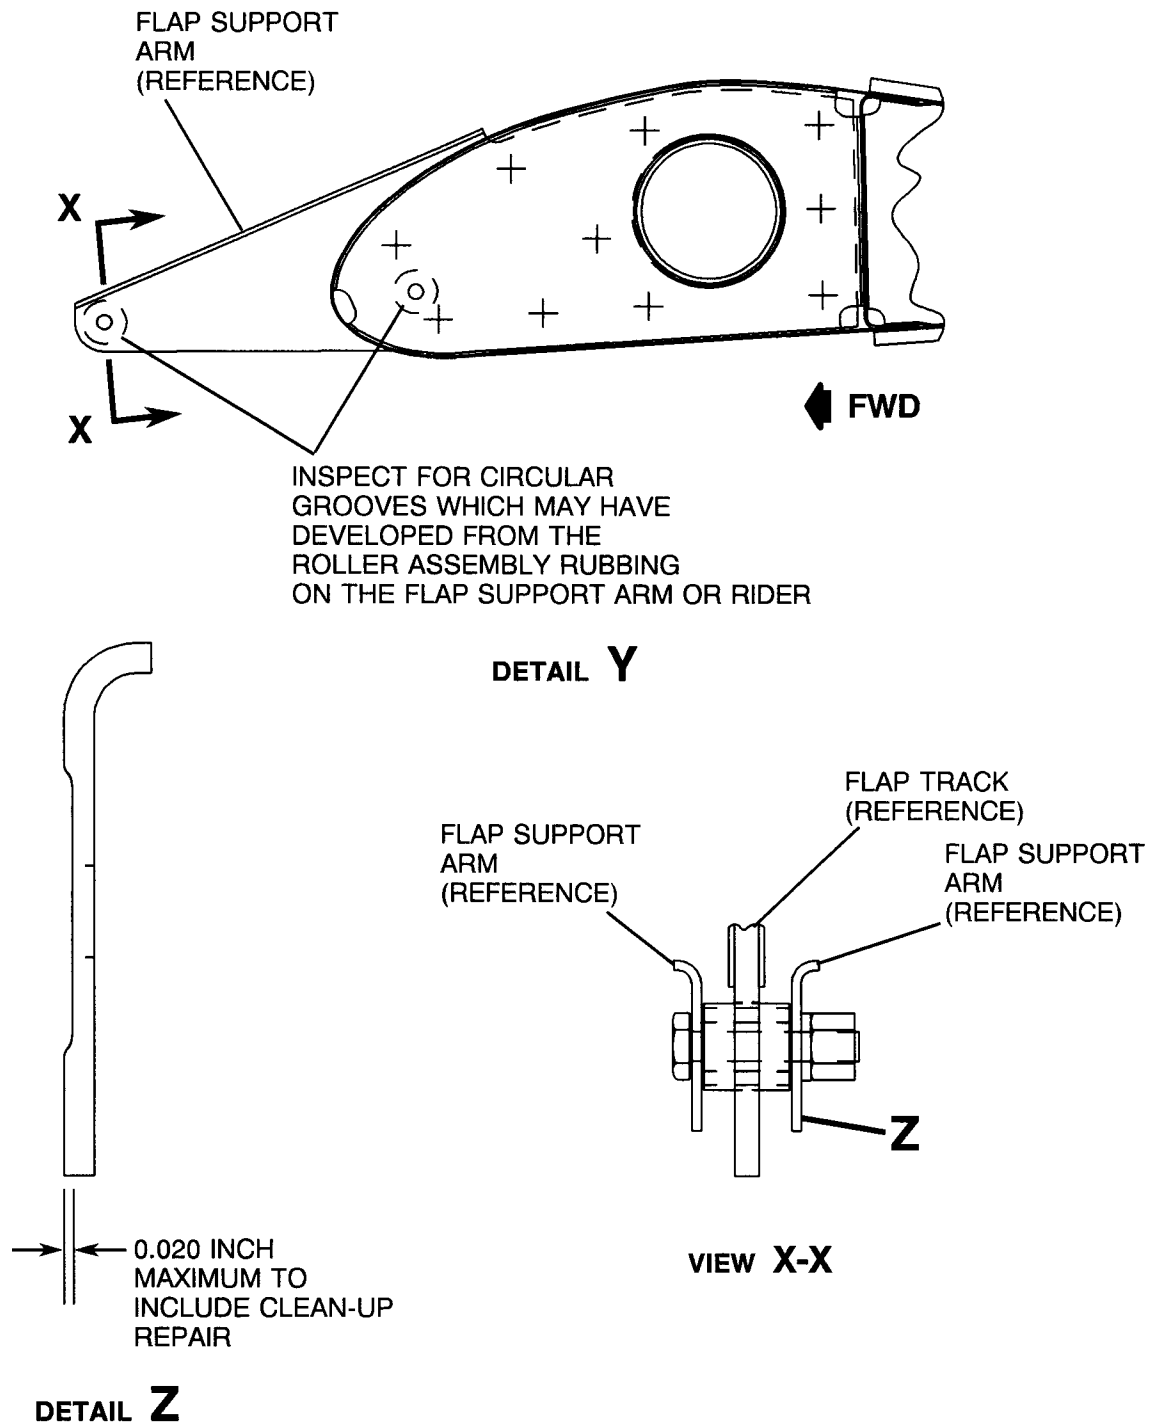
Figure 1. Flap Support Rib Assembly and Roller Bearing Inspection (Sheet 6)

5. (Refer to Figure 1, Sheet 6, Detail Y.) Using a dye penetrant, inspect each flap support arm or rider at the forward and aft roller assembly mounting points for grooves and/or cracks.

NOTE: Circular grooves may have developed from the roller assembly rubbing on the flap support arm or rider. If this condition is present, use an optical or mechanical depth micrometer and measure the depth of the grooves.

- A. If no cracks are present and if any grooves are present, use 400 grit Emory cloth and blend out the grooves using care not to remove excessive material; blending to remove grooves shall not exceed the maximum depth of 0.020 inch.

NOTE: Maximum wear and clean-up shall not exceed 0.020 inch material loss. If cracks are present or grooves exceeds a 0.020 inch depth, replace the flap support arms by installing one SK180-44-1 per affected flap station. For airplanes equipped with extended length flaps (refer to Figure 1, Sheet 3) at the outboard flap attach station, install SK180-44-2 or SK180-44-3 as required.
