Service Newsletter

SNL04-1

PRATT & WHITNEY CANADA PT6A COMPRESSOR TURBINE (CT) BLADE FRACTURES

Subject PT6A Compressor Turbine (CT) Blade Fractures

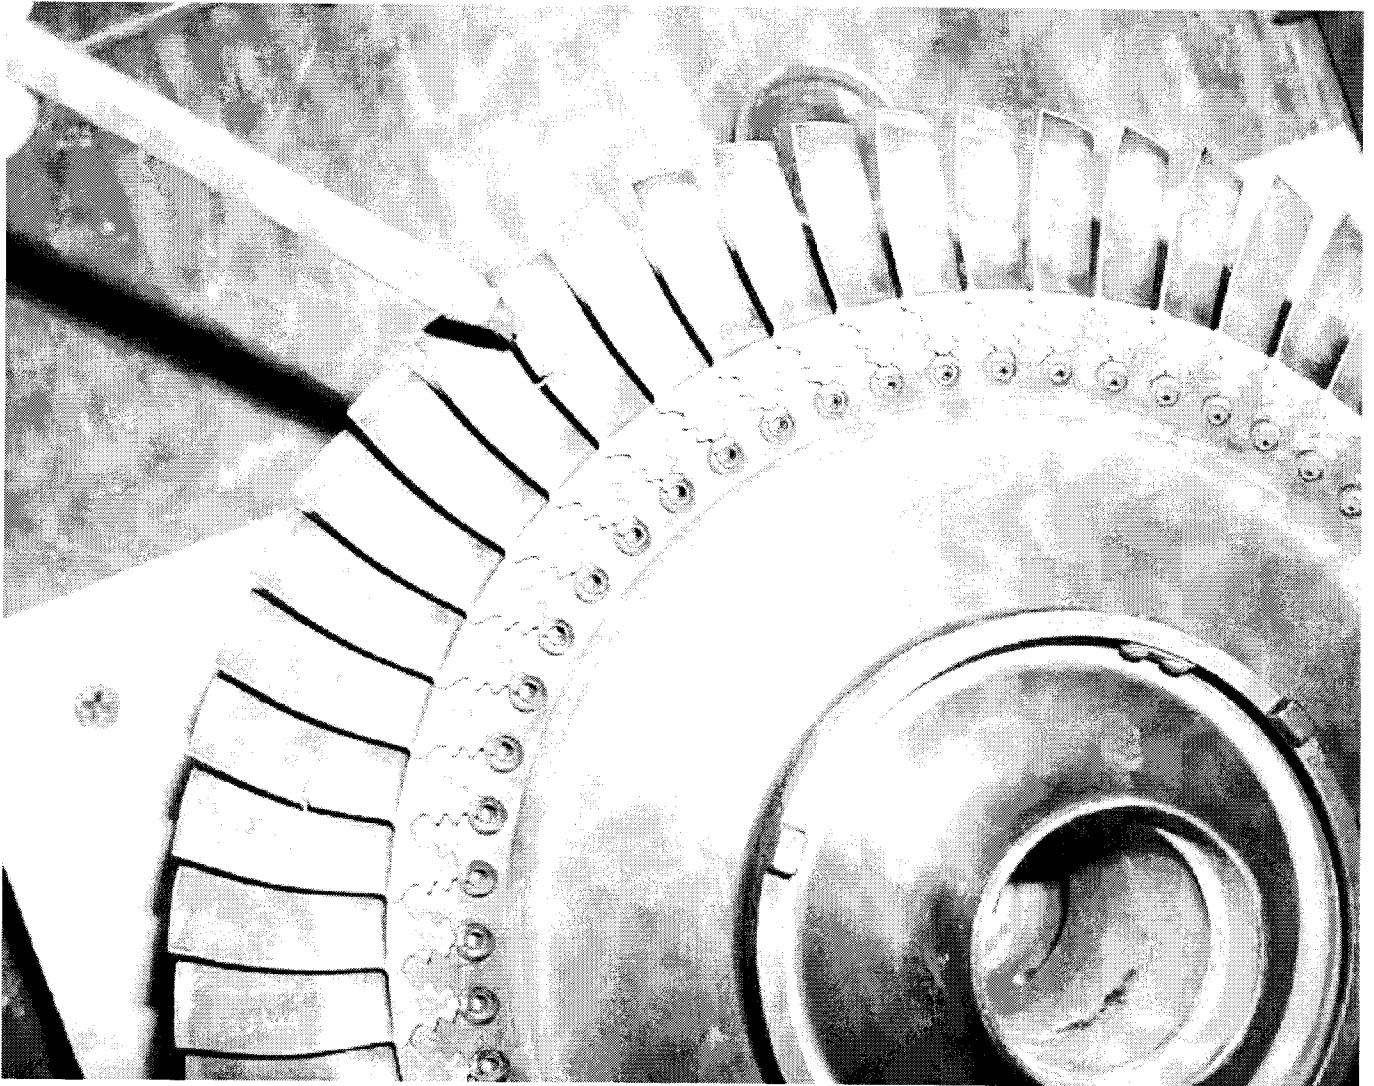
Figure 1

An example of CT Blades that were likely exposed to an overtemp condition are shown in Fig.1, these blades were in operation prior to being discovered during an H.S.I., cracking is evident on the trailing edge of some blades. Fig. 2 shows a CT disc assembly following a CT blade fracture event.

Follow the applicable Engine Maintenance Manual recommendations for all overtemp conditions.
