single-engine SERVICE LETTER

SE72-7

SUBJECT: OPERATIONAL FUEL MANAGEMENT PROCEDURE

AIRCRAFT AFFECTED: Model 172/Skyhawk ---- 1956 through early 1970 models
F172 --- 1963 through early 1971 models

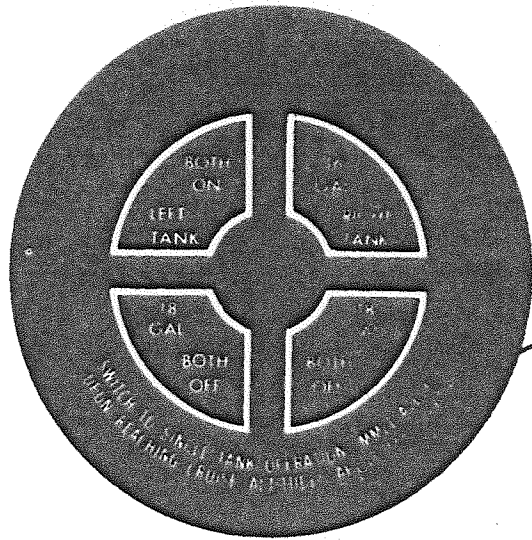
PART NUMBER 0509021-1 PLACARD

17228000 THRU 17251822
(1956 THRU 1964 MODELS)

SWITCH TO SINGLE TANK OPERATION IMMEDIATELY UPON REACHING
CRUISE ALTITUDES ABOVE 5000 FEET.

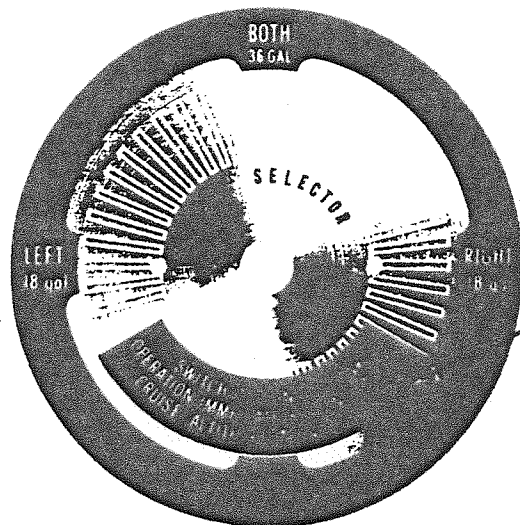
PART NUMBER 0509021-2 PLACARD

17251823 THRU 17256512
(1965 THRU 1967 MODELS)

F1720001 THRU F1720446
(1963 THRU 1967 MODELS)

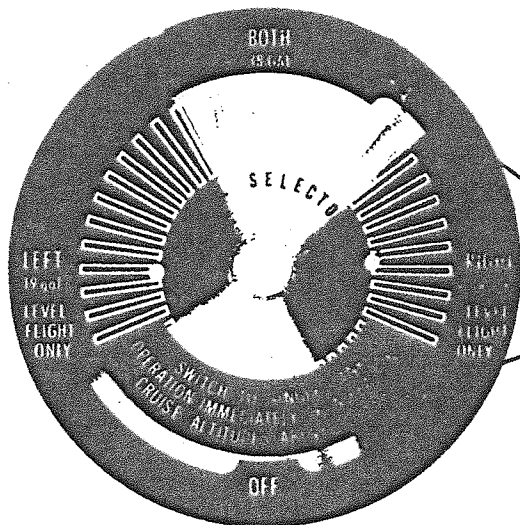
PART NUMBER 0509021-3 PLACARD

17256513 THRU 17258856
(1968 THRU MID-1970 MODELS)

F1720447 THRU F1720780
(1968 THRU MID-1971 MODELS)
