WINGS - WING STATION 48.00 RIB INSPECTION

525B (CJ3+)

SL525B-57-04
 Page 1 of 9

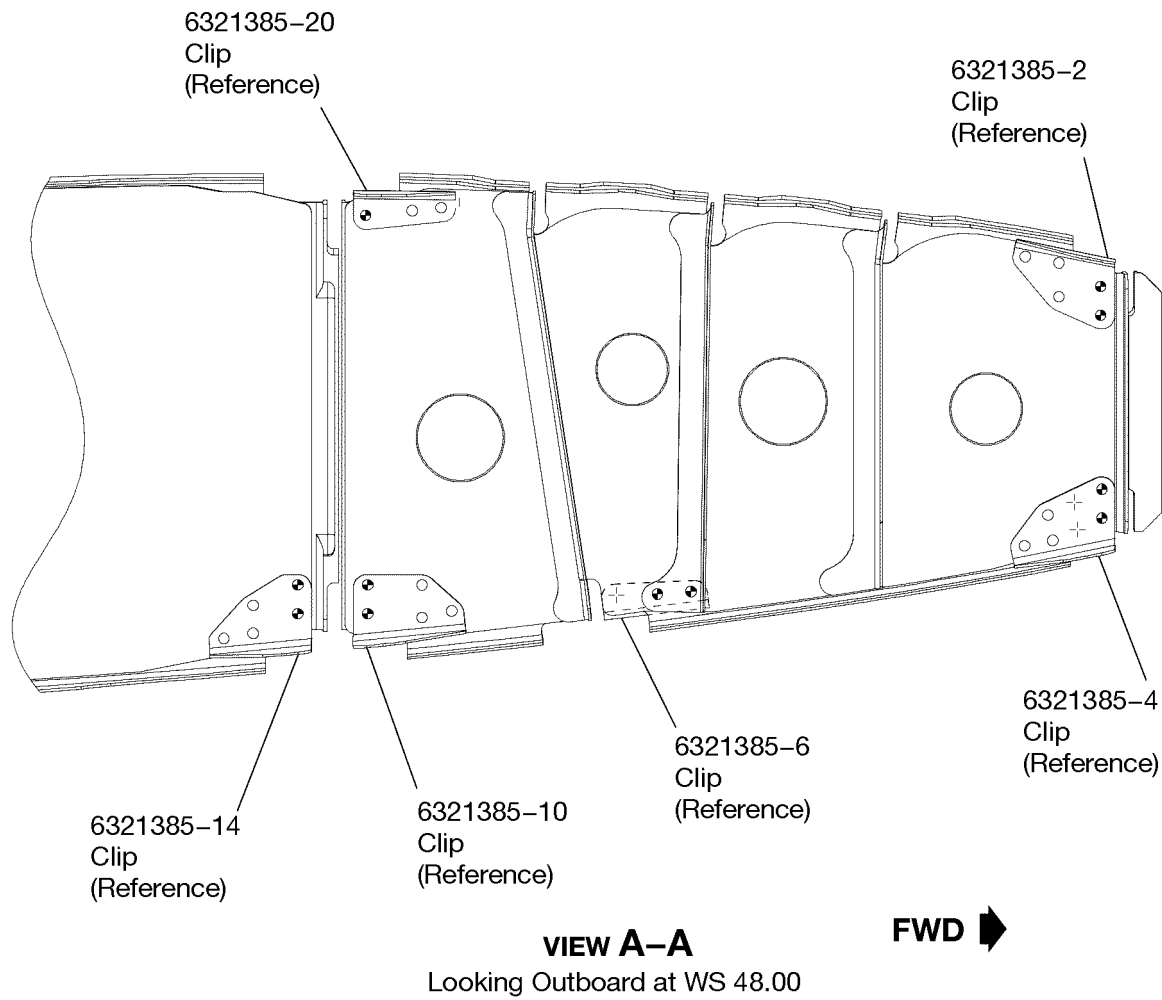
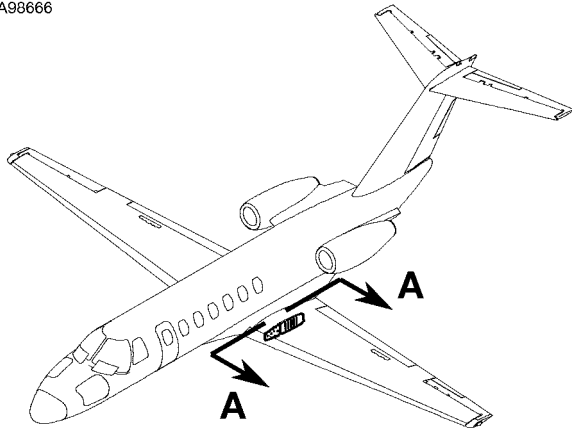
Figure 1. WS 48.00 Clip Locations (Sheet 1)

The clips that attach WS 48.00 Rib to the skin and spars may not have the proper heat treatment.

- B. Do an inspection of the clips identified in Figure 1 to determine if they are of the proper heat treat condition.
- (1) Measure the conductivity of the identified clips with the Eddy Current instrument.
NOTE: The surface area of the part where the probe is placed must be at least as big as the surface area of the probe. The probe must be placed on a flat surface of the part and make complete contact.

- (2) Acceptable apparent (value through the cladding) conductivity values for 2024-T42 0.063 inch thick is in the range of 29.2% to 33.8% IACS.
NOTE: If Cladding is removed, the conductivity values of bare 2024-T42 0.063 inch thick range between 27.5% to 34% IACS.

4. (Refer to Figure 1.) Replace clips identified by TeamCJ.
- A. Place tact cloths in the fuel bay to catch metal shavings and other FOD.
CAUTION: Remove all metal shavings and FOD from the wing fuel tank. Failure to remove metal shavings and FOD from the wing fuel tank can damage the fuel pumps, clog the engine fuel filters, and cause false fuel level indications.

- B. Remove and replace the 6321385-2 Clip.
- (1) Remove and discard the 6321385-2 Clip.
 - (2) Put the 6321385-2 Clip into position and ream five holes to a diameter between 0.1625 and 0.1645 inch-diameter that align with the holes in the WS 48.00 Rib.

- C. Remove and replace the 6321385-4 Clip.
- (1) Remove and discard the 6321385-4 Clip.
 - (2) Put the 6321385-4 Clip into position and match drill two Number 21 (0.159 inch-diameter) holes in the clip that align with the existing holes in the rib.

- D. Remove and replace the 6321385-6 Clip.
- (1) Remove and discard the 6321385-6 Clip.
 - (2) Put the 6321385-6 Clip into position and match drill one Number 21 (0.159 inch-diameter) hole in the clip that align with the existing holes in the rib.

- E. Remove and replace the 6321385-10 Clip.
- (1) Remove and discard the 6321385-10 Clip.
 - (2) Put the 6321385-10 Clip into position and ream five holes to a diameter between 0.1625 and 0.1645 inch-diameter that align with the holes in the WS 48.00 Rib.

- F. Remove and replace the 6321385-14 Clip.
- (1) Remove and discard the 6321385-14 Clip.
 - (2) Put the 6321385-14 Clip into position and ream five holes to a diameter between 0.1625 and 0.1645 inch-diameter that align with the holes in the WS 48.00 Rib.

- G. Remove and replace the 6321385-20 Clip.
- (1) Remove and discard the 6321385-20 Clip.
 - (2) Put the 6321385-20 Clip into position and ream three holes to a diameter between 0.1625 and 0.1645 inch-diameter that align with the holes in the WS 48.00 Rib.

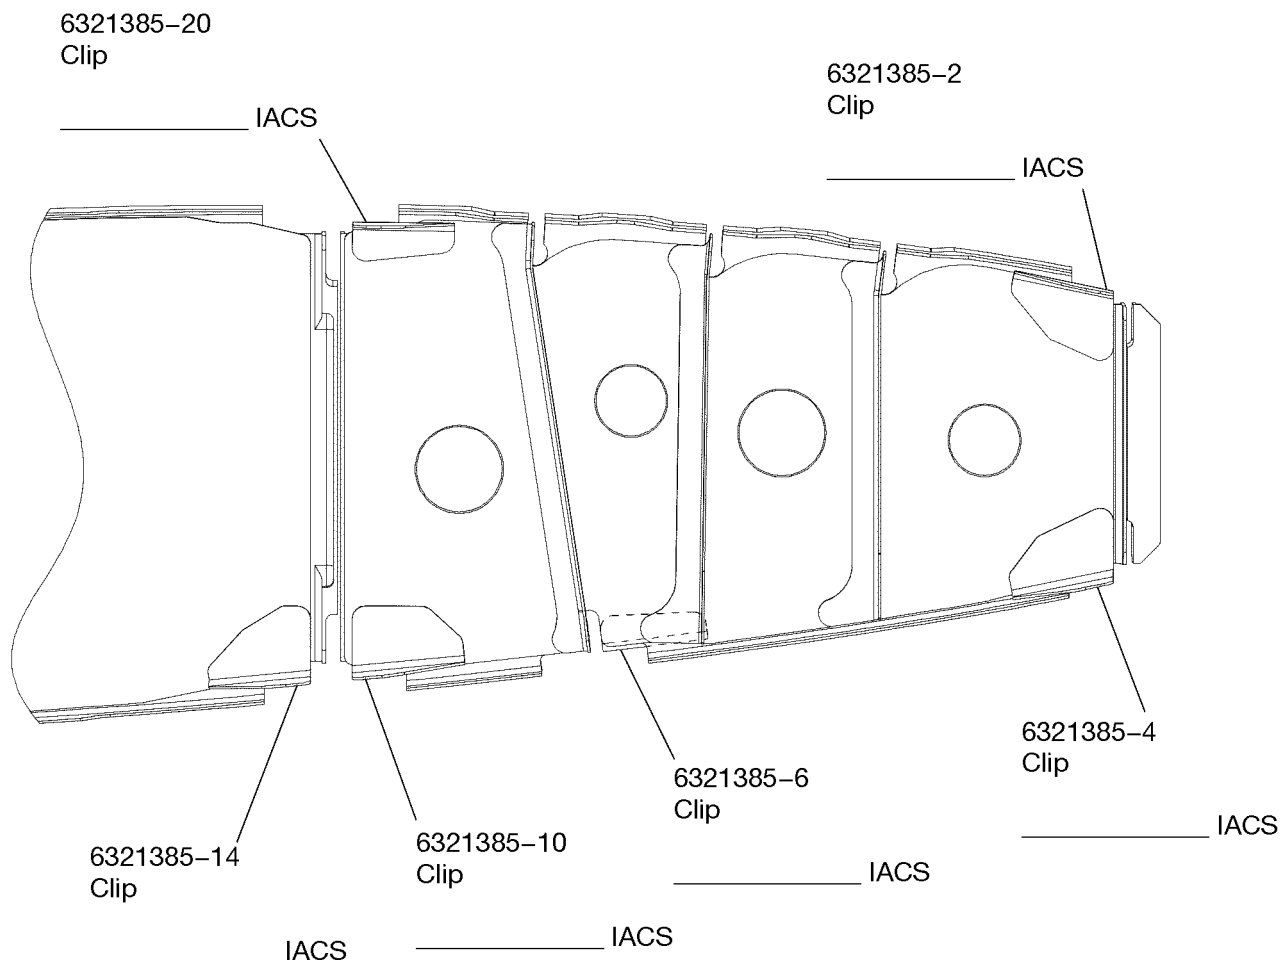
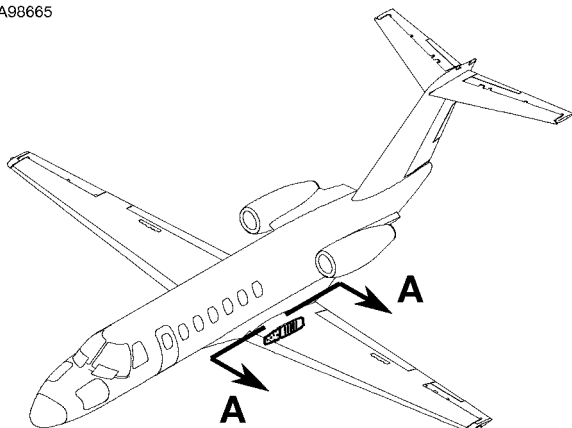
Figure 2. WS 48.00 Conductivity Results (Sheet 1)

3. (Refer to Figure 2.) Measure the conductivity of the identified clips with an Eddy Current instrument.

- (3) Record the conductivity values in Figure 2.
 - (4) If the apparent value is outside of the acceptable range contact Team CJ at 1-855-832-9831, 1-316-517-7785, or TeamCJ@txtav.com.
