MANDATORY**CAL-61-04****TITLE**

PROPELLER - B-40755A SPRAY HEAD ASSEMBLY REPLACEMENT

SB274

B-40755A SPRAY HEAD ASSEMBLY REPLACEMENT

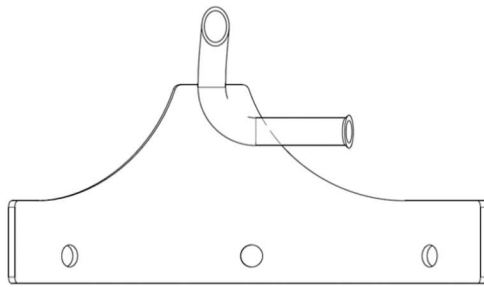
B-40755A

Figure 1. TKS Spray Head Assembly (Sheet 1)
