FLIGHT CONTROLS - INSPECTION OF THE AFT ELEVATOR SECTOR BOLT FOR CORRECT INSTALLATION

680A (Citation Latitude)

-0005 thru -0225

SL680A-27-08  
Page 1 of 6

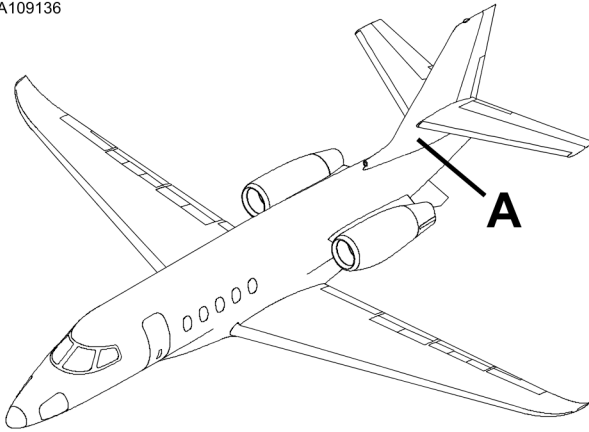
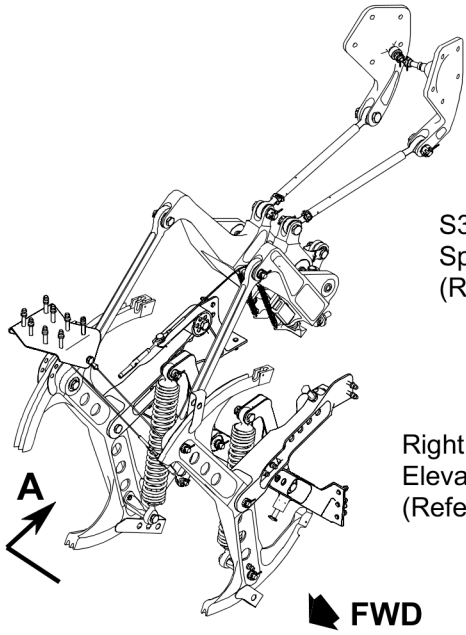
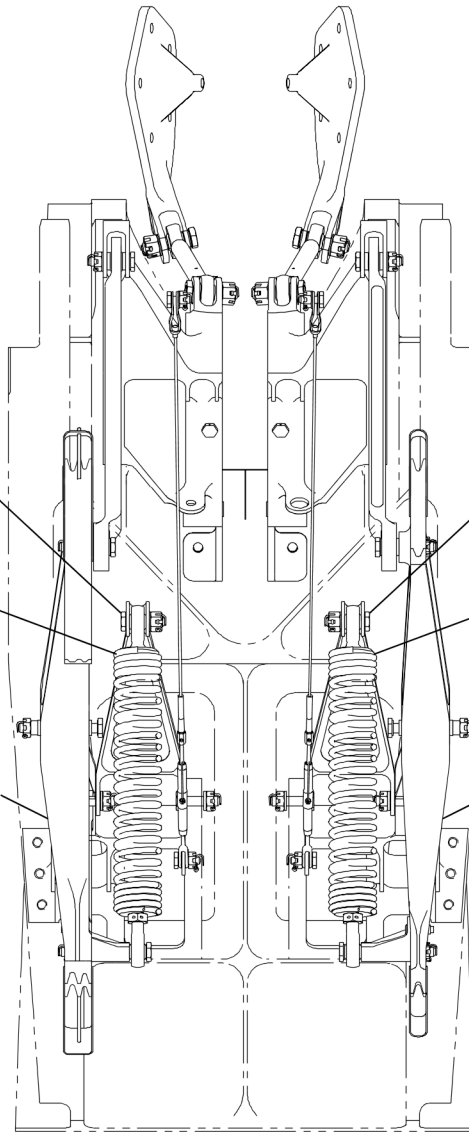
Figure 1. Inspection of the Aft Elevator Sector Bolt for Correct Installation (Sheet 1)

The bolts that attach the S3775-1 Spring to the aft elevator sector may have been installed with their heads oriented on the inboard side instead of outboard side.

- L. Using a high intensity light, examine the upper bolts that attach the down spring to the aft elevator sector for correct installation (bolt head installed facing outboard).

**NOTE:** The NAS6204-10D Bolt should be installed with the bolt head facing outboard.

- (e) Install the kept bolts with the head of the bolts facing outboard.
  - (f) Install the washers and nuts.
  - (g) Torque the bolts. (Refer to the Citation Standard Practices Manual, Chapter 20, Torque Data - Maintenance Practices.)

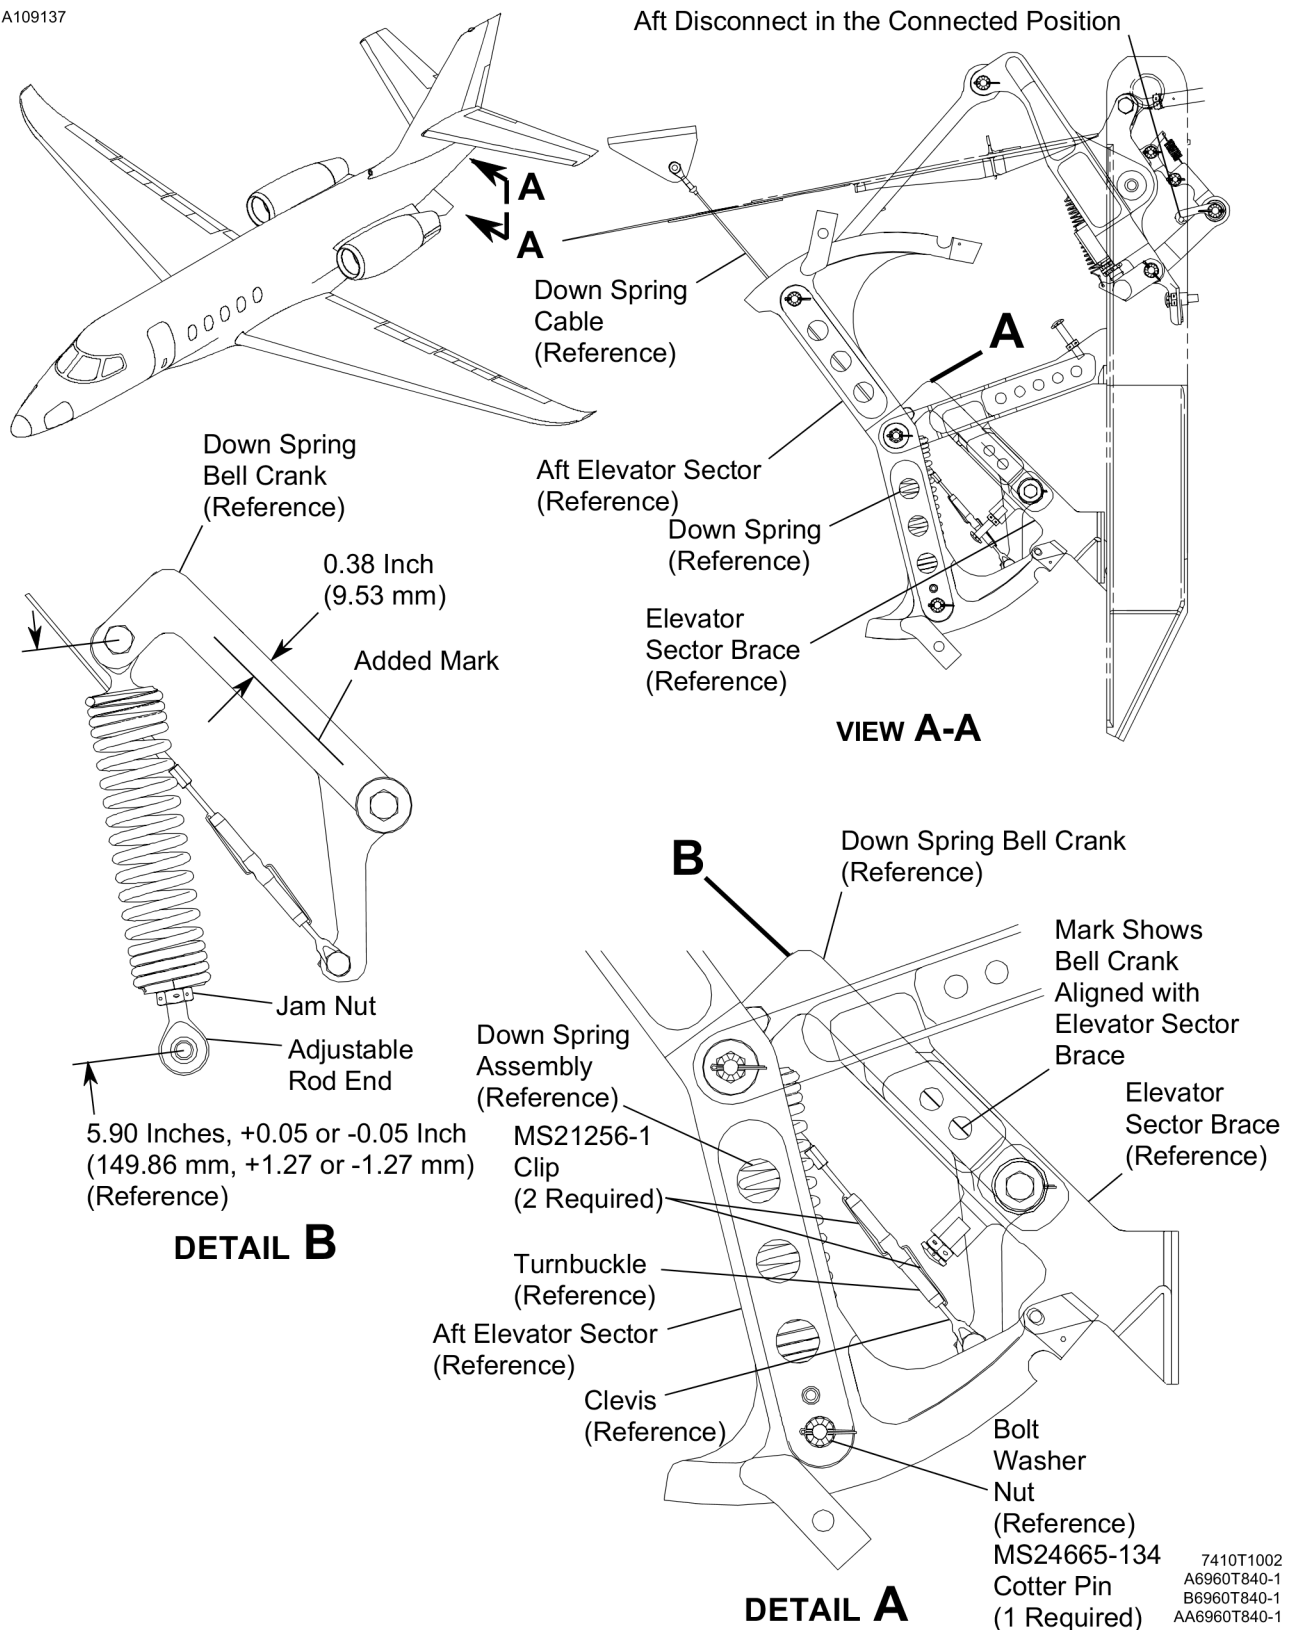
Figure 1. Inspection of the Aft Elevator Sector Bolt for Correct Installation (Sheet 2)

- (i) (Refer to Figure 2, Sheet 1.) If not already done, using an indelible marker, make a mark along the center line of both down spring bell cranks.

- (j) Adjust the down spring cable turnbuckles until the marks on both down spring bell cranks are aligned with the center of the holes in the aft elevator sector brace.
