FUSELAGE - EMPENNAGE FASTENER VERIFICATION

MODEL	SERIAL NUMBERS
560XL (Citation Excel)	-5002 thru -5372
560XL (Citation XLS)	-5501 thru -5830
560XL (Citation XLS+)	-6001 thru -6230, -6232

SL560XL-53-19
Page 1 of 8

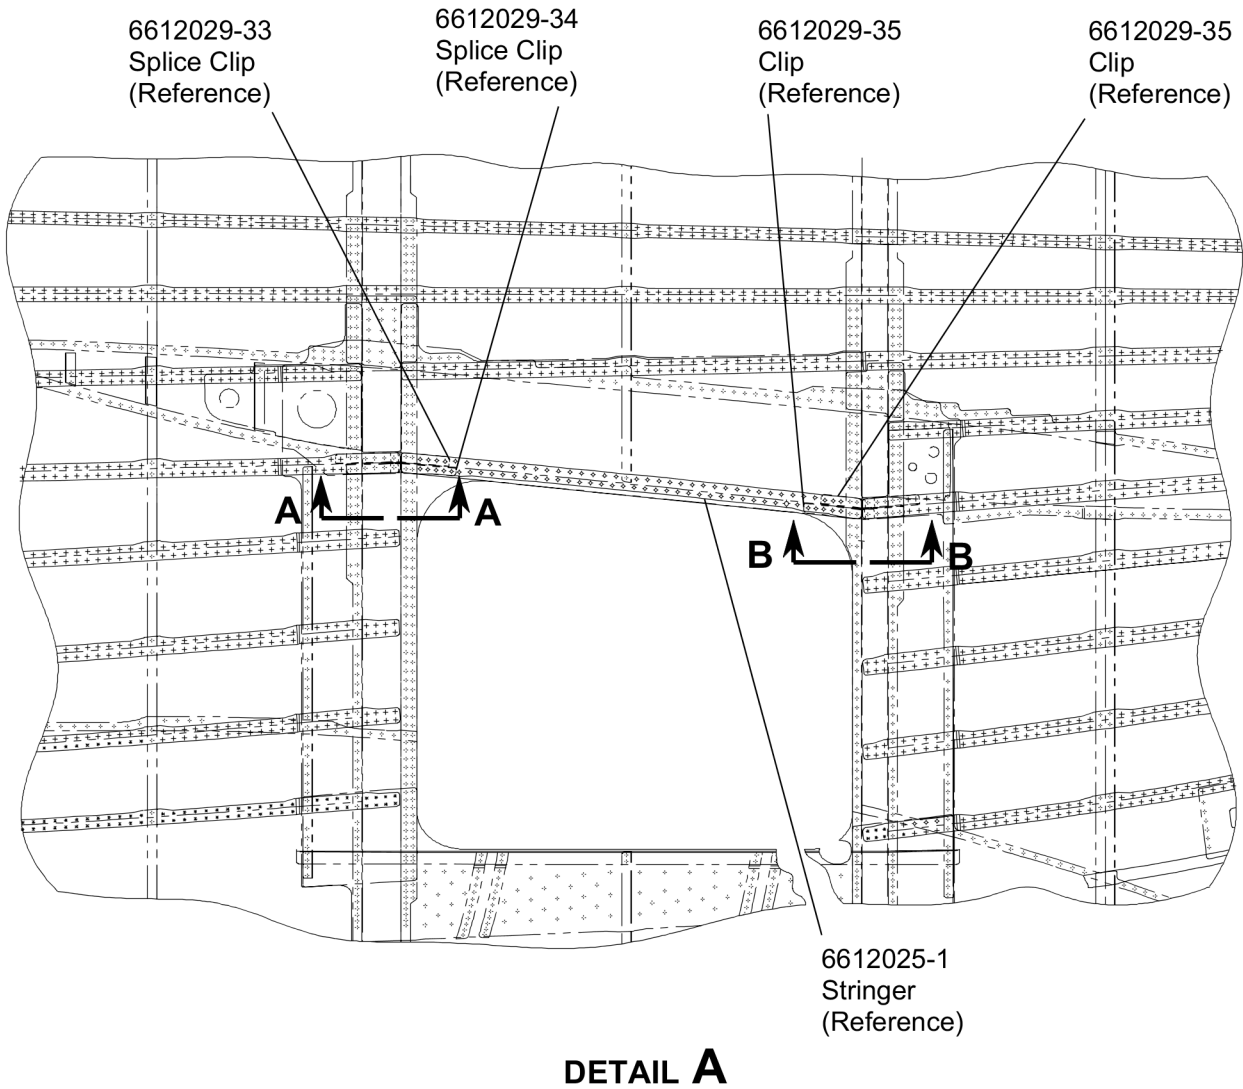
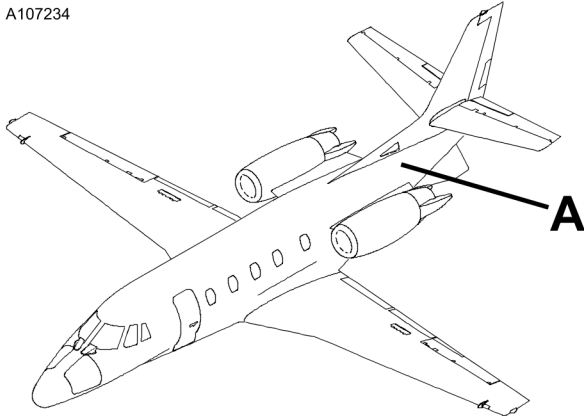
Figure 1. Rivet Inspection/Replacement (Sheet 1)

A fastener in the aft baggage door structure may have been omitted during manufacturing.

- B. (Refer to Figure 1, Detail A, View A-A and Detail B.) Inspect the rivets at FS 424 common to the 6612025-1 Stringer, 6612067-3 Longerons, 6612029-33 Clip and 6612029-34 Clip.

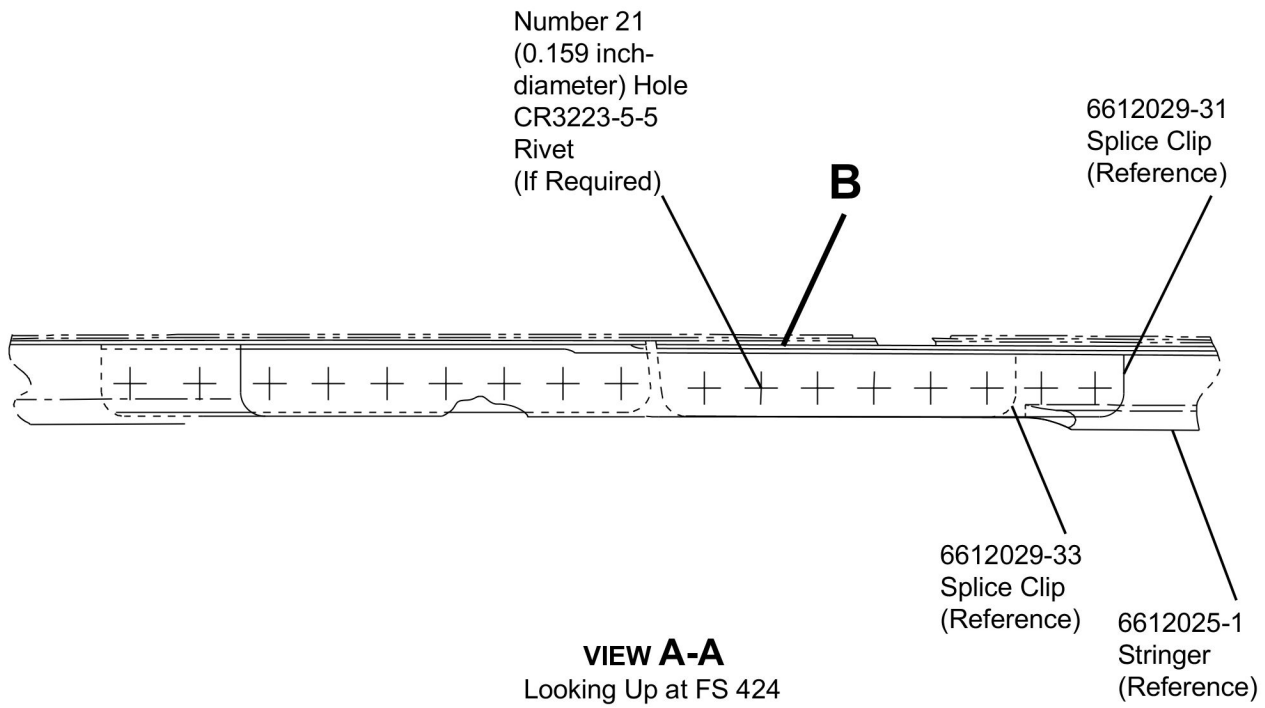
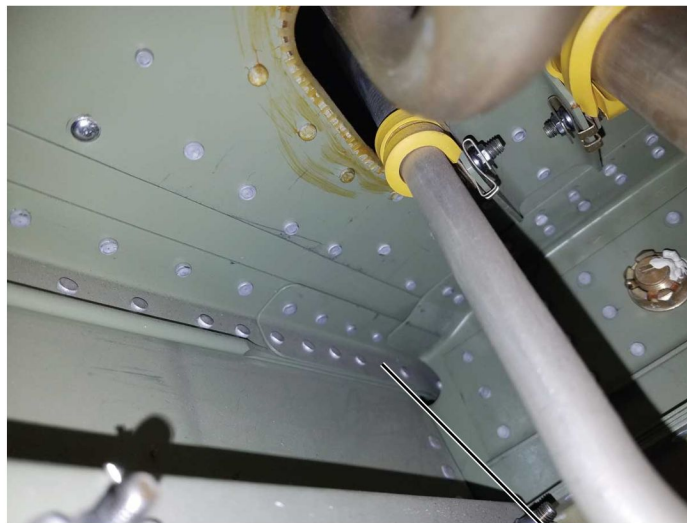
Figure 1. Rivet Inspection/Replacement (Sheet 2)

- (1) If there are six rivets common to the 6612025-1 Stringer, 6612067-3 Longerons, 6612029-33 Clip and 6612029-34 Clip, go to Step 3.C.

- (a) If there are not six rivets common to the 6612025-1 Stringer, 6612067-3 Longerons, 6612029-33 Clip and 6612029-34 Clip, do the steps that follow.

Location of possible missing rivet

1 (Refer to Figure 1, View A-A and Detail B.) Layout and drill one Number 21 (0.159 inch-diameter) hole in the 6612025-1 Stringer, 6612067-3 Longerons, 6612029-33 Clip and 6612029-34 Clip at the location shown.

2 Deburr the hole.

3 Apply U074093 color chem film treatment to the hole that was drilled. (Refer to the Model 560XL Structural Repair Manual, Chapter 51, Protective Treatment of Metal.)

4 Apply K000574 corrosion resistant primer to the hole that was drilled. (Refer to the Model 560XL Structural Repair Manual, Chapter 51, Protective Treatment of Metal.)

5 Install one CR3223-5-5 Rivet in the 6612025-1 Stringer, 6612067-3 Longerons, 6612029-33 Clip and 6612029-34 Clip.

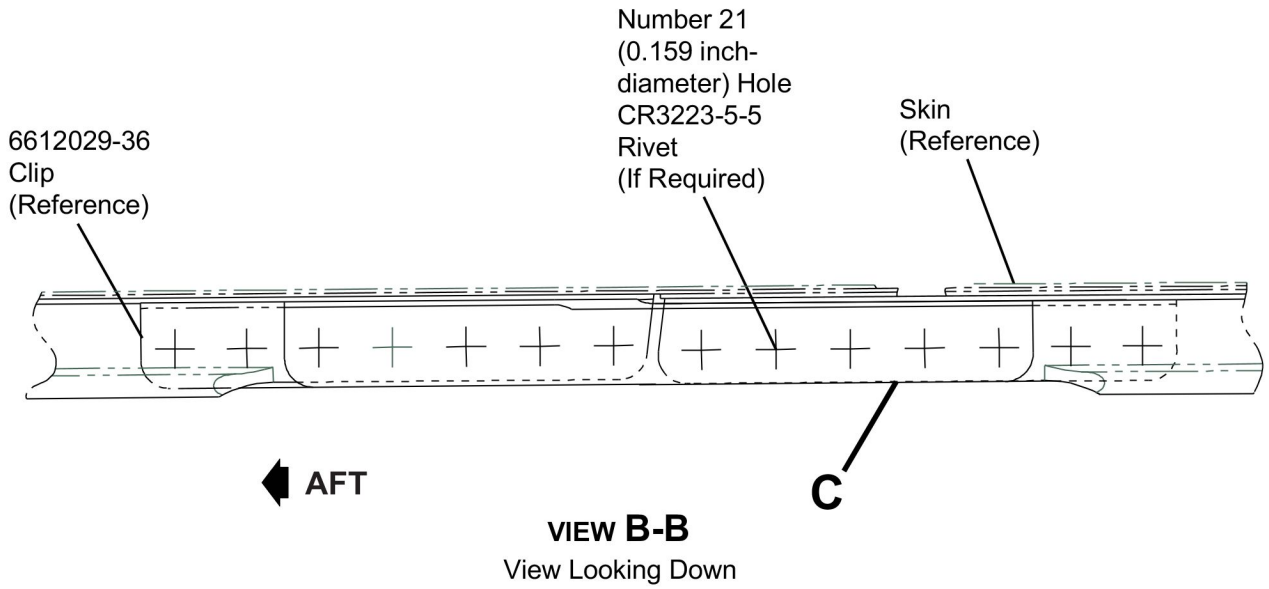
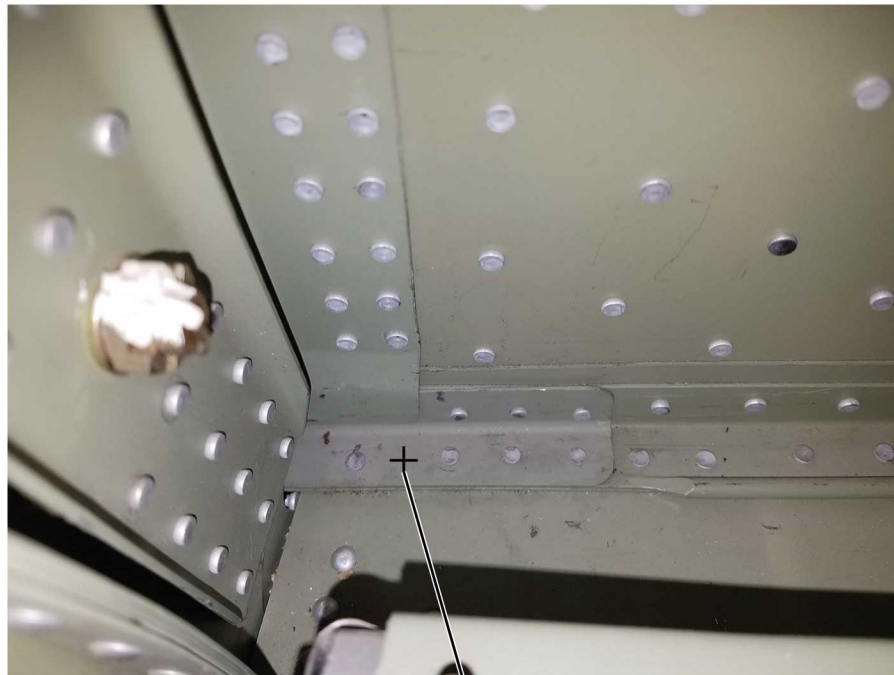
Figure 1. Rivet Inspection/Replacement (Sheet 3)

- C. (Refer to Figure 1, Detail A, View B-B and Detail C.) Inspect the rivets at FS 460 common to the 6612025-3 Stringer, 6612067-3 Longerons, 6612029-35 Clip and 6612029-36 Clip.

- (1) If there are five rivets common to the 6612025-3 Stringer, 6612067-3 Longerons, 6612029-35 Clip and 6612029-36 Clip, go to Step 3.
- (2) If there are not five rivets common to the 6612025-3 Stringer, 6612067-3 Longerons, 6612029-35 Clip and 6612029-36 Clip, do the steps that follow.

Location of possible missing rivet

- (a) (Refer to Figure 1, View B-B and Detail C.) Layout and drill one Number 21 (0.159 inch-diameter) hole in the 6612025-3 Stringer, 6612067-3 Longerons, 6612029-35 Clip and 6612029-36 Clip at the location shown.

(b) Deburr the hole.

(c) Apply U074093 color chem film treatment to the hole that was drilled. (Refer to the Model 560XL Structural Repair Manual, Chapter 51, Protective Treatment of Metal.)

(d) Apply K000574 corrosion resistant primer to the hole that was drilled. (Refer to the Model 560XL Structural Repair Manual, Chapter 51, Protective Treatment of Metal.)

(e) Install one CR3223-5-5 Rivet in the 6612025-3 Stringer, 6612067-3 Longerons, 6612029-35 Clip and 6612029-36 Clip.
