FLIGHT CONTROLS - INSPECTION OF THE ROLL SPOILER SECTOR ASSEMBLY FOR MISSING BUSHING

680A (Citation Latitude)

SL680A-27-07
Page 1 of 6

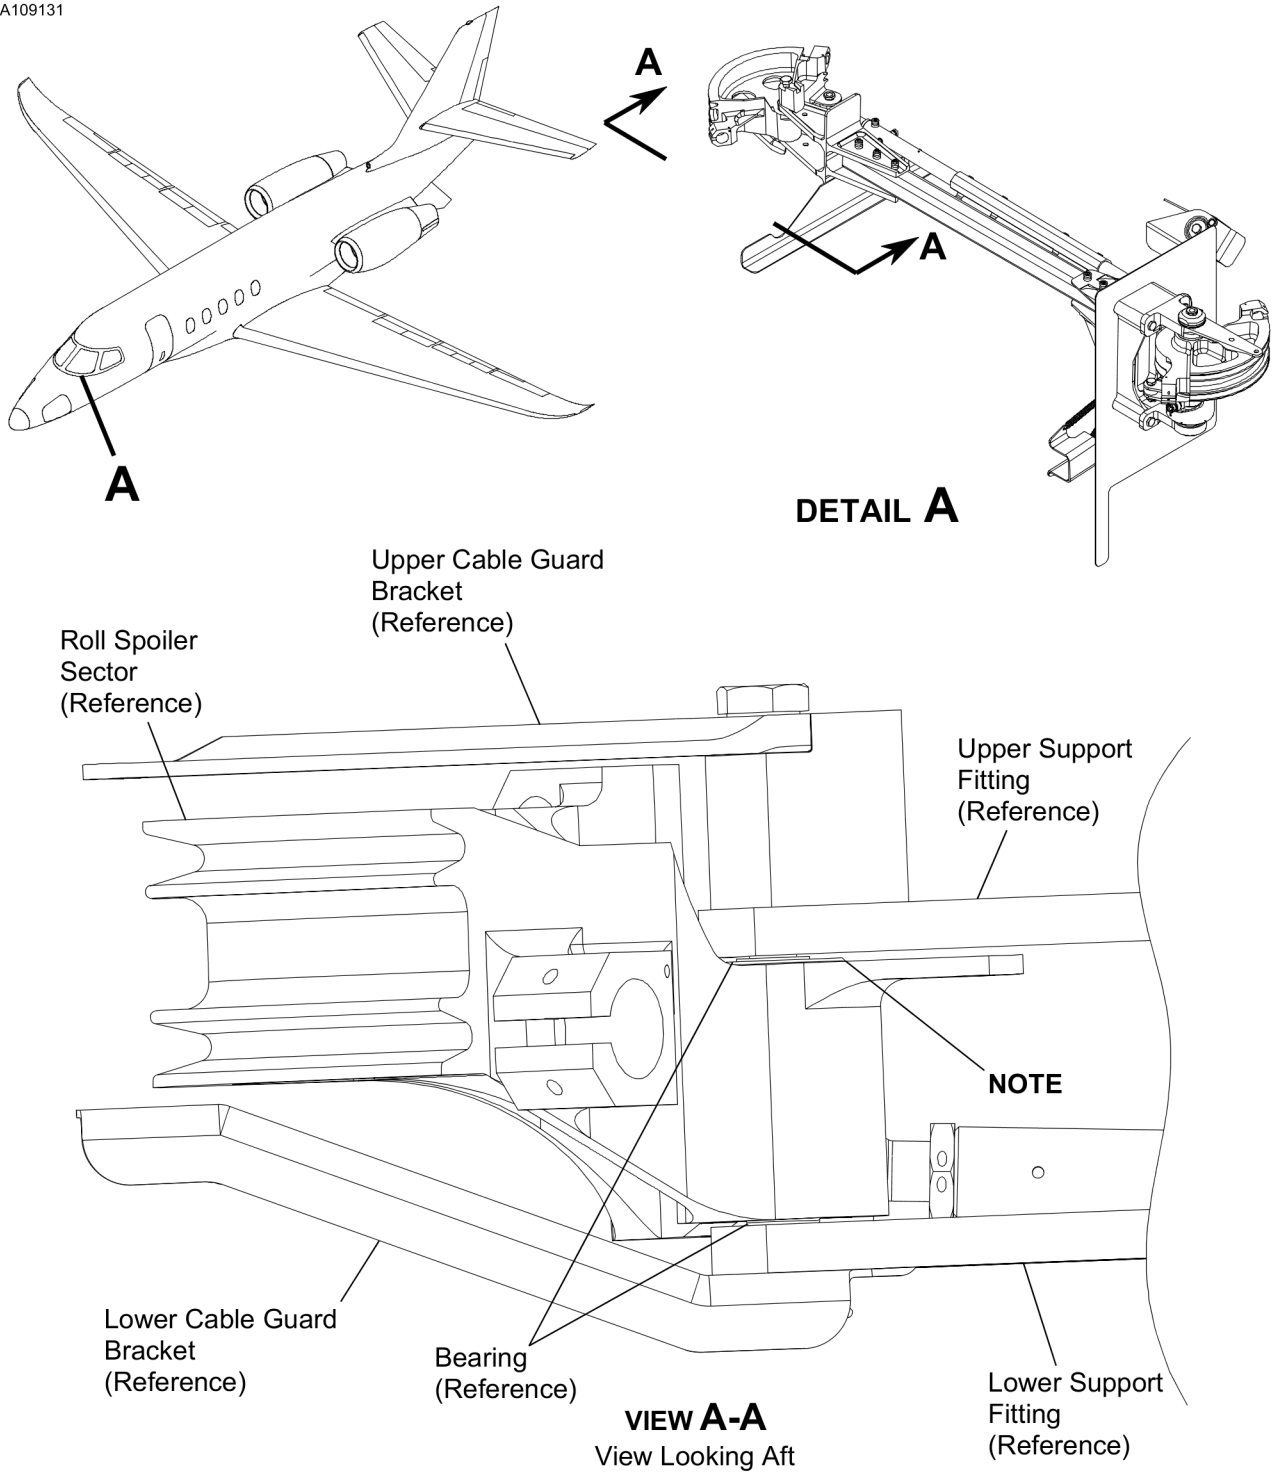
Figure 1. Inspection of the Roll Spoiler Sector Assembly for Missing Bushing (Sheet 1)

To inspect the roll spoiler sector assembly for a missing bushing and any damage that may have happened from scraping and/or clamping loads.

2. (Refer to Figure 1, Sheet 1.) Examine the roll spoiler sector assembly for a missing bushing as follows:
 - A. Using a high intensity light and 0.020 inch feeler gauge, make sure there is a minimum of 0.020 inch clearance between the surfaces of the upper support fitting and the roll spoiler sector.

NOTE: Make sure there is a minimum of 0.020 inch (0.5 mm) between the upper support fitting surface and the bearing.

- NOTE:** The NAS75-4-027 Bushing should be installed between the two bearings on the roll spoiler sector assembly.
- (i) Install the roll spoiler sector assembly as follows:

- 1 If necessary, install one NAS75-4-027 Bushing through the roll sector upper and lower bearings.
 - 2 Install the roll spoiler sector, cable guard spacer, upper cable guard bracket and bolt.
