FUSELAGE - WIRE BUNDLE ANCHOR AND FLOOR SUPPORT ANGLE VERIFICATION

750 (Citation X+)

A wire bundle anchor and angle support may have been omitted during manufacturing.

SB750-53-34
Page 1 of 7

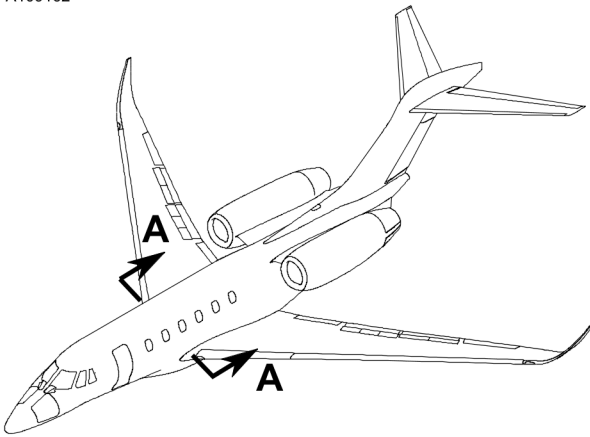
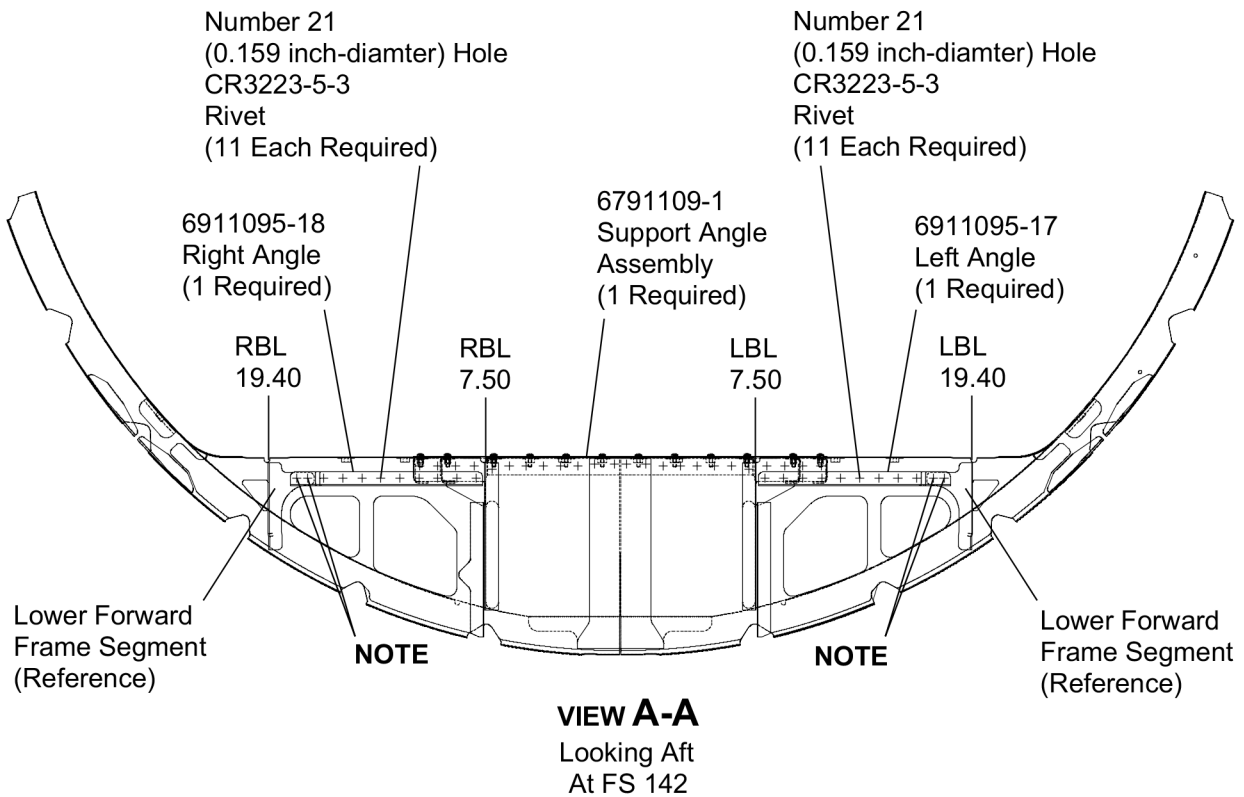
Figure 1. Wire Bundle Anchor Installation (Sheet 1)

NOTE: The edge distance at these locations must be at least 1.25D.
 If it is less than that contact Textron Aviation Engineering.

5. (Refer to Figure 1, View A-A, Detail B.) Do an inspection for the 6911095-17 Left Angle and 6911095-18 Right Angle.
 - A. If the 6911095-17 Left Angle is installed, go to Step 6.

- (3) Install the 6911095-17S Left Angle.
- (a) Put the 6911095-17S Left Angle on the lower forward frame segment.
 - (b) Drill 11 Number 21 (0.159 inch-diameter) hole in the lower forward frame segment to match the pilot holes in the 6911095-17 Left Angle.
NOTE: The edge distance (ED) of the two inboard holes must be at least 1.25D edge distance. If the ED is less than this contact Textron Aviation Engineering.
