NAVIGATION - GPS-4000S GLOBAL POSITIONING SYSTEM SOFTWARE UPDATE

560XL

SL560XL-34-27
Page 1 of 2

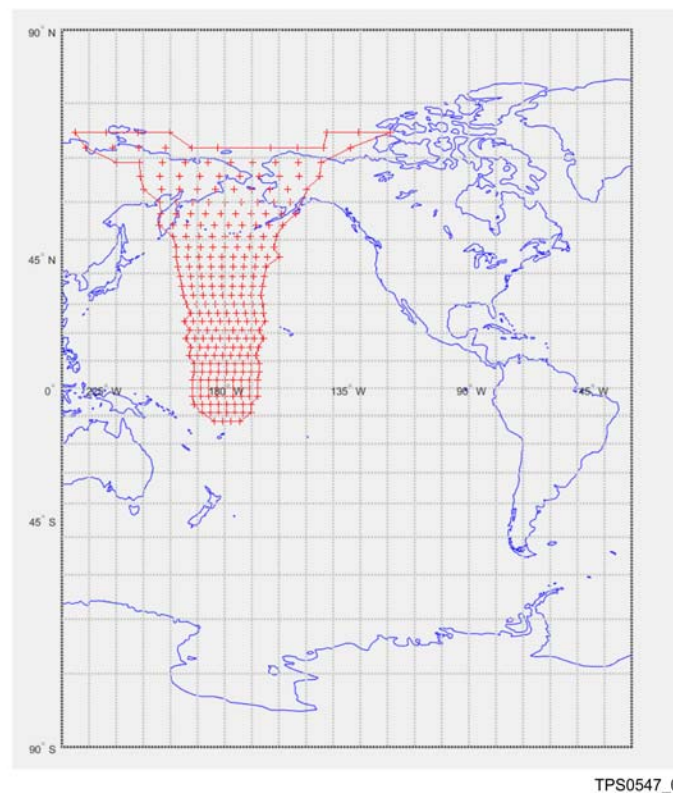
Map
Figure 1

- (1) The Root Cause has been identified as an improper implementation in the computation of the longitude at which the GPS signal penetrates the ionosphere when the satellite is located across 180 degrees W Longitude.
- (2) The affected region is limited to the area within the solid red line boundary indicated in the attached map. The region extends 20 degrees on either side of 180 degrees W Longitude and extends from the Northern Hemisphere to 10 degrees Latitude in the Southern Hemisphere. Refer to Figure 1.

- (3) The potential reduction in position accuracy caused by the computational issue prevents the GPS-4000S, CPN 822-2189-100, from supporting LPV approaches at LPV-equipped airports in the affected region.
- (4) Un-announced, but bounded reduced positional accuracy in the affected region limits operations to RNP 0.3 NM, or higher (Positional error will be bounded to 0.3 NM but may not be bounded by the protection level (HPL) that is output by the GNSS).

- (1) A software update that corrects this issue is targeted to be available in Q1 2020.
- (2) Until that software update is available, operational limitations will need to be applied. The operational limits are:
 - (a) Do not use the GPS-4000S, CPN 822-2189-100, to perform LPV approaches at airports in Alaska listed below. There are no airports outside of Alaska that are in the affected region that support LPV approaches at the time of this SIL publication. LPV-equipped airports will be monitored on every database update and if additional LPV-equipped airports are identified, this SIL will be updated.
 - (b) Do not perform operations that require an accuracy better than RNP 0.3 NM (For example, 0.1, 0.11, 0.15, etc.) in the region identified in the above map (+/- 20 degrees of 180 degrees W Longitude) or at the airports in Alaska listed below.
