ELECTRICAL POWER - WIRE BUNDLE ASSEMBLY (WBA) CLAMP AND ANCHOR MODIFICATION

700 (Citation Longitude)

SB700-24-01
Page 1 of 4

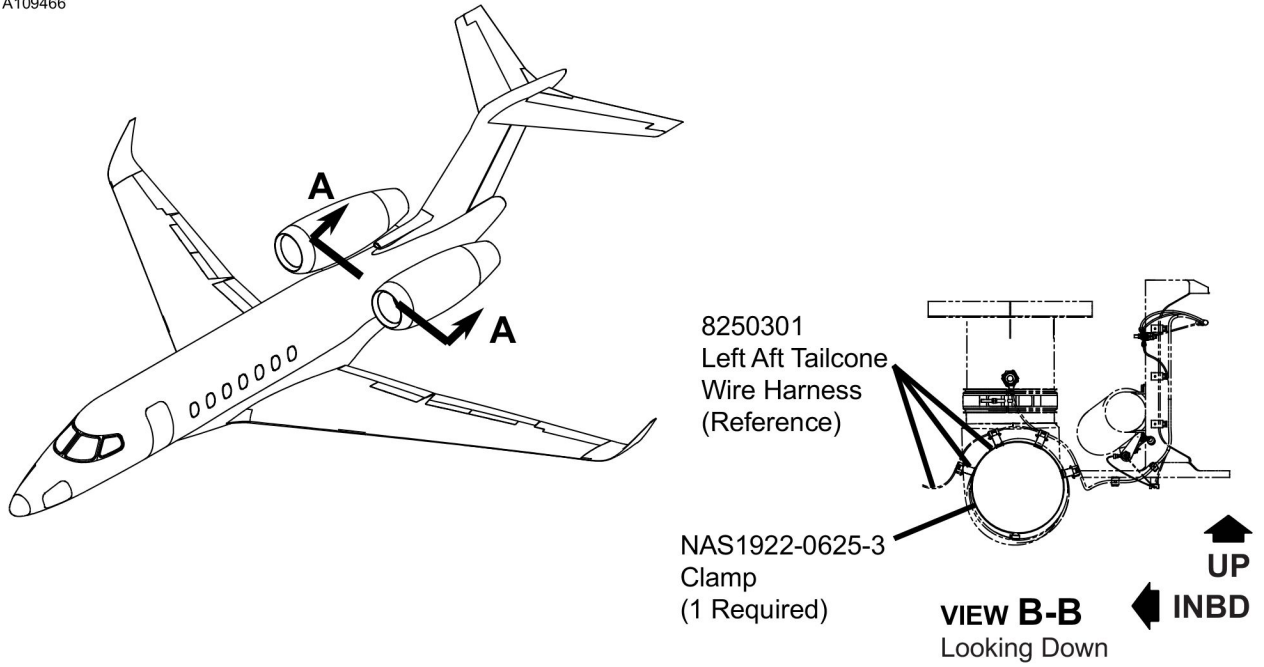
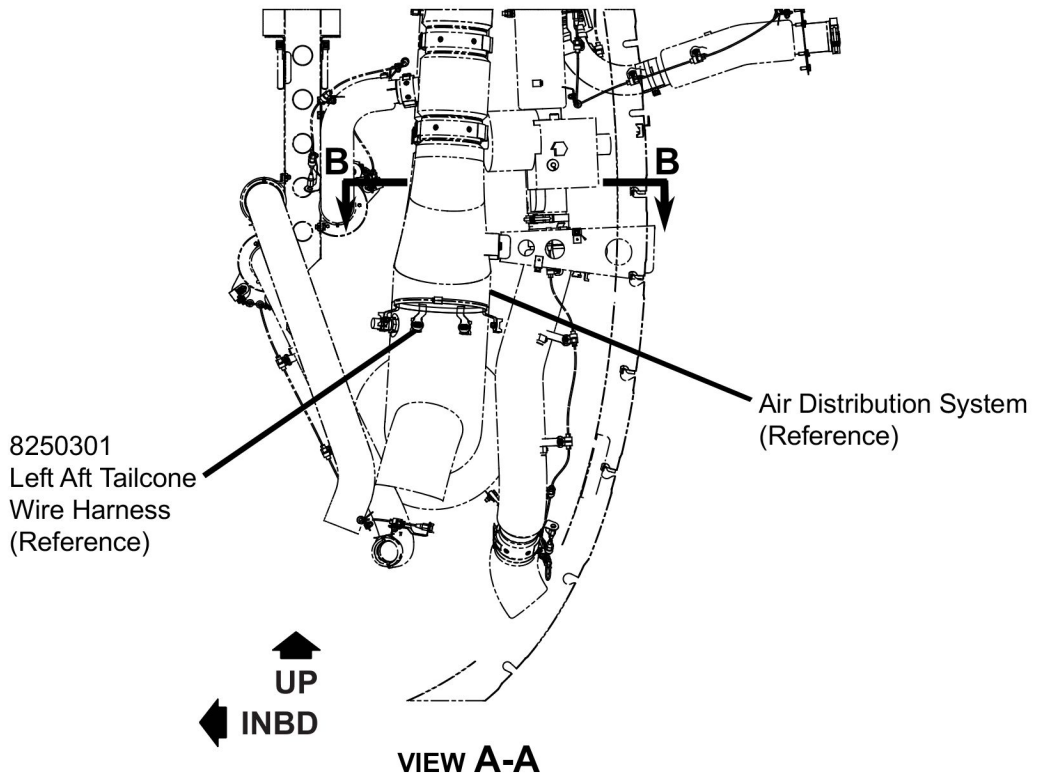
Figure 1. Wire Bundle Assembly Clamp Removal/Installation (Sheet 1)

The current wire bundle assembly clamp does not tighten.

3. (Refer to Figure 1, View A-A and View B-B.) Install a new NAS1922-0625-3 Clamp that attaches to the 8250301 Left Aft Tailcone Wire Harness to the air distribution system.

- A. Remove the 8250301 Left Aft Tailcone Wire Harness from the NAS1922-0700-3 Clamp.
 - B. Remove and discard the NAS1922-0700-3 Clamp from the air distribution system.

- C. Install the new NAS1922-0625-3 on the air distribution system.
4. Remove the maintenance warning tags and connect the airplane batteries.
5. Close the tailcone access door. (Refer to the Model 700 Maintenance Manual, Chapter 6, Dimensions and Areas - Description and Operation.)
