EQUIPMENT/FURNISHINGS - SEAT PAN TILT BLOCKING TAB INSTALLATION

CIL-25-03
Page 1 of 1

Model 2050 Seating System: Seat Pan Tilt Blocking Tab Installation

Document No: SB2050-25-20-03
Revision: IR
Date: 1/15/2020

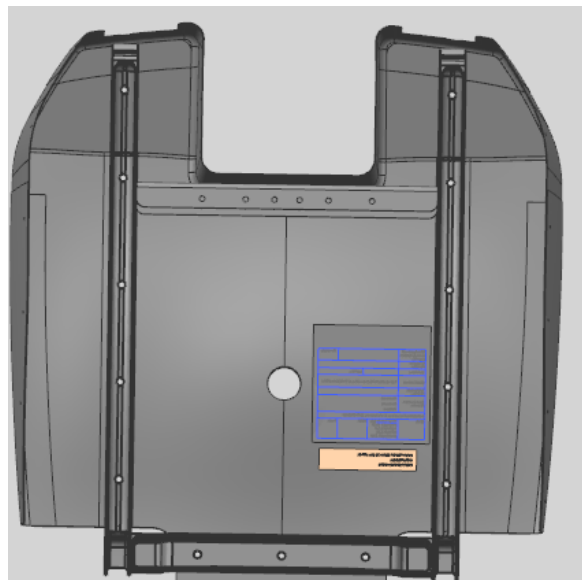
Figure 2.1 Modification ID Label and Protective Film Location

The new SB label should be installed on the bottom side of the composite seat pan as close to the existing seat ID label as space allows.

- A. Install 9000-1130008-001 Modification ID Label adjacent to the existing TSO ID label (or adjacent to existing modification labels) approximately as shown in Figure 2.1

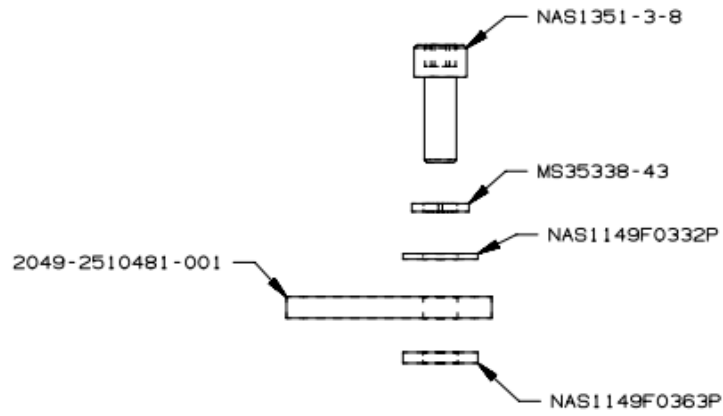
Figure 3.1 Stack-up Sequence

- A. The modification to the seat shall be performed outside the airplane (i.e. seat not installed).
- B. For best access it is recommended to adjust the seat to highest position with the seat pan tilt option adjusted “full up”.
- C. Stack the blocking tab with screw and washers per Figure 3.1
- D. Locate and orient the cable end fitting per Figure 3.2.
- E. Orient the blocking tab per Figure 3.3
- F. Install the blocking tab onto the cable end fitting using unused threaded hole in the cable end fitting (both sides). See Figure 3.2.
- G. Final check installation. See Figure 3.4 for the final configuration.

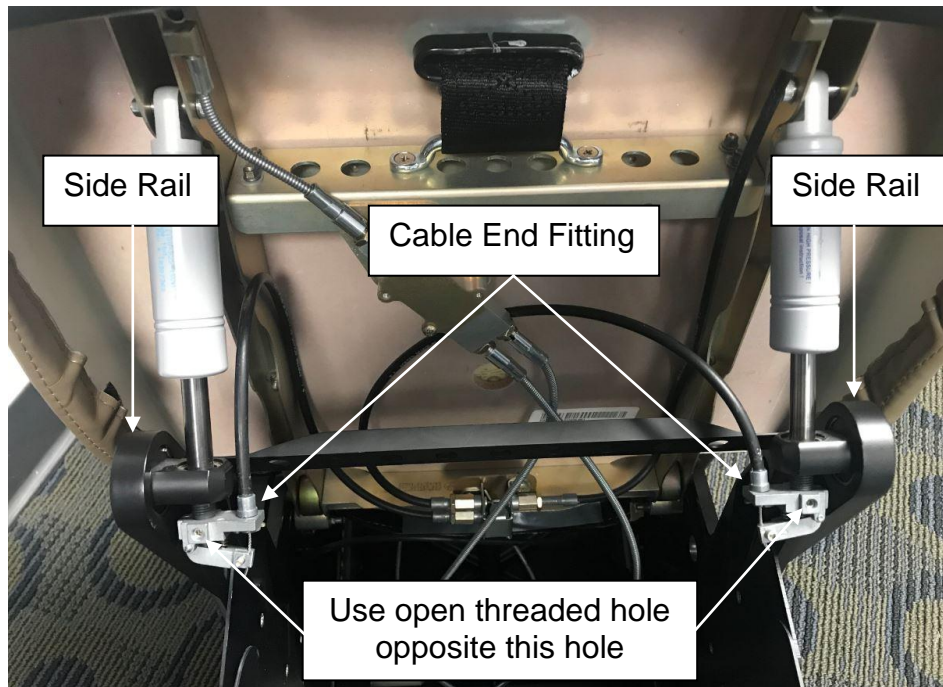
Note that this condition can also be remedied by simply rotating the cable end fittings to the position shown in Figure 3.2; however, this remedy does not prevent the fitting from rotating or being forced back to the discrepant position.

Figure 3.2 Cable End Fitting

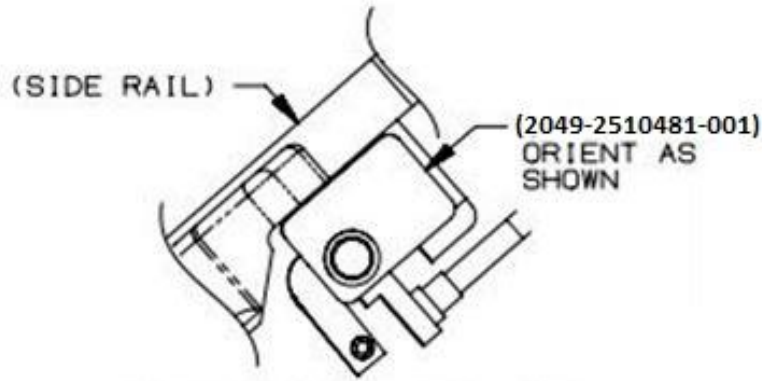
Figure 3.3 Blocking Tab Orientation

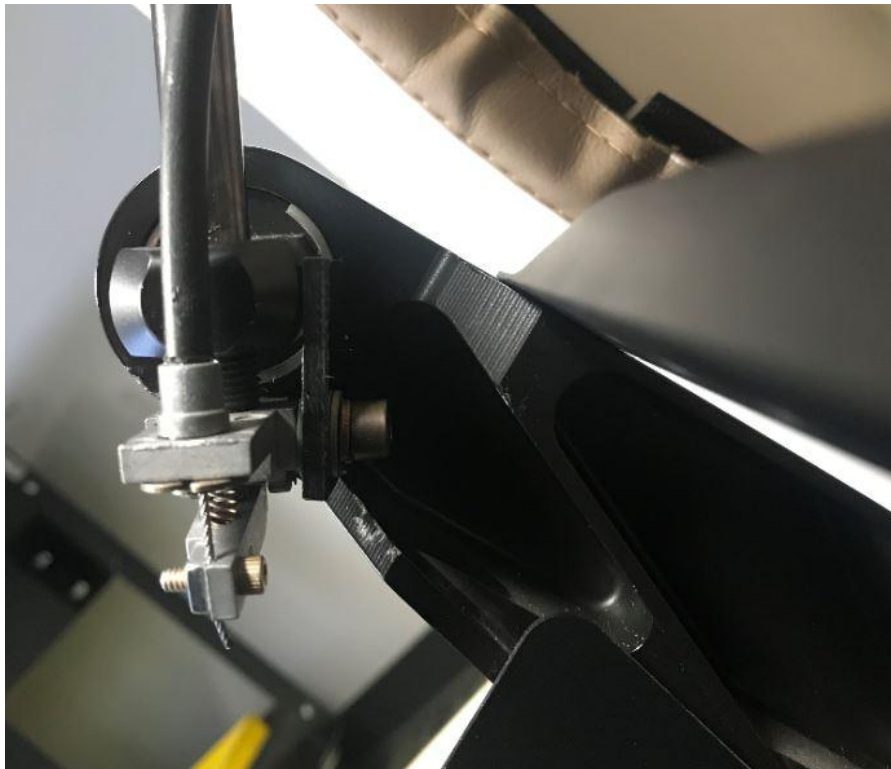
Figure 3.4 Blocking Tab Installed

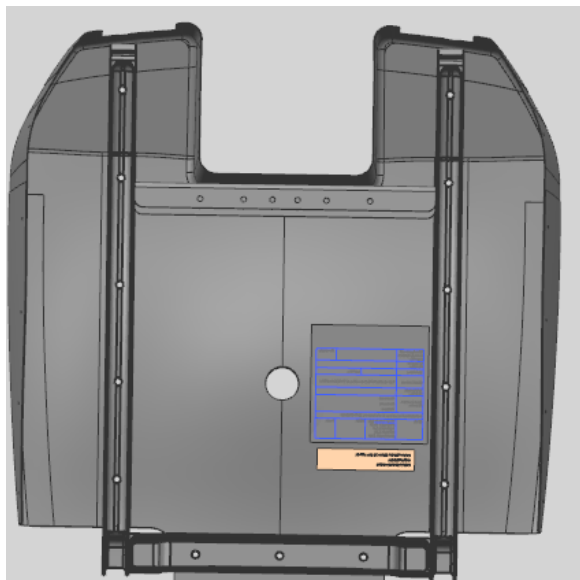
Figure 2.1 Modification ID Label and Protective Film Location

The new SB label should be installed on the bottom side of the composite seat pan as close to the existing seat ID label as space allows.

- A. Install 9000-1130008-001 Modification ID Label adjacent to the existing TSO ID label (or adjacent to existing modification labels) approximately as shown in Figure 2.1

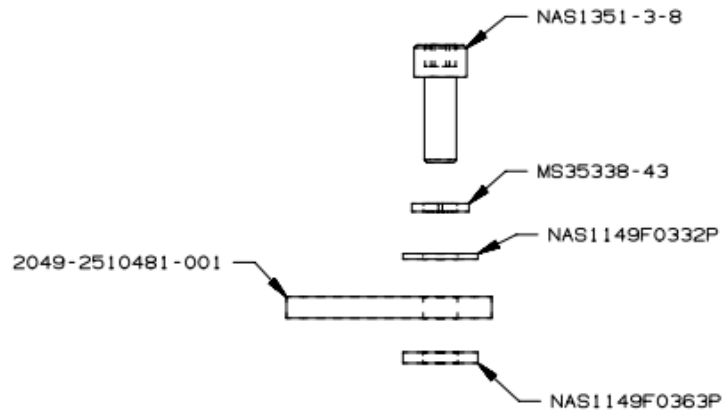
Figure 3.1 Stack-up Sequence

- A. The modification to the seat shall be performed outside the airplane (i.e. seat not installed).
- B. For best access it is recommended to adjust the seat to highest position with the seat pan tilt option adjusted "full up".
- C. Stack the blocking tab with screw and washers per Figure 3.1
- D. Locate and orient the cable end fitting per Figure 3.2.
- E. Orient the blocking tab per Figure 3.3
- F. Install the blocking tab onto the cable end fitting using unused threaded hole in the cable end fitting (both sides). See Figure 3.2.
- G. Final check installation. See Figure 3.4 for the final configuration.

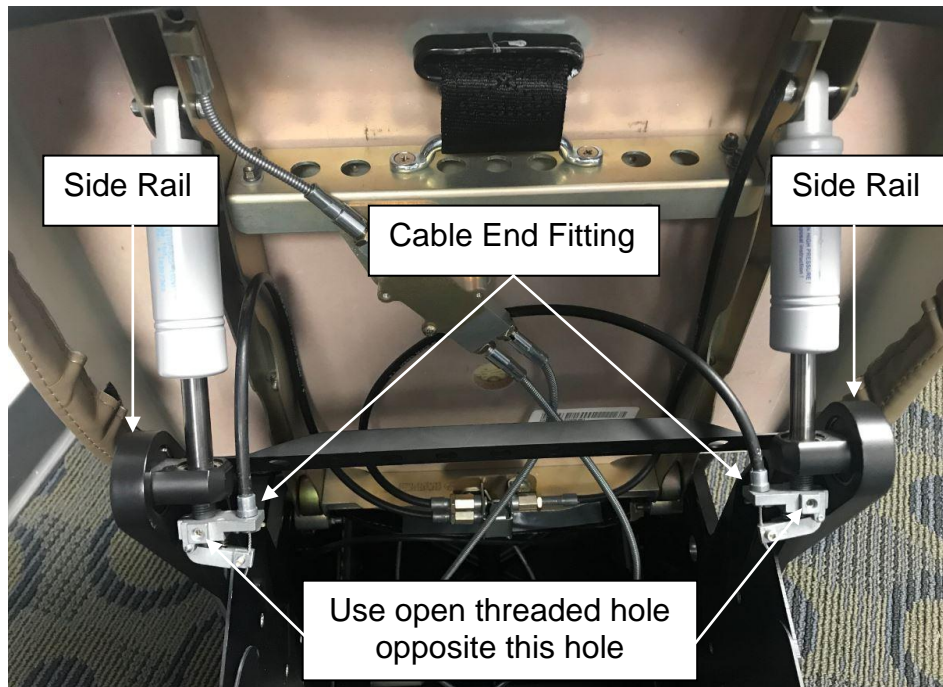
Note that this condition can also be remedied by simply rotating the cable end fittings to the position shown in Figure 3.2; however, this remedy does not prevent the fitting from rotating or being forced back to the discrepant position.

Figure 3.2 Cable End Fitting

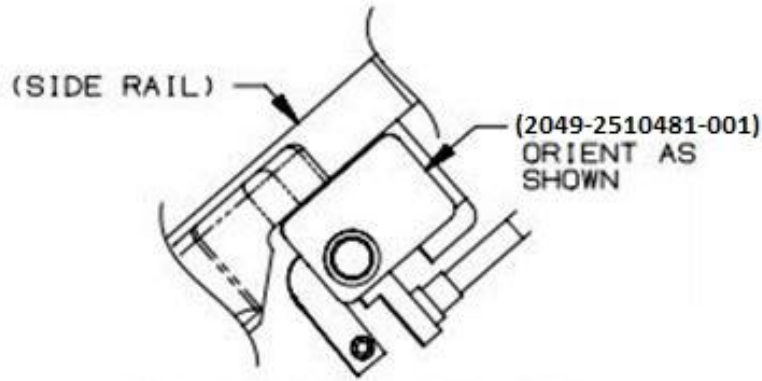
Figure 3.3 Blocking Tab Orientation

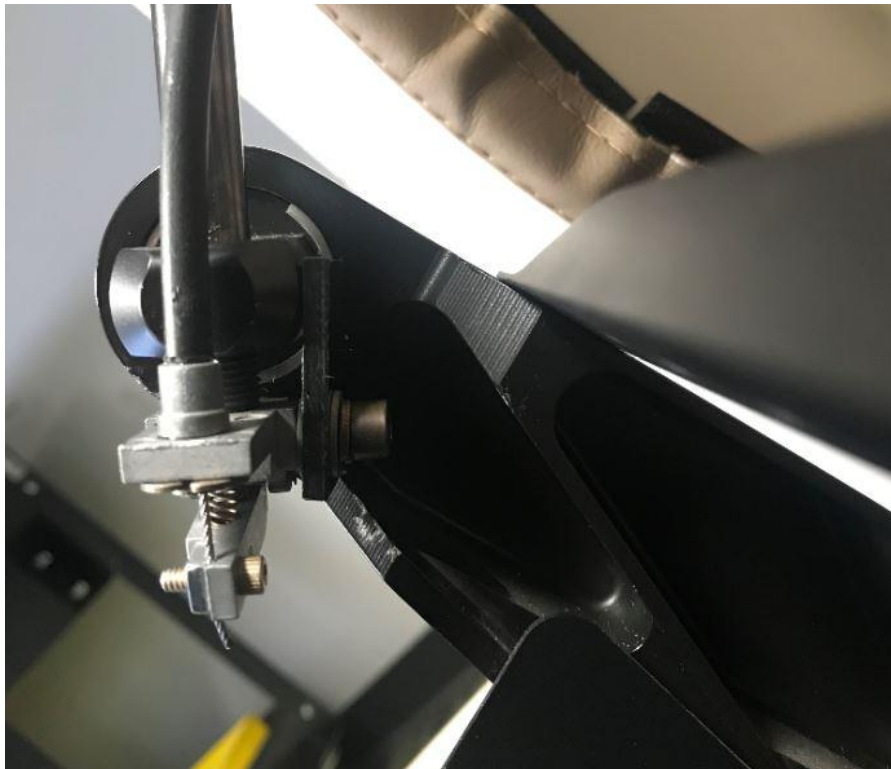
Figure 3.4 Blocking Tab Installed
