DOORS - EMERGENCY EXIT DOOR INNER HANDLE HARDWARE REPLACEMENT

MODEL	SERIAL NUMBERS
700 (Citation Longitude)	-0001 thru -0006, -0008 thru -0014
The equivalent of this service document has been incorporated on production airplanes -0007 and -0015 and On.

SB700-52-01
 Page 1 of 4

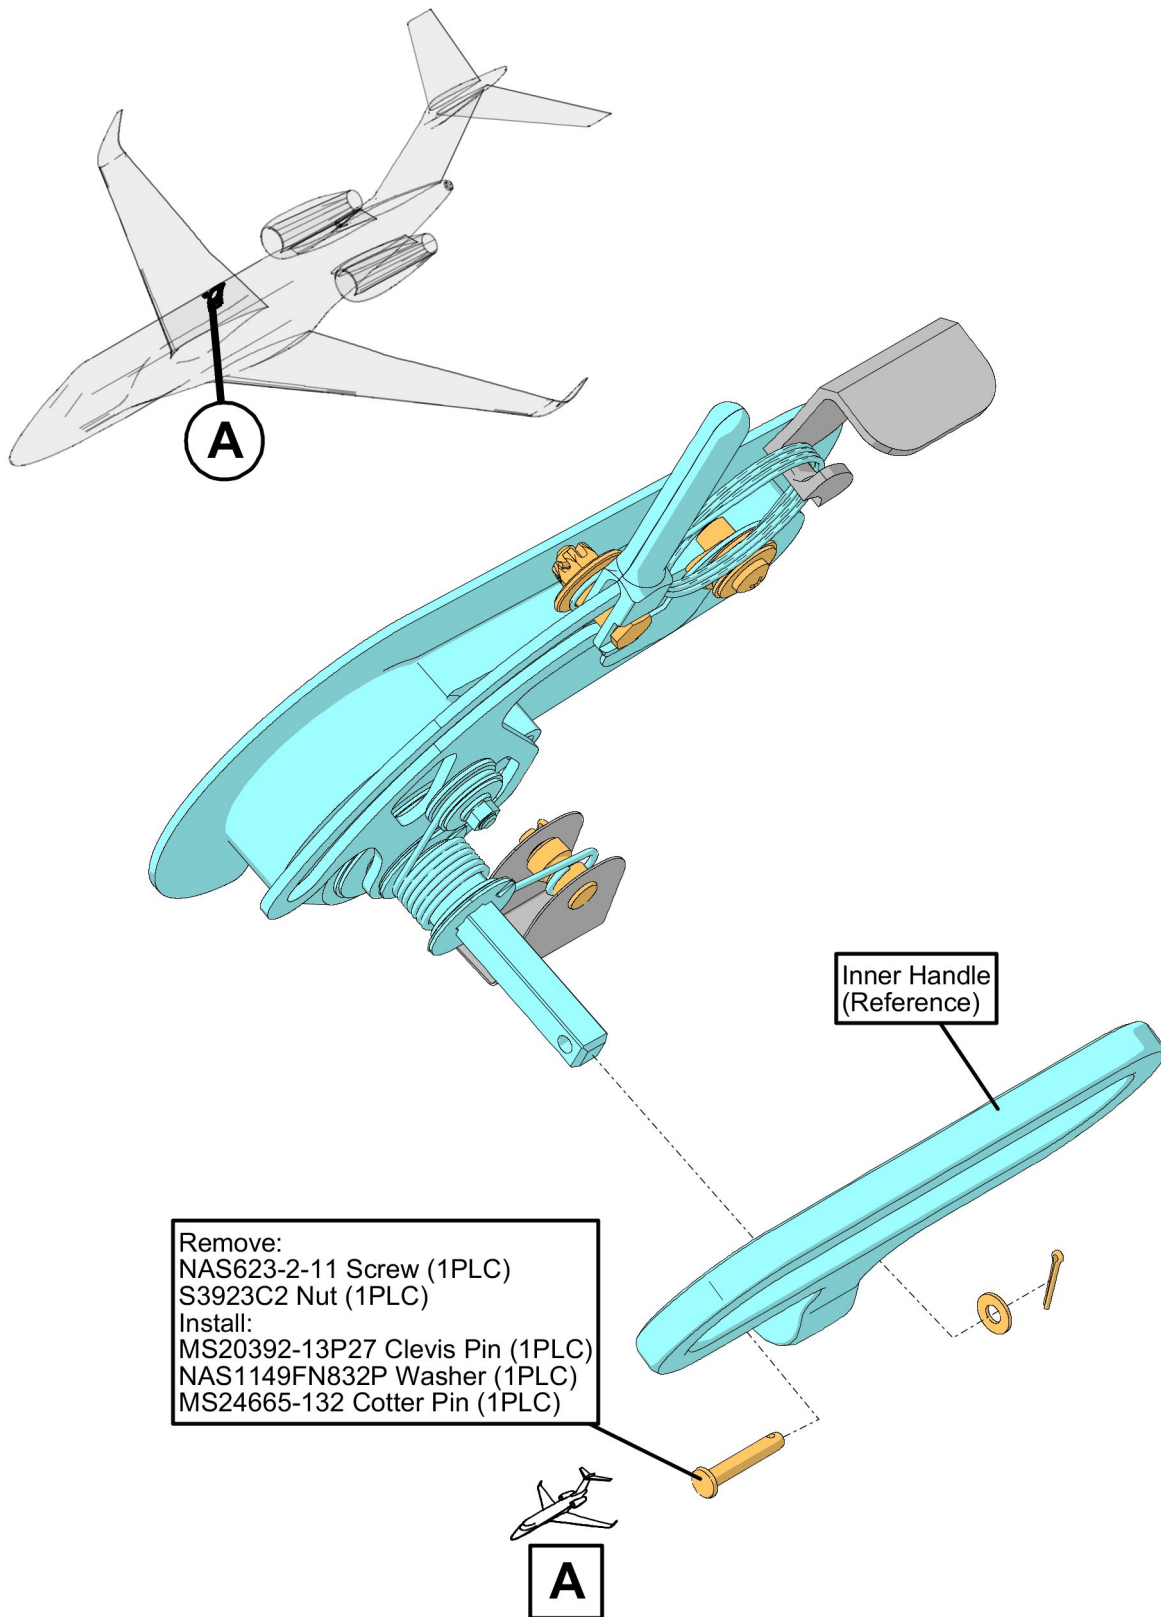
Figure 1. Emergency Exit Door Inner Handle Hardware Replacement (Sheet 1)

To replace the screw and nut that attach the emergency exit door inner handle with a clevis pin and cotter pin to eliminate the possibility of the door handle hardware from becoming loose and dislodged. Failing to comply with this Service Bulletin could result in difficulty in occupant egress from the aircraft in an emergency situation.

1. Remove the emergency exit door inner handle cover.
2. Replace the emergency exit door inner handle attach hardware as follows:
 - A. Loosen and remove the NAS623-2-11 Screw and S3923C2 Nut from the emergency exit door inner handle. Discard the hardware.
 - B. Install one MS20392-13P27 Clevis Pin through the emergency exit door inner handle and latch mechanism.
 - C. Install one NAS1149FN832P Washer and MS24665-132 Cotter Pin on the end of the clevis pin. (Refer to Cessna Citation Standard Practices Manual, Chapter 20, Safetying - Maintenance Practices.)
3. Install the emergency exit door inner handle cover.
4. Make an entry in the airplane logbook that states compliance and method of compliance with this service document.
