MANDATORY**SL560XL-76-04****TITLE**

ENGINE CONTROLS - THROTTLE QUADRANT RVDT LINKAGE INSPECTION

MODEL	SERIAL NUMBERS
560XL (Citation XLS+)	-6001 thru -6290

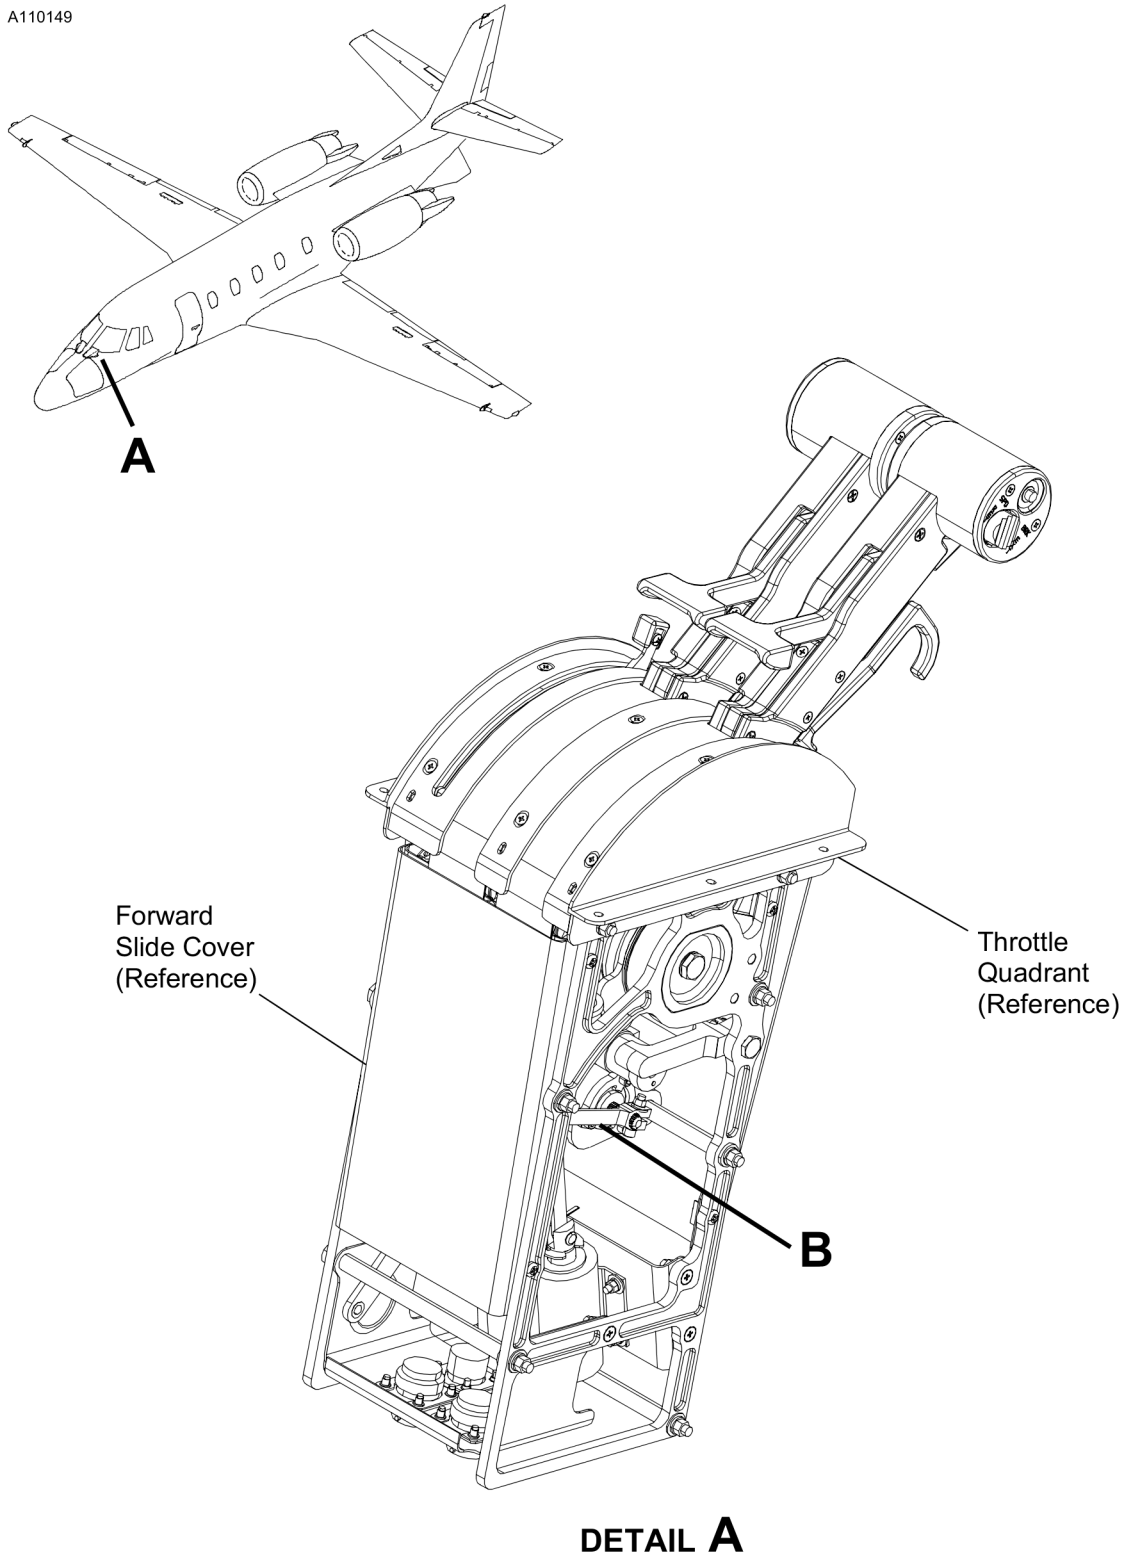
Figure 1. Throttle Quadrant RVDT Linkage Inspection (Sheet 1)

It is possible that a rivet in the throttle quadrant RVDT linkage is not installed correctly, which may cause an uncontrolled thrust increase.

- A. Remove and keep the forward slide cover assembly to access the RVDT linkage.
- B. The minimum allowable diameter of the rivet butt is 0.210 inch and the minimum allowable height is 0.040 inch.
 - (1) If both rivets are installed correctly, go to Step 3.C.
 - (2) If either of the rivets is not installed correctly, do the steps that follow:
 - (a) For rivets that do not have the correct minimum diameter and are above the minimum height of 0.040 inch, do the steps that follow:

- 1 Use a C-squeeze to achieve the correct minimum diameter of 0.210 inch. Make sure the rivet butt height remains between 0.040 and 0.080 inch.
- 2 Inspect the rivet butt for cracks.
 - a If cracks are not found, go to Step 3.C.
 - b If cracks are found, go to Step 3.B.(2)(b)1.

- (b) For rivets that fail the minimum height or fail both minimum height and minimum diameter, do the steps that follow:
- 1 Mark the RVDT shaft and linkage to create an alignment mark with a fine tip marker.
 - 2 Remove the clamp from the applicable sensor link. Keep the attaching hardware except for the MS20142-06 Nut.
 - 3 Remove the applicable RVDT linkage from the throttle quadrant.
 - a Keep the attaching hardware except for the cotter pins and nuts.
 - b Remove and discard the current MS20470AD6-7.5 Rivet. (Refer to the Model 560XL Structural Repair Manual, Chapter 51, Fastener Installation and Removal.)
 - 4 Install a new MS20470AD6-7.5 Rivet through the bearing in the Sensor Drive Arm and Sensor Link.
 - a Make sure the butt of the rivet is 0.210 to 0.225 inch diameter and the height is 0.040 to 0.080 inch.
