PNEUMATIC - INSPECTION OF THE TAILCONE BLEED AIR SENSING ELEMENT FOR INTERFERENCE WITH THE LADDER RETAINER DOOR

700 (Citation Longitude)

SL700-36-01
Page 1 of 6

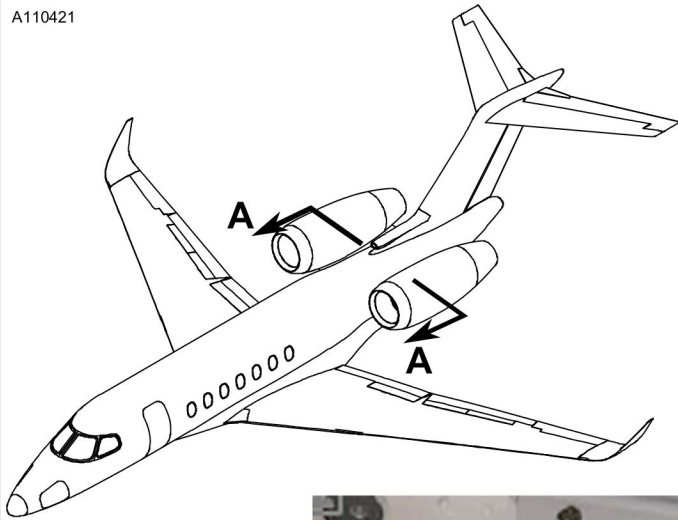
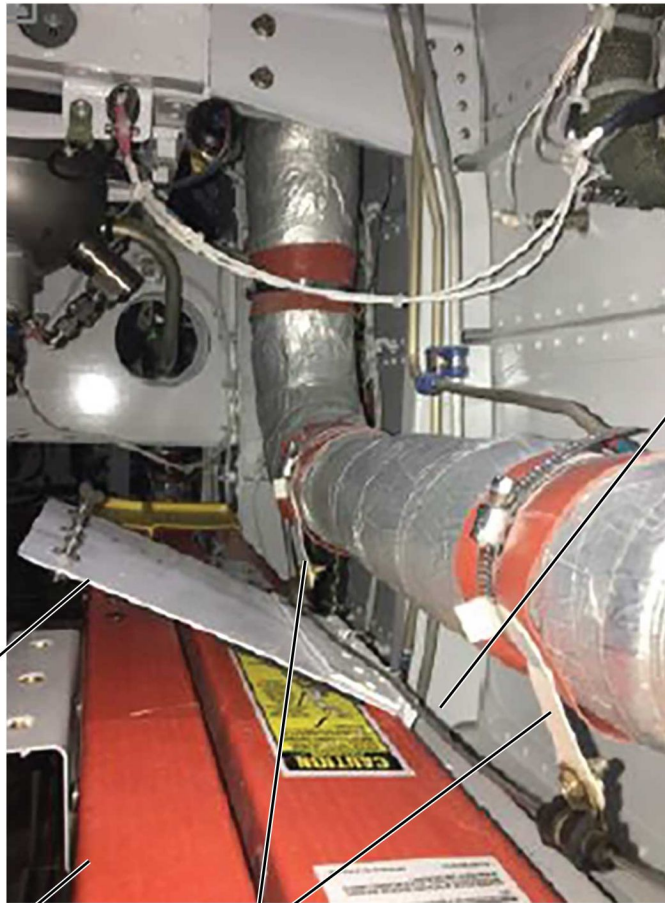
Figure 1. Tailcone Sensing Element Clearance Between the Retainer Door and Aircraft Structure (Sheet 1)

View Looking Forward With Sensing Element Interference
