# Single-Engine Turboprop Communiqué

Communiqué # SE-TP-009  
December 2020

## **ATA 32 – Center spring chafing damage from center spring fairing screws**

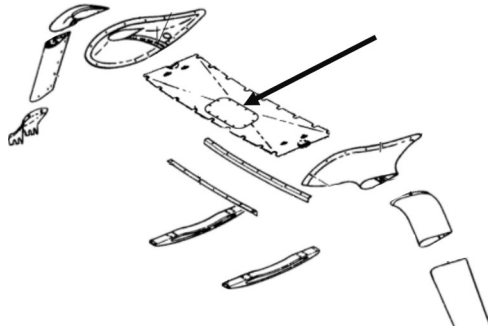
Figure 1: Fairing p/n 2611103-14 with access panel p/n 2611103-16

Aircraft equipped with a cargo pod or that still have center spring cover assembly part number 2611103-14 installed, must ensure that the proper screws are used to secure access panel part number 2611103-16 to that cover. The correct part number screw is MS27039-1-05 and, when installed, the threads of these screws must extend between .05” and .10” beyond the nut plate. Screws protruding beyond .10” may contact the center spring and cause damage. If chafing damage is present, inspect and repair the damage or replace the spring as necessary per the aircraft maintenance manual ATA 32. If the damage exceeds the limits set forth in the maintenance manual, the spring must be replaced.

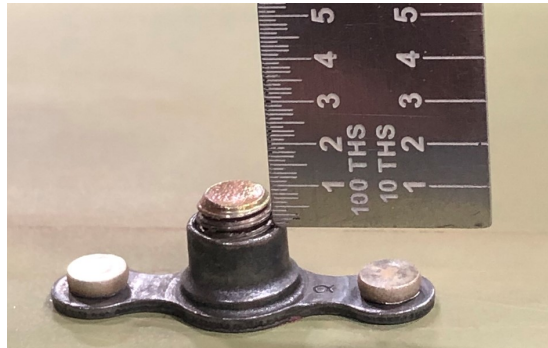
Figure 2: Proper thread protrusion of .05"-.10" beyond nut plate

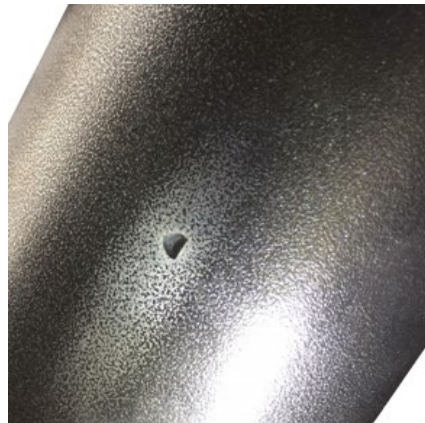
Figure 3: Chafing damage to center spring

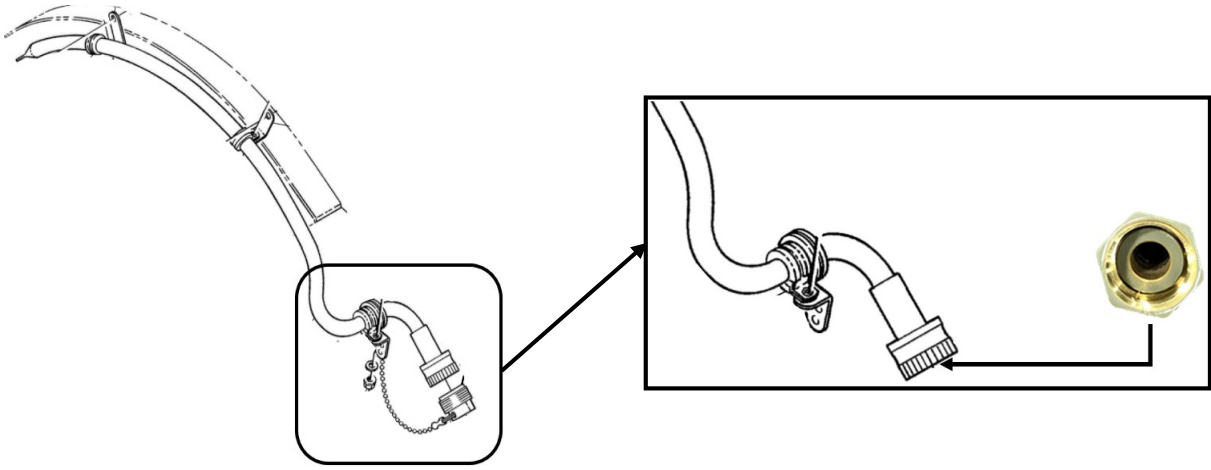
**ATA 71 – Compressor wash ring P/N 2650044-3 hose attach seal**

If the compressor wash ring leaks where the wash cart hose attaches, inspect the seal in the hose fitting end. Install a new seal if it is missing or replace it if condition warrants. For wash ring part number 2650044-3, the seal part number is 5911212W. This seal is inserted into the wash ring fitting end and is commercially available.
