FLIGHT CONTROLS - WING AILERON SECTOR PIN AND COLLAR INSPECTION

MANDATORY**SL525C-27-08****CONSUMABLE MATERIAL**

January 15, 2021

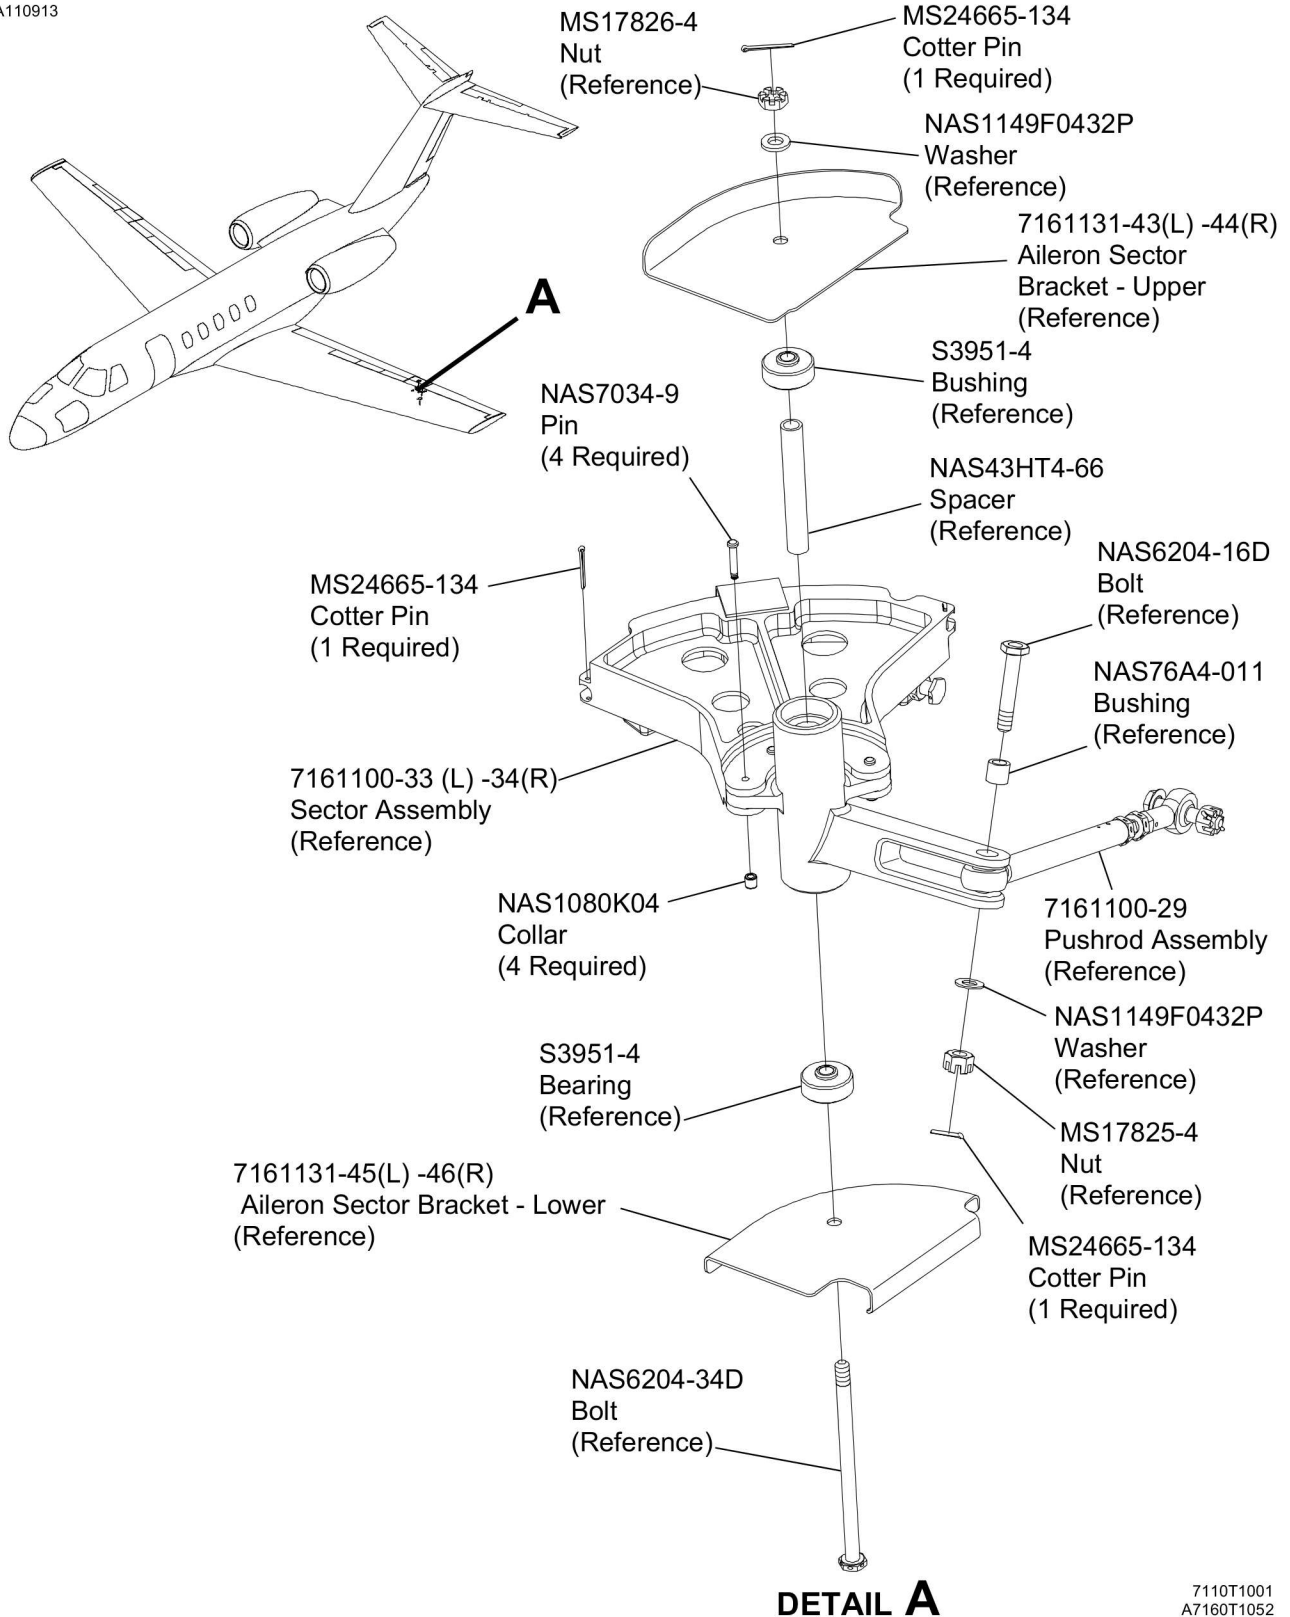
Figure 1. Aileron Sector (Sheet 1)

The swage lock fasteners on the left and right wing aileron sectors may not have been correctly installed. Failure to comply with this service letter could result in reduced control or loss of control of the aircraft.

4. (Refer to Figure 1, Sheet 1.) Replace any NAS7034-9 Pin and NAS1080K04 Collar that is not installed correctly.
 - A. Remove the affected aileron sector. (Refer to the Model 525C Maintenance Manual, Chapter 27, Wing Aileron Sector - Removal/Installation.)

- B. Remove the affected NAS7034-9 Pin and NAS1080K04 Collar.
 - C. Measure the hole diameter in multiple locations to make sure the hole is 0.124 to 0.1277 inch-diameter.

- (b) No further action is required, go to Step 4.C.(3)
 - (2) If the hole is not 0.124 to 0.1277 inch-diameter, use a ream to increase the hole size to 0.155 to 0.1585 inch-diameter.

NOTE: When the hole is reamed to the next size, a NAS7035-9 Pin and NAS1080K05 Collar will be used.
