LIGHTS - LED WING INSPECTION LIGHT INSTALLATION

208B

CAB-33-06
Page 1 of 10

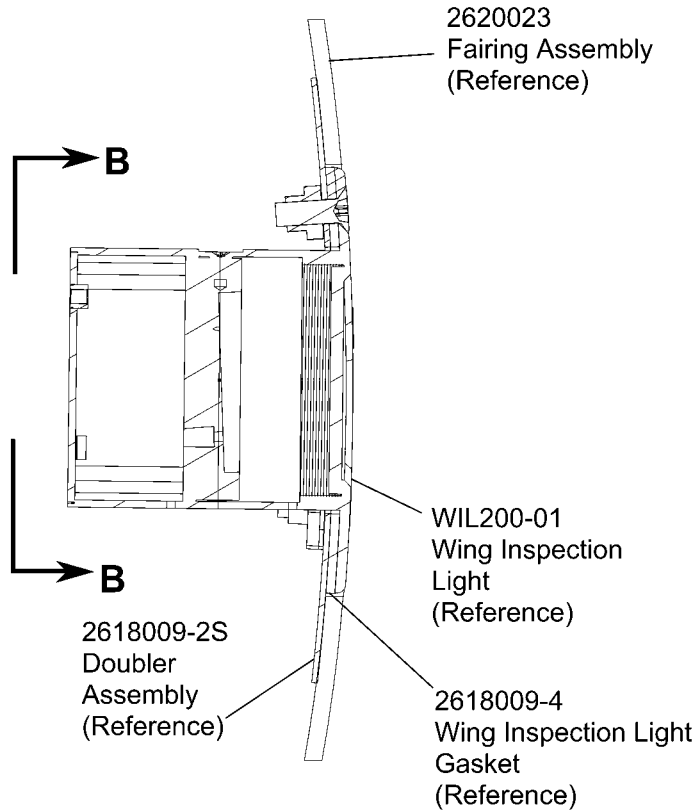
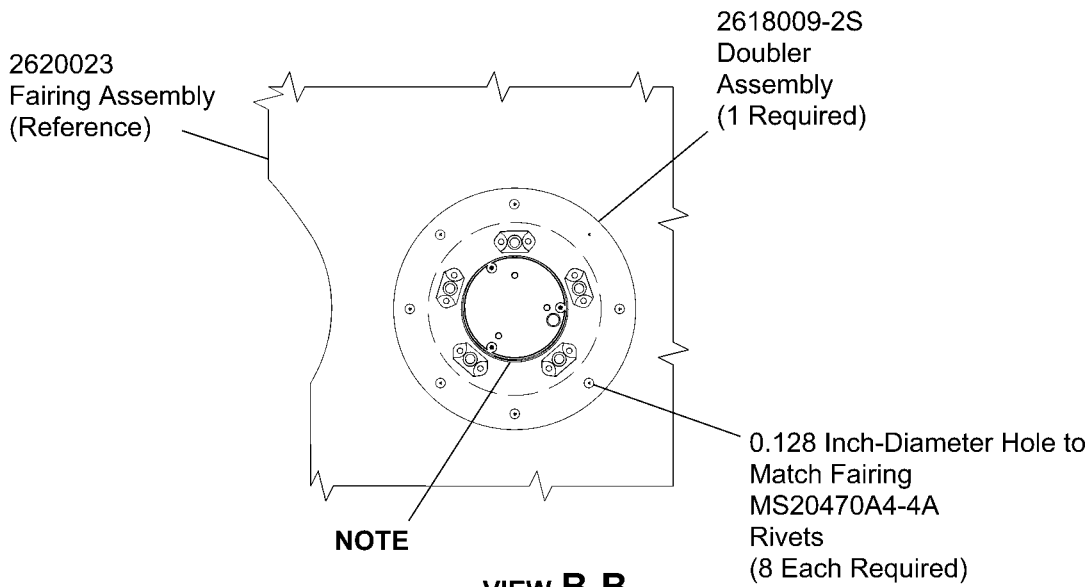
Figure 2. LED Wing Inspection Light Installation (Sheet 2)

NOTE: Position light assembly so drain hole is on bottom.

- E. Remove the WIL200-01 Light Assembly from the 2618009-2S Doubler.
 - F. (Refer to Figure 2, Sheet 2, View B-B.) Match drill eight 0.128 Inch-Diameter holes.

- G. Deburr the drilled holes.
 - H. Install the 2618009-2S Doubler on the 2620023 Fairing with eight MS20470A4-4A Rivets.
6. Use U000978 Adhesive and bond the 2618009-4 Gasket on the 2618009-2S Doubler Assembly making sure the holes are aligned.
