OIL - OIL PRESSURE SWITCH RELOCATION

Airplane Serial numbers that follow that have a Lycoming IO-360-L2A engine.

Cessna Model 172R and 172S Aircraft Owner

SEB-79-10  
Page 1 of 2

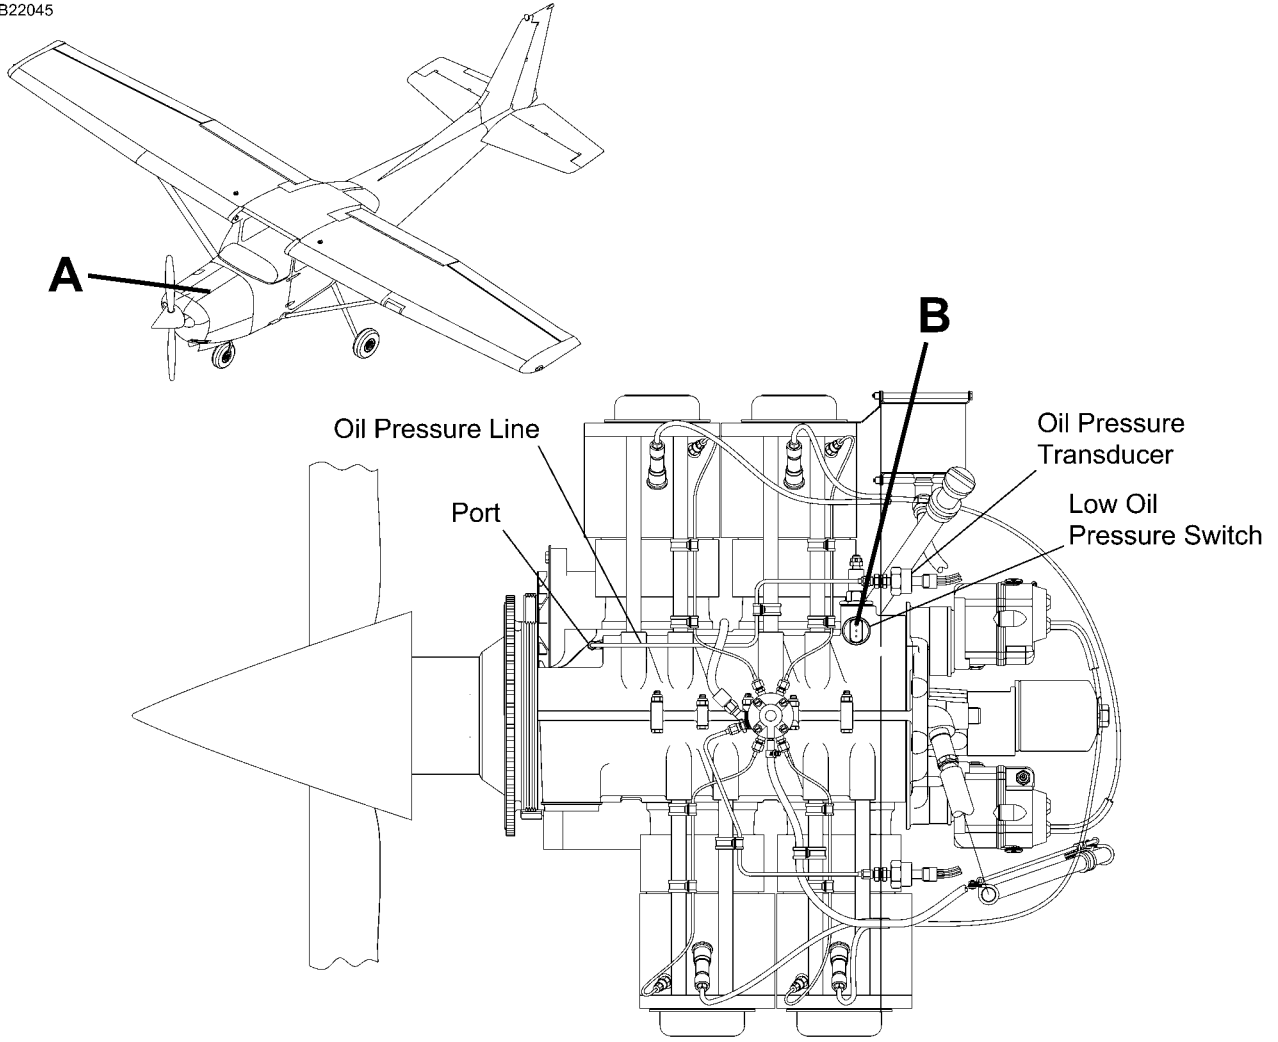
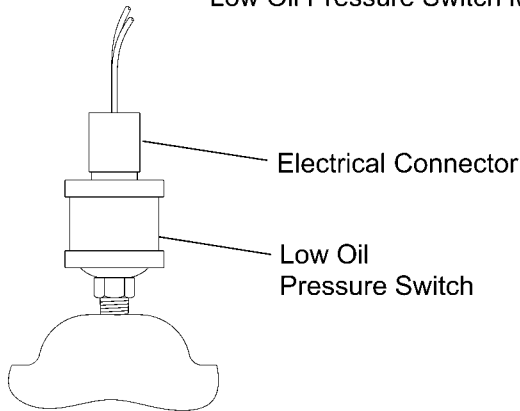
Figure 1. Oil Pressure Switch Locations (Sheet 1)

Low Oil Pressure Switch Mounted on Top of Right-Hand Case at the Aft End

2. Remove the upper cowl. (Refer to the Model 172R/172S Maintenance Manual, Chapter 71, Cowling - Maintenance Practices).
3. (Refer to Figure 1, Sheet 1.) Disconnect the electrical connector (JN005) from the 83278 Oil Pressure Switch (SN001).

4. (Refer to Figure 1, Sheet 1.) Remove and discard the 83278 Oil Pressure Switch mounted on top of the Right-Hand crank case at the aft end.
5. (Refer to Figure 1, Sheet 3.) Remove and keep the 1102 plug from accessory housing oil port.

6. (Refer to Figure 1, Sheet 1.) Put a light coat of U544006 (or equivalent) Sealant on the external (male) threads of the 1102 Plug and install in the right side engine crankcase engine oil port and torque 40 to 44 Inch-Pounds. Do not allow sealant to enter oil port.
7. (Refer to Figure 1, Sheet 2.) Install the 83278 Oil Pressure Switch as follows:

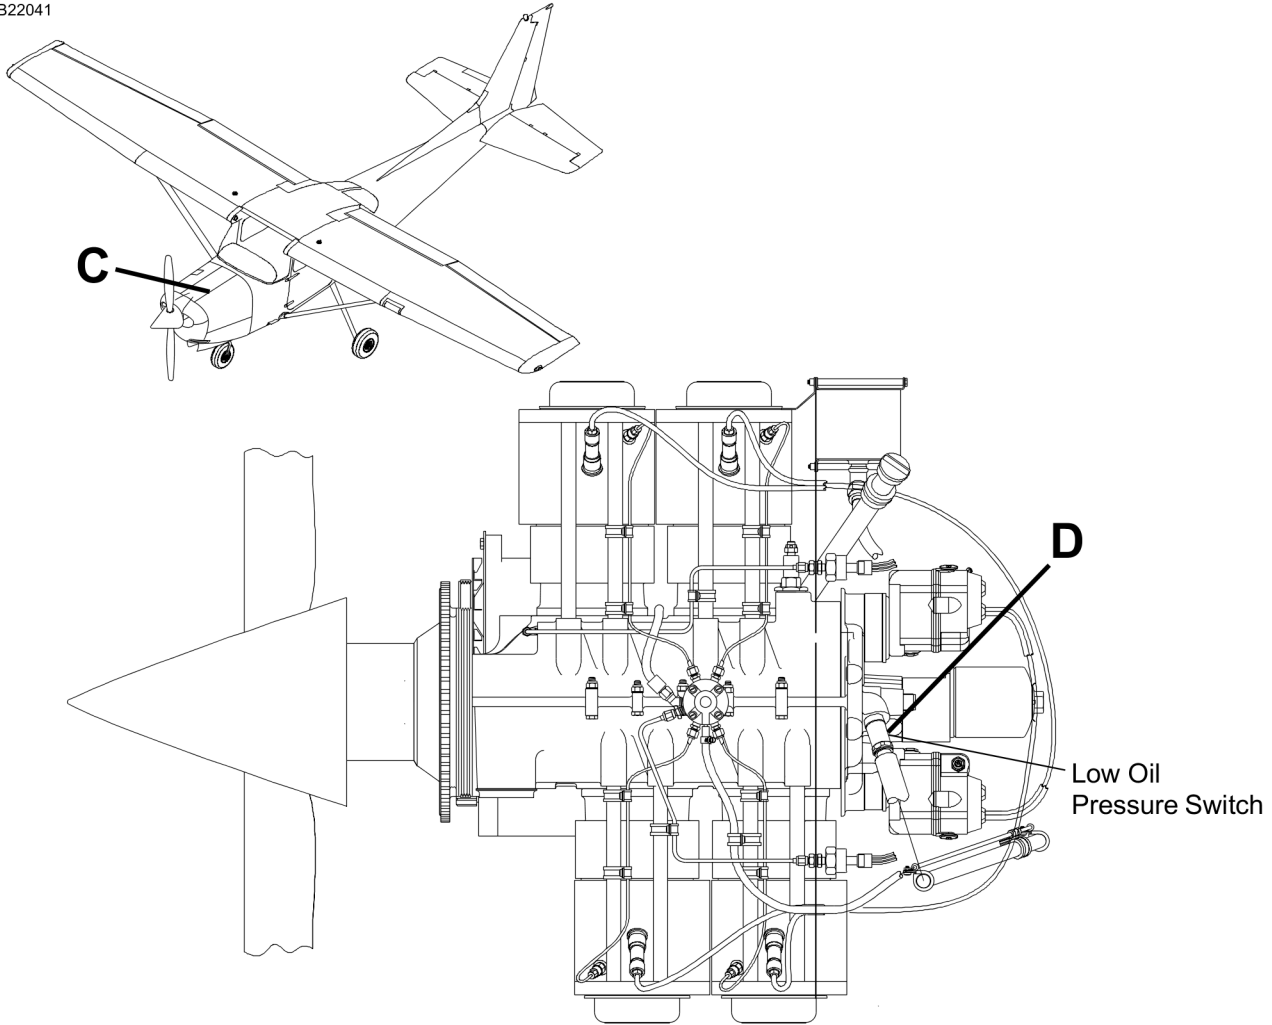
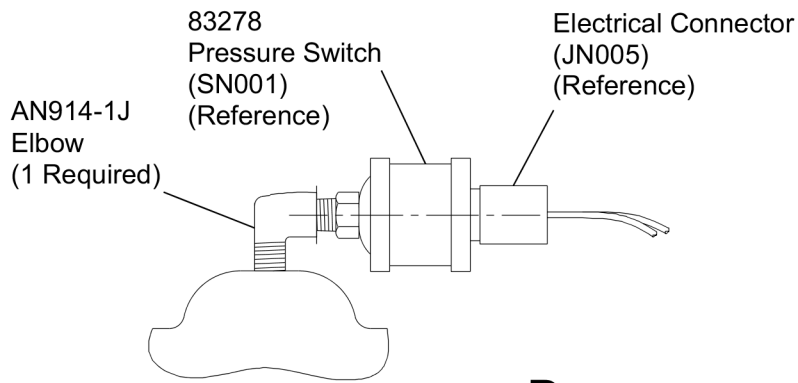
Figure 1. Oil Pressure Switch Locations (Sheet 2)

Low Oil Pressure Switch Mounted Left Side of the Accessory Housing

- A. Put a light coat of U544006 (or equivalent) Sealant, on the external (male) threads of the AN914-1J Elbow and 83278 Oil Pressure Switch.
- B. Install the AN914-1J Elbow until hand tight then rotate one additional turn and then rotate until the elbow is in an aft direction that provides clearance as not to be in contact with any other components.
- C. Install the new 83278 Oil Pressure Switch to the AN914-1J Elbow.
  - (1) Make sure that there is optimum clearance of all surrounding components and structure.

**CAUTION:** Use only the hex fitting to final tighten. Do not use plier-type tools on the plastic housing or the circular metal base of the 83278 Oil Pressure Switch. The switch can be damaged between the swaged connections between plastic housing and circular metal base and/or the metal base and the hex fitting. Damage to either of these swaged connections can cause an oil leak.

- D. Tighten the 83278 Oil Pressure Switch approximately 1 to 1 1/2 turns beyond hand tight.
