REVISION TRANSMITTAL

NAVIGATION - GPS-4000S GLOBAL POSITIONING SYSTEM SOFTWARE UPDATE

560XL

SL560XL-34-27
Page 1 of 2

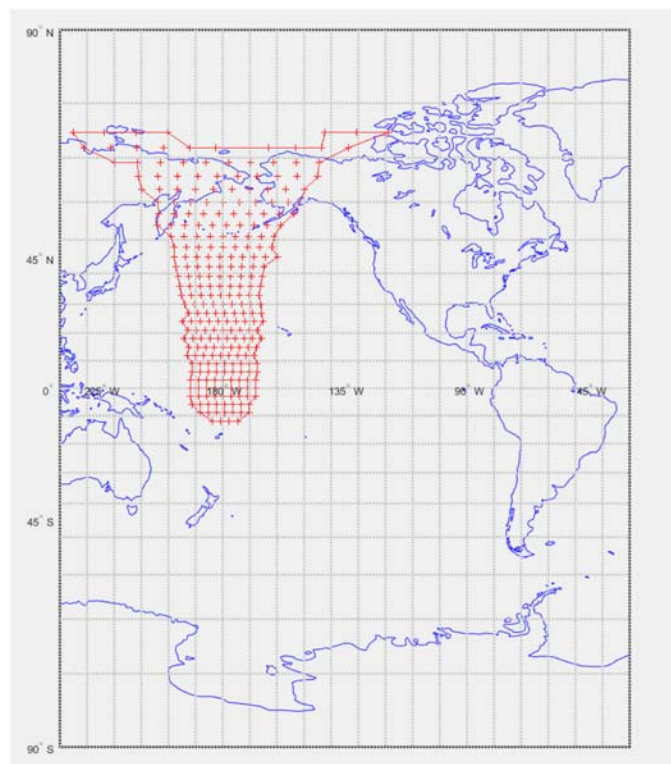
Map
Figure 1

- (1) The Root Cause has been identified as an improper implementation in the computation of the longitude at which the GPS signal penetrates the ionosphere when the satellite is located across 180 degrees W Longitude.
- (2) The affected region is limited to the area within the solid red line boundary indicated in the attached map. The region extends 20 degrees on either side of 180 degrees W Longitude and extends from the Northern Hemisphere to 10 degrees Latitude in the Southern Hemisphere. Refer to Figure 1.

- (3) The potential reduction in position accuracy caused by the computational issue prevents the GPS-4000S, CPN 822-2189-100, from supporting LPV approaches at LPV-equipped airports in the affected region.
- (4) Un-announced, but bounded reduced positional accuracy in the affected region limits operations to RNP 0.3 NM, or higher (Positional error will be bounded to 0.3 NM but may not be bounded by the protection level (HPL) that is output by the GNSS).

- (1) A software update that corrects this issue is targeted to be available in Q1 2020.
- (2) Until that software update is available, operational limitations will need to be applied. The operational limits are:
 - (a) Do not use the GPS-4000S, CPN 822-2189-100, to perform LPV approaches at airports in Alaska listed below. There are no airports outside of Alaska that are in the affected region that support LPV approaches at the time of this SIL publication. LPV-equipped airports will be monitored on every database update and if additional LPV-equipped airports are identified, this SIL will be updated.
 - (b) Do not perform operations that require an accuracy better than RNP 0.3 NM (For example, 0.1, 0.11, 0.15, etc.) in the region identified in the above map (+/- 20 degrees of 180 degrees W Longitude) or at the airports in Alaska listed below.
