**MANDATORY****SL700-55-02****TITLE**

STABILIZERS - INSPECTION OF THE VERTICAL STABILIZER SIDE PLATE BOLTS

700 (Citation Longitude)

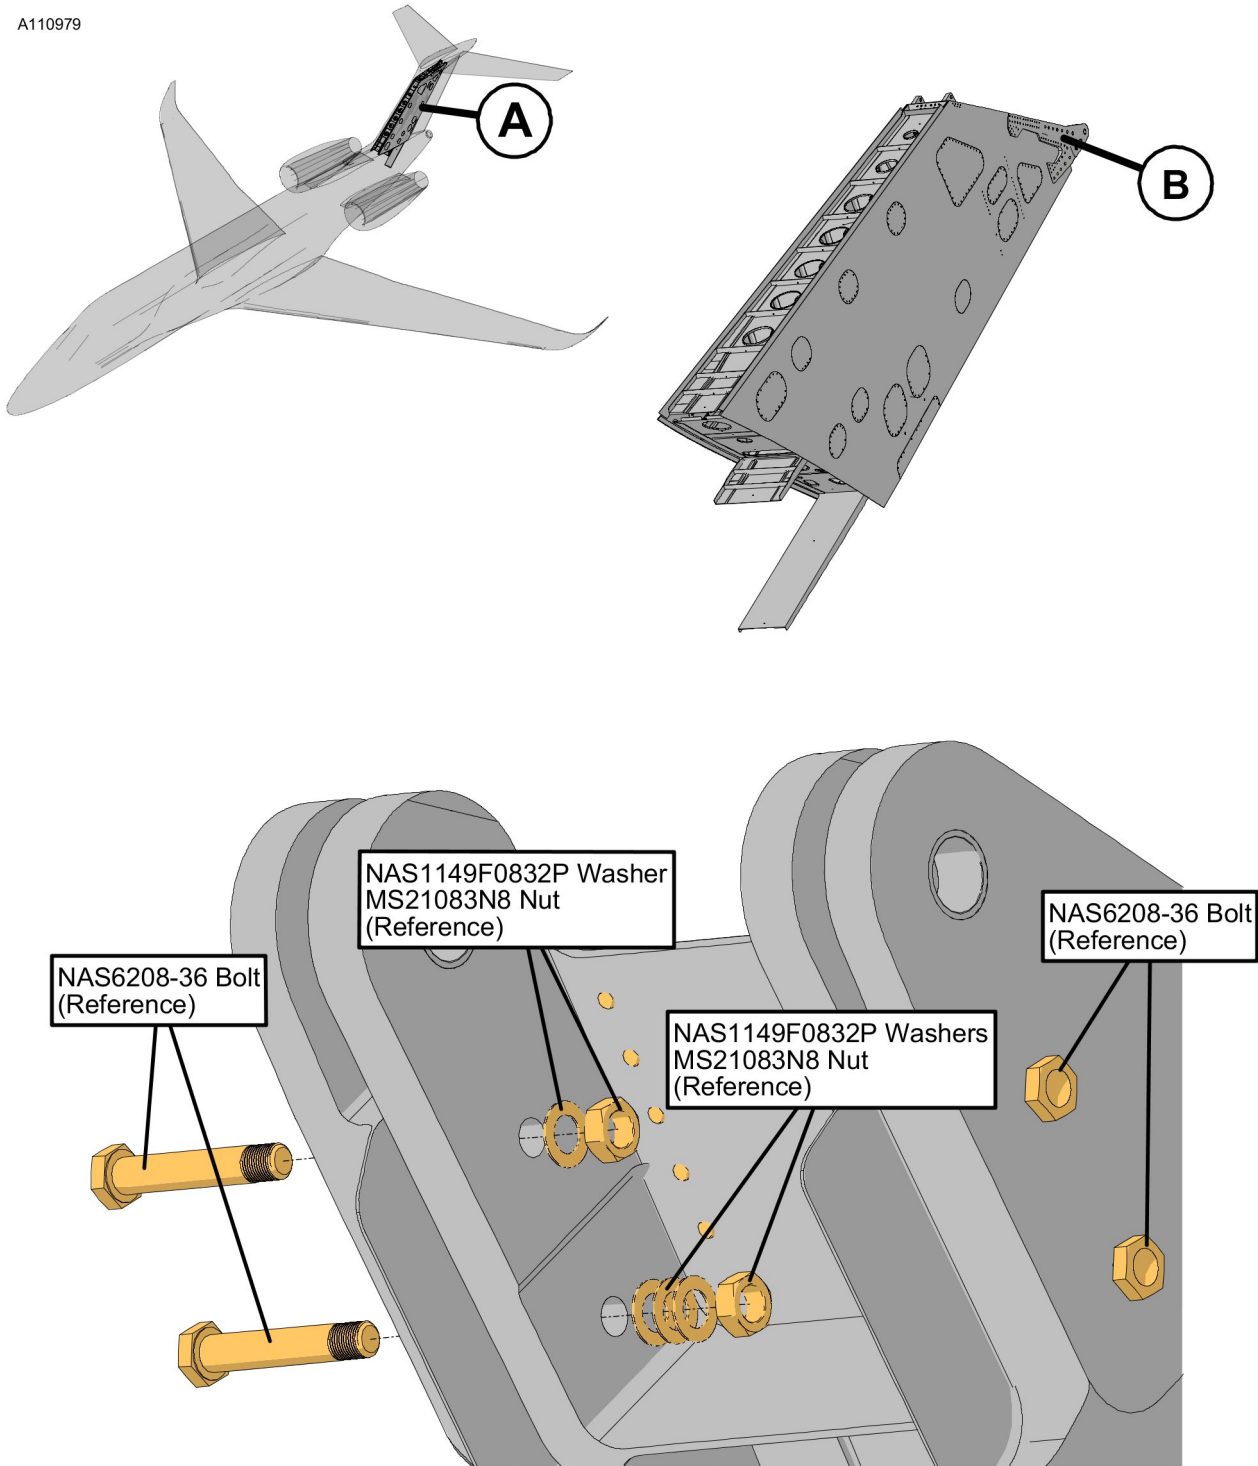
Figure 1. Inspection of the Vertical Stabilizer Side Plate Bolts (Sheet 1)

The vertical stabilizer left and right side plate assemblies attach bolts could have been incorrectly torqued during installation.

2. Remove the bullet fairing from the aircraft. (Refer to Cessna Model 700 Maintenance Manual, Chapter 55, Bulletin Fairing - Removal/Installation.)
3. (Refer to Figure 1, Detail A.) Do a visual inspection of the left and right vertical stabilizer side panel assembly attach bolts as follows:

- A. Examine the left and right vertical stabilizer side panel assembly attach bolts for loose or missing hardware.
    - (1) Make sure the top bolt has one MS21083N8 Nut and one NAS1149F0832P Washer under the nut.

- (2) Make sure the bottom bolt has one MS21083N8 Nut and three NAS1149F0832P Washers under the nut.
    - (3) If the examination reveals missing hardware, do the steps that follow:

- (a) Remove and replace the NAS6208-36 Bolt, NAS1149F0832P Washer(s) and the MS21083N8 Nut as required.
      - (b) Using a torque wrench, torque the four MS21083N8 nuts to 350.0 (± 60.0 ) inch pounds (39.55 (±6.75) Nm). (Refer to Citation Standard Practices Manual, Chapter 20, Torque Data - Maintenance Practices.)

- (c) Go to Step 4.
    - (4) If the examination does not reveal loose or missing hardware, do the steps that follow:
      - (a) Loosen the four MS21083N8 Nuts until all torque is removed.

- (b) Using an torque wrench, torque the four MS21083N8 Nuts to 350.0 (± 60.0) inch pounds (39.55 Nm (± 6.75 Nm)). (Refer to Citation Standard Practices Manual, Chapter 20, Torque Data - Maintenance Practices.)
