AUXILIARY POWER - APU BLEED DUCT REPLACEMENT

700 Citation Longitude

-0004, -0007 thru -0041

SL700-49-01
Page 1 of 6

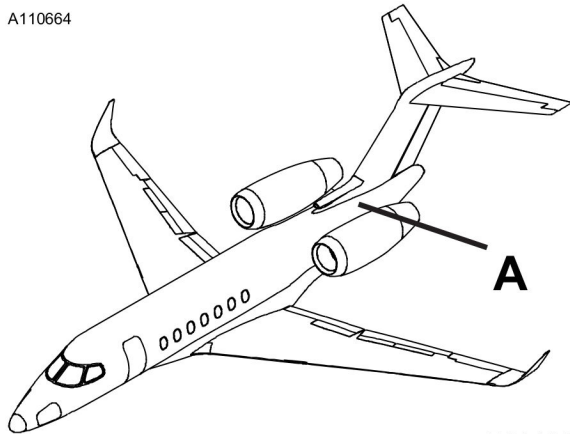
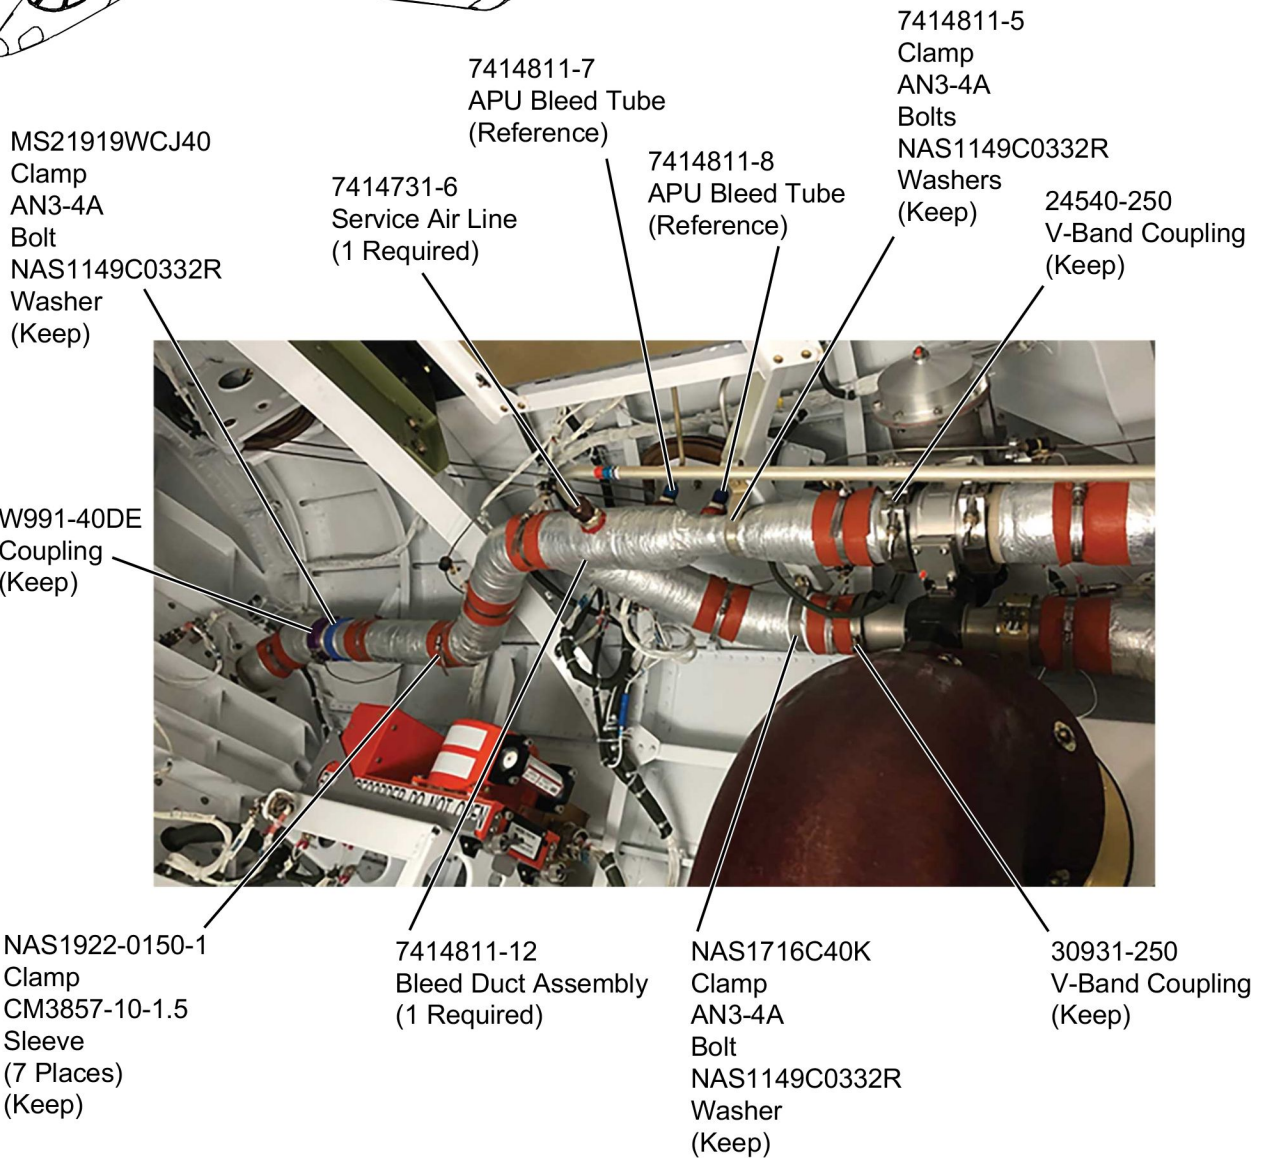
Figure 1. APU Bleed Air Duct (Sheet 1)

APU bleed duct may leak due to weld failure.

3. Open the tailcone access door. (Refer to the 700 Maintenance Manual, Chapter 52, Service Doors - Description and Operation.)
 - A. (Refer to Figure 1, Sheet 1.) Remove the 7490705-11 APU Bleed Duct Assembly.

- (12) Remove the bleed duct assembly from the airplane and discard.
- B. (Refer to Figure 1, Sheet 1.) Install the 7414811-12 Bleed Duct Assembly.
 - (1) Remove the protective wrap and caps from the bleed duct assembly.
