HYDRAULIC POWER - INSPECTION OF THE RUDDER STANDBY DIRECT CURRENT (DC) HYDRAULIC PUMP ASSEMBLY FOR INCORRECT HYDRAULIC FLUID SPECIFICATION NUMBER INK MARKING

700 (Citation Longitude)

SL700-29-01  
Page 1 of 4

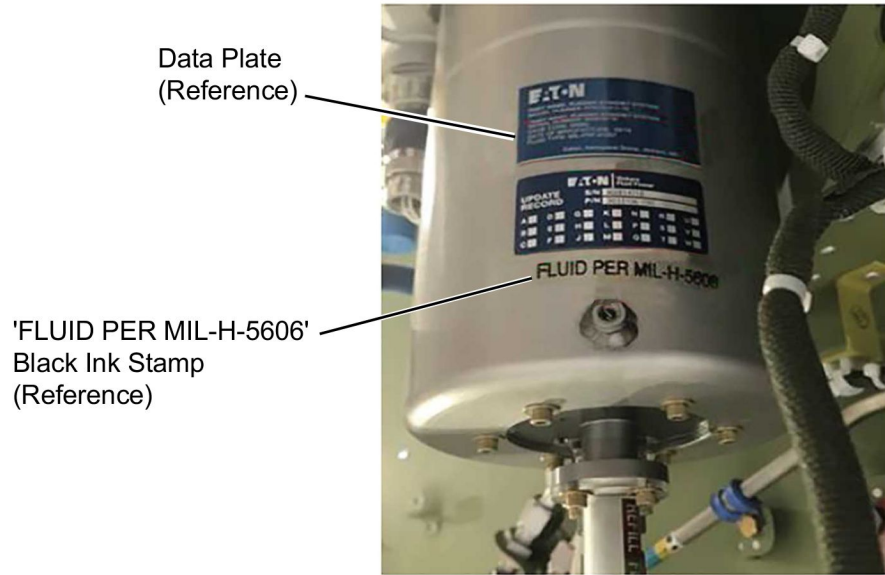
A111369

3. Examine the rudder standby DC hydraulic pump assembly for incorrect hydraulic fluid specification number as follows:
  - A. Using an inspection mirror and high intensity light, examine the rudder standby DC hydraulic pump assembly for a black 'FLUID PER MIL-H-5606' ink marking.

**NOTE:** The ink marking should be below the hydraulic pump Data/ Update Record plate located on the surface of the pump.
