FLIGHT CONTROLS - GARMIN GSM 86 ELEVATOR TRIM MODIFICATION

525 (M2)

-0685, -0800 thru -1067

SB525-27-25
Page 1 of 8

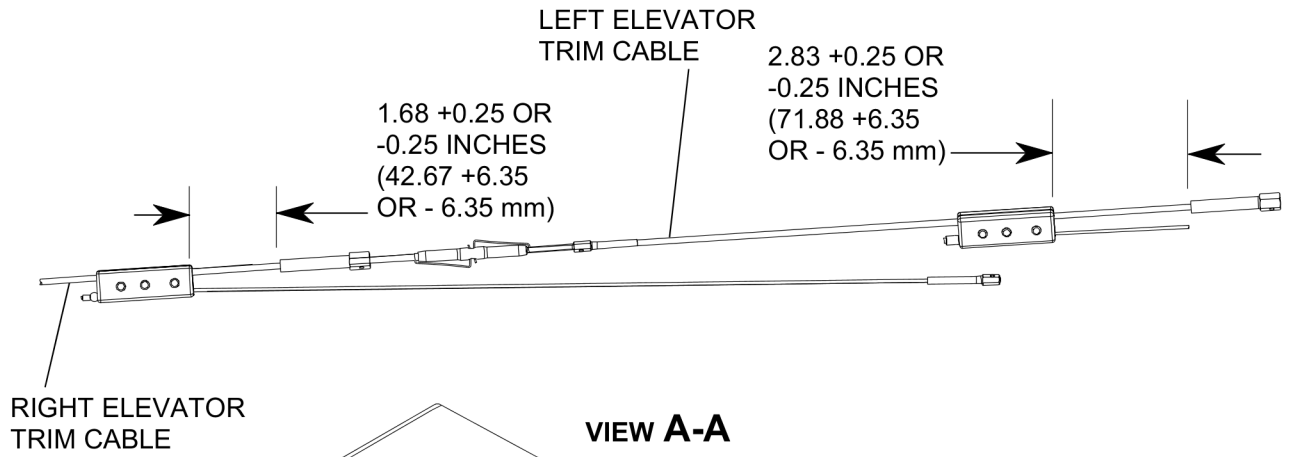
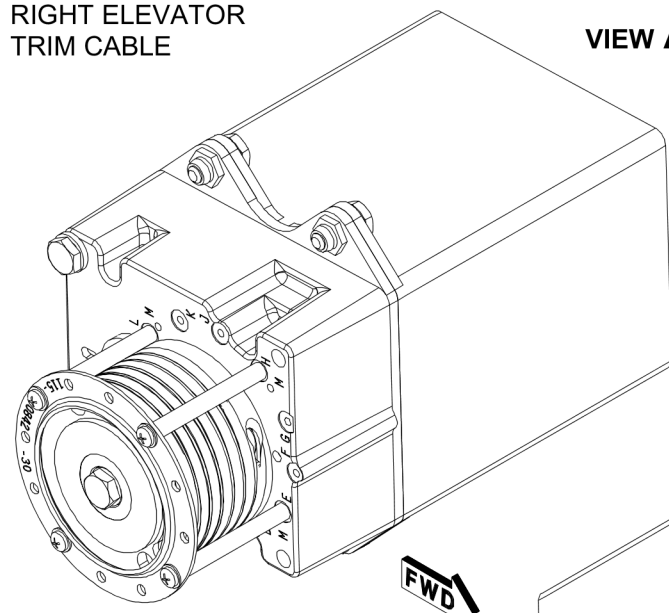
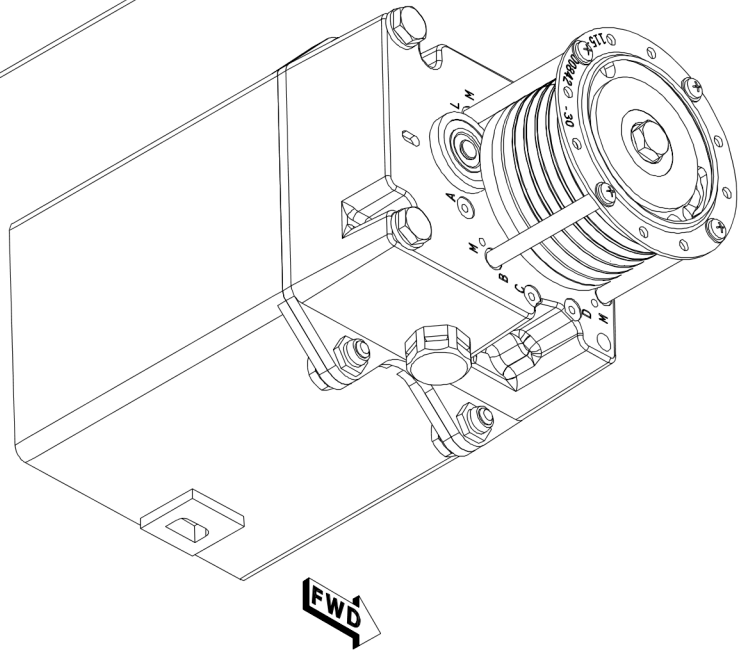
Figure 1. GARMIN GSM 86 ELEVATOR TRIM MODIFICATION (Sheet 2)

NOTE: THE CABLE GUARD PINS SHOULD BE LOCATED AT B, E, H AND L.

- (1) (Refer to Figure 1, Sheet 2). Make sure that the cable guard pins are located at B,E,H and L.
 - D. Put the kept capstan cover in its position on the cable guard pins.

NOTE: (Refer to Figure 1, Sheet 2.) The forward edge of the forward clamp block is 2.83 ± 0.25 inches (71.88 ± 6.35 mm) from the edge of the left aft elevator trim cable terminal.

NOTE: (Refer to Figure 1, Sheet 2.) The forward edge of the aft clamp block is 1.68 ± 0.25 inches (42.67 ± 6.35 mm) from the edge of the right aft elevator trim cable terminal.
