FLIGHT CONTROLS - GARMIN GSM 86 ELEVATOR TRIM MODIFICATION

525B (CJ3+)

-0057, -0451 thru -0631

SB525B-27-05  
Page 1 of 8

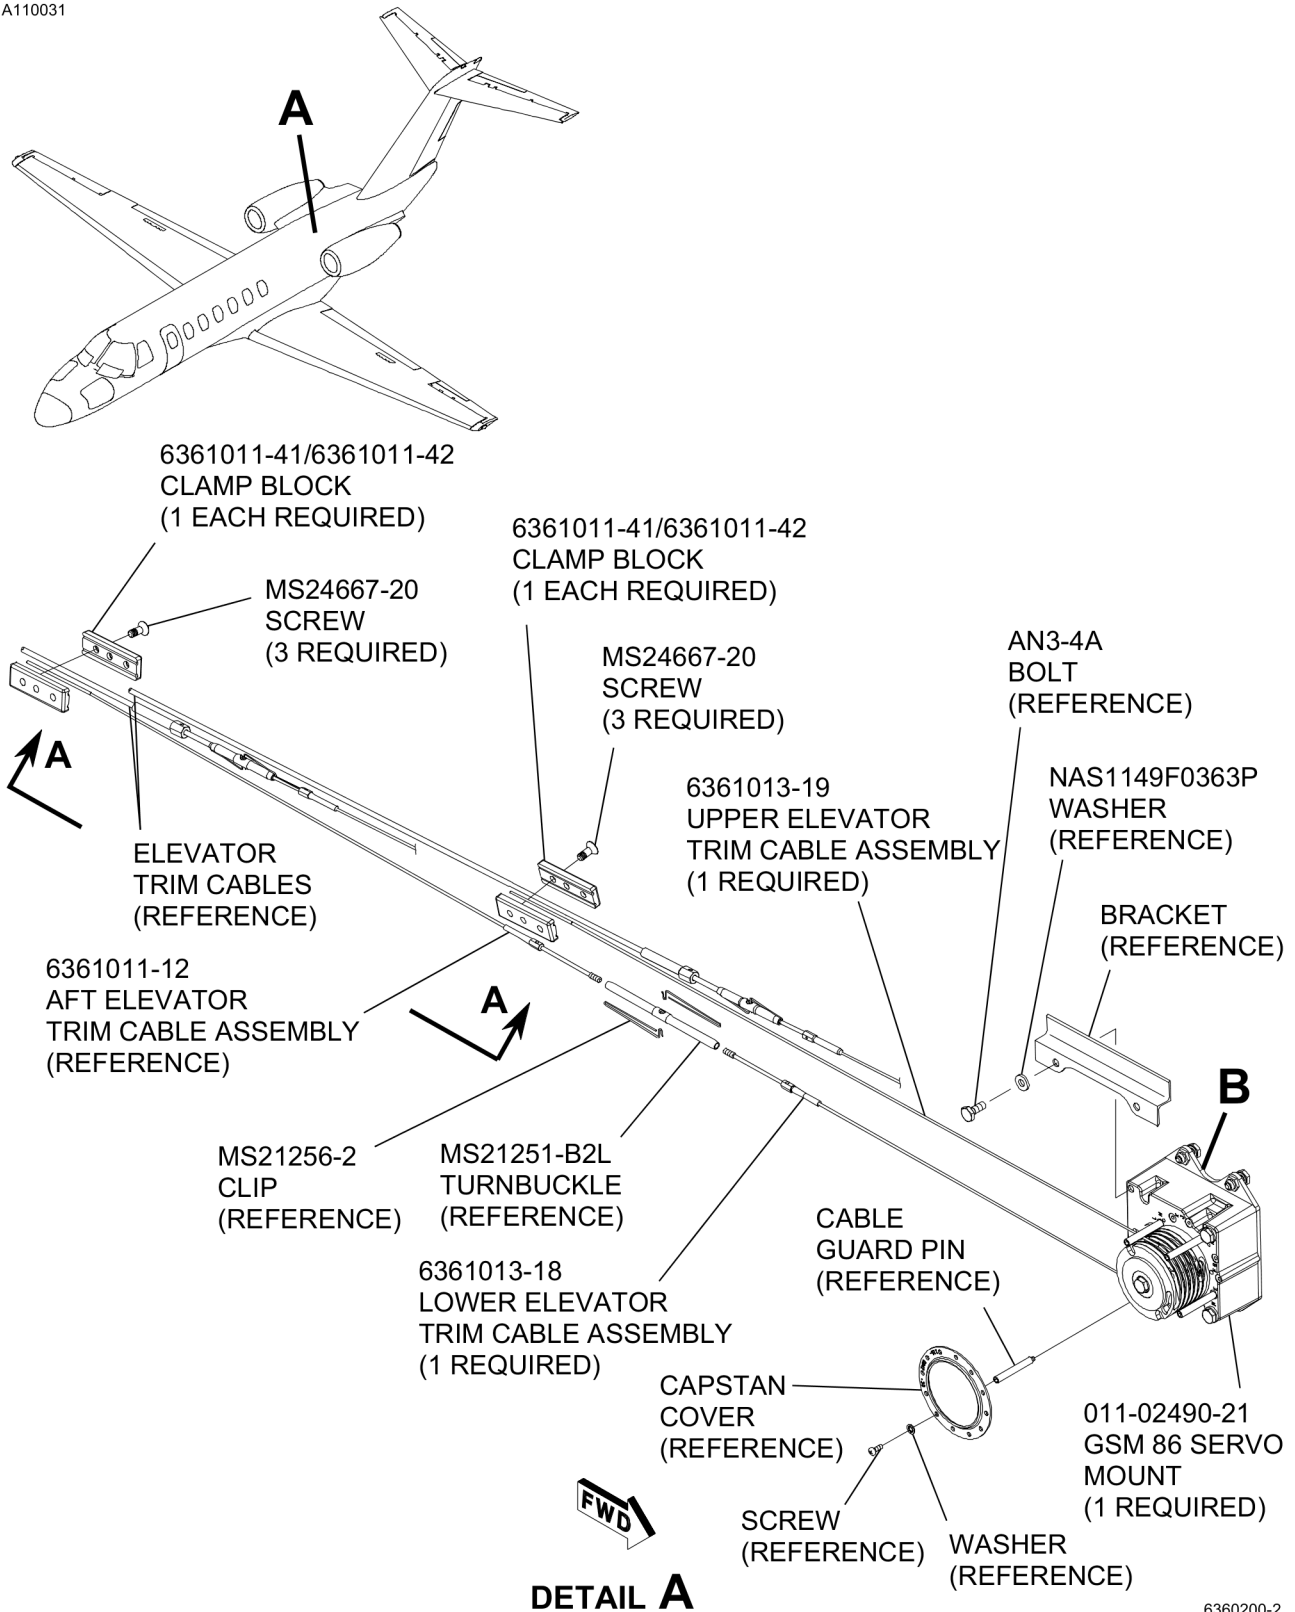
Figure 1. Installation Of The Elevator Trim Capstan and Servo Mount (Sheet 1)

The current continuous travel capstan design may cause the elevator trim bridle cable to slip.

6. (Refer to Figure 1). Install the 011-02490-21 GSM 86 Servo Mount.
- A. Remove and keep the capstan cover screws, washers, capstan cover and five cable guard pins.

- B. Carefully install the ball ends of the 6361013-19 Upper Elevator Trim Cable Assembly and 6361013-18 Lower Elevator Trim Cable Assembly on the 011-02490-21 GSM 86 Servo Mount.

- (1) Make sure that the ball is fully seated in the capstan drum.
  - C. Install using the kept cable guard pins in its positions on the 011-02490-21 GSM 86 Servo Mount.

- E. Put the 011-02490-21 GSM 86 Servo Mount and the cable assemblies in their position at the servo mount bracket assembly.
  - F. Install the 011-02490-21 GSM 86 Servo Mount using the kept four each AN3-4A Bolts and the NAS1149F0363P Washers.

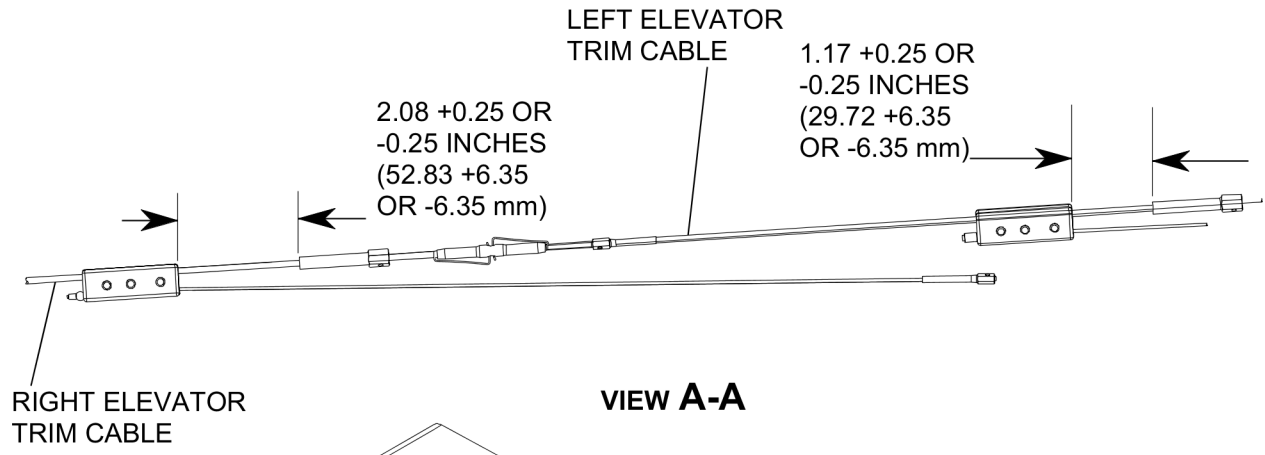
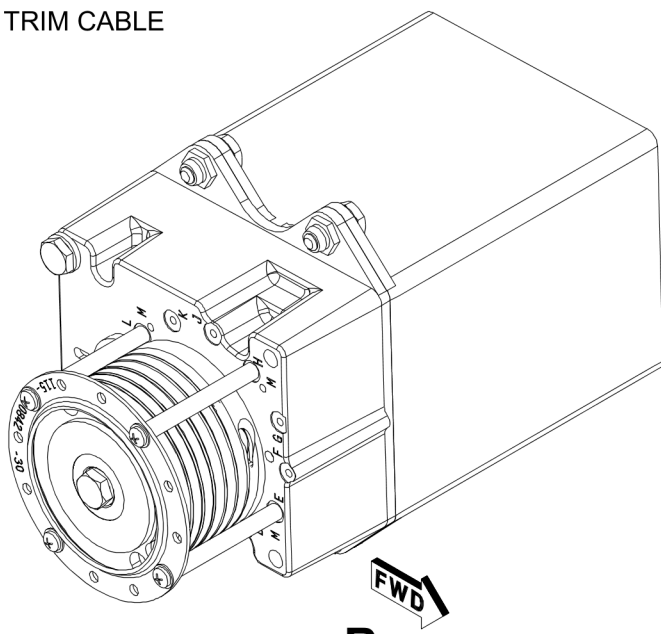
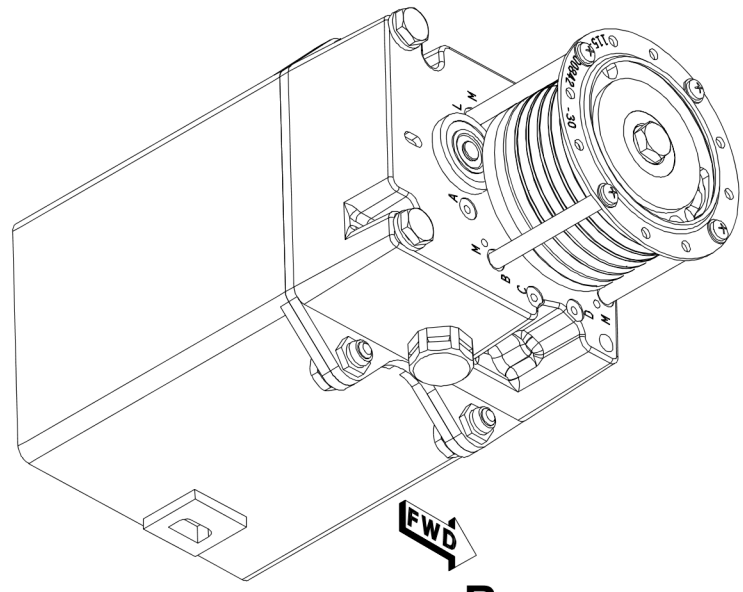
Figure 1. Installation Of The Elevator Trim Capstan and Servo Mount (Sheet 2)

NOTE: THE CABLE GUARD PINS SHOULD BE LOCATED AT B, E, H AND L.

- (1) (Refer to Figure 1, Sheet 2). Make sure that the cable guard pins are located at B, E, H and L.
  - D. Put the kept capstan cover in its position on the cable guard pins.

**NOTE:** (Refer to Figure 1, Sheet 2). The forward edge of the forward clamp block is  $1.17 \pm 0.25$  inches ( $29.72 \pm 6.35$  mm) from the edge of the left aft elevator trim cable terminal.

**NOTE:** (Refer to Figure 1, Sheet 2). The forward edge of the aft clamp block is  $2.08 \pm 0.25$  inches ( $52.83 \pm 6.35$  mm) from the edge of the right aft elevator trim cable terminal.
