NAVIGATION - INSTALLATION OF DUAL LITEF HYBRID NAVIGATOR UNITS AND RNP AR = 0.3 SOFTWARE

MODEL	SERIAL NUMBERS
680 (Citation Sovereign+)	-0501 thru -0600

SB680-34-41
Page 1 of 8

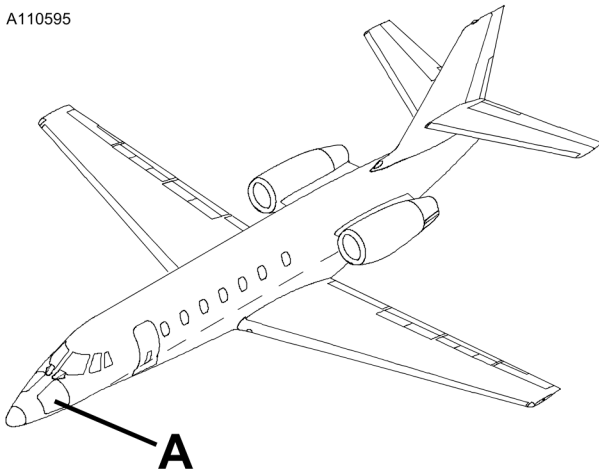
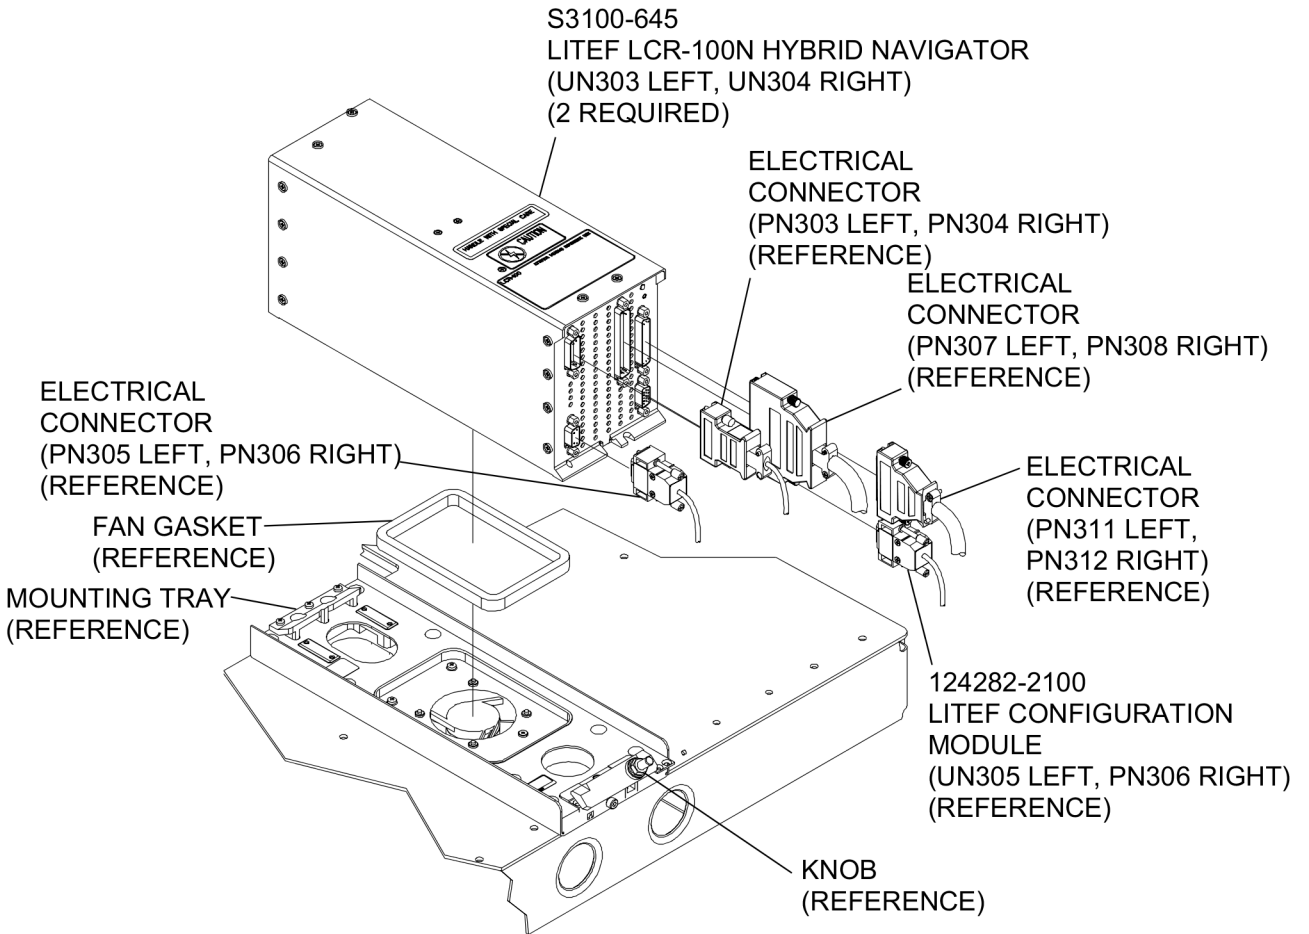
Figure 1. Installation of the Dual Litef Hybrid Navigator Units and Configuration Modules (Sheet 1)

DETAIL A

LEFT SIDE SHOWN, RIGHT SIDE TYPICAL

2. (Refer to Figure 1, Detail A.) Install Upgraded Dual Litef Hybrid Navigator Units as follows:
 - A. On aircraft with 145130-3000 LCR-100N Hybrid Navigator Units installed, do the steps that follow:

- C. Install two S3100-645 Litef LCR-100N Hybrid Navigator Units (UN303 left, UN304 right). (Refer to Cessna Model 680 Maintenance Manual, Chapter 34, Litef LCR-100N Hybrid Navigation System (HNS) - Maintenance Practices (Airplanes 0501 and ON)).
