NAVIGATION - TRANSMITTAL OF GARMIN SERVICE ADVISORY NO. 1612 REVISION F, 2020 IGRF (INTERNATIONAL GEOMAGNETIC REFERENCE FIELD) MAGNETIC FIELD MODEL

SL525B-34-10  
Page 1 of 2

## **SERVICE ADVISORY**

**NO.: 1612 Rev F**

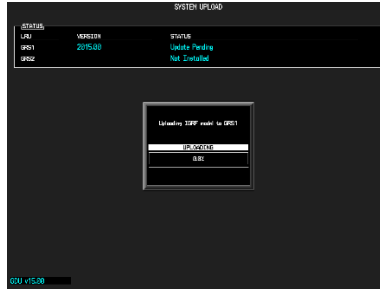
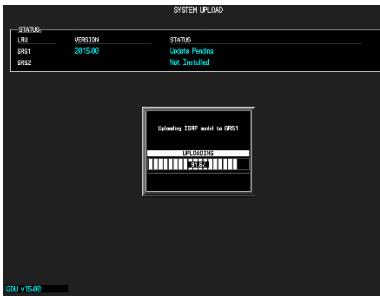
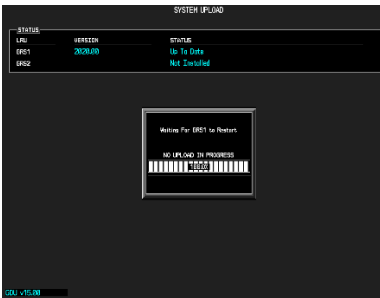
14. Do the following if progress does not begin:
  - a. Stop power to the appropriate GRS.
  - b. Energize the appropriate GRS.

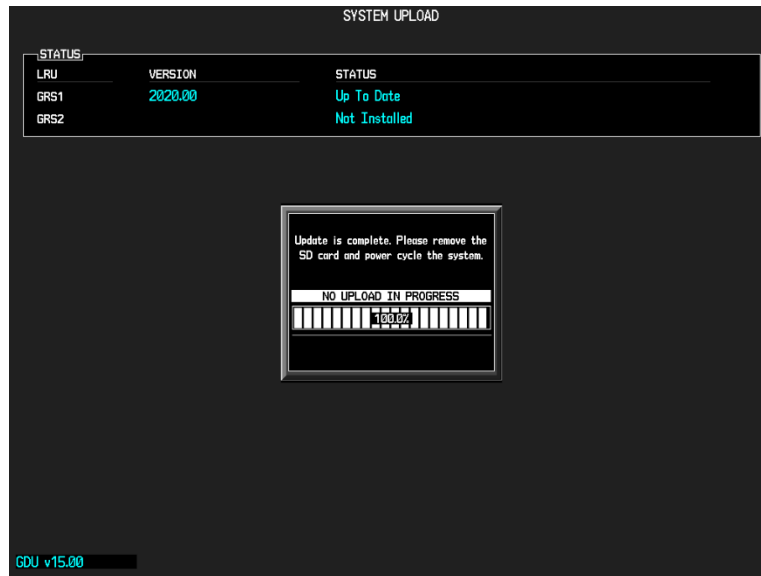
15. When the update is complete this prompt will show on the display.

16. Remove the SD card.
17. Restore GIA #2 circuit breaker.
18. Stop power to the system.
