NAVIGATION - GARMIN SOFTWARE UPDATE TO VERSION 4.8.11

525 (Citation M2)

To update the Garmin G3000 software to version 4.8.11.

SB525-34-97
Page 1 of 20

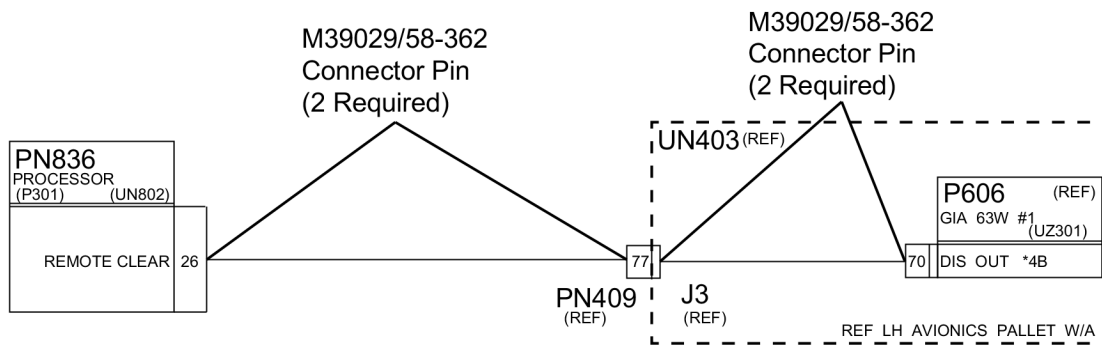
Figure 1. Wiring Modification (Sheet 1)

Airplanes Equipped with the Stormscope Option

- G. Remove the PN409 electrical connector from the left avionics pallet.
 - H. (Refer to Figure 1, Sheet 1.) Install the 26PN836-77PN409 Electrical Wire using two M39029/58-362 Connector Pins.

- I. (Refer to Figure 1, Sheet 1.) Install the 77J3-70P606 Electrical Wire using two M39029/58-362 Connector Pins.
 - J. Install the PN836 electrical connector in the Stormscope processor.
