This sheet transmits Revision 1 to SL680A-30-01, which:

ICE AND RAIN PROTECTION - ADD SEALANT BETWEEN PICCOLO TUBES AND LANDING LIGHT BOX FASTENERS TO PREVENT CHAFING

680A (Citation Latitude)

SL680A-30-01  
Page 1 of 10

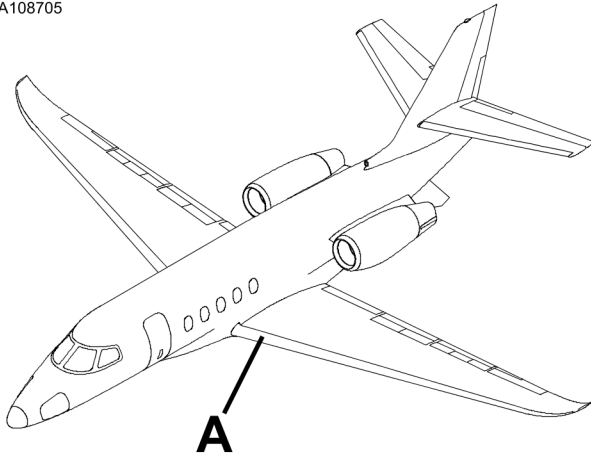
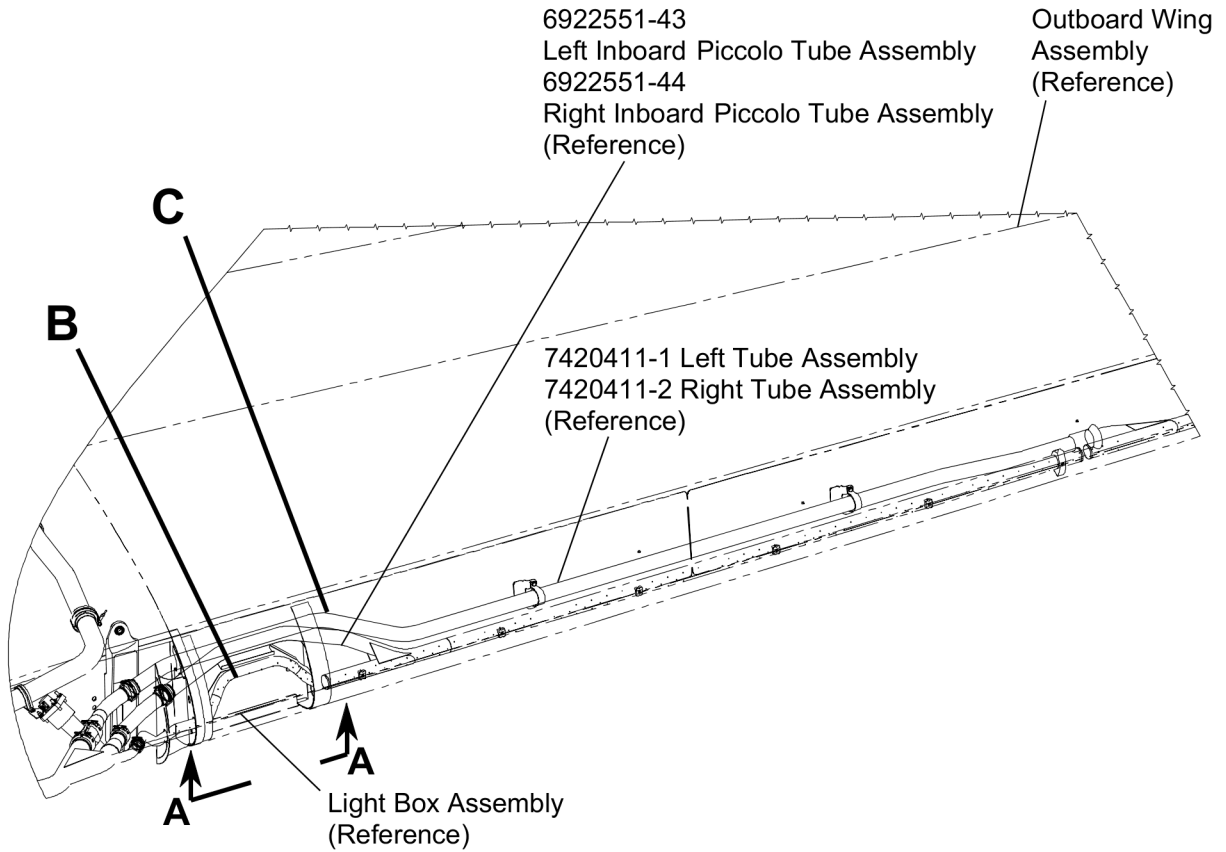
Figure 1. Piccolo Tube Sealing (Sheet 1)

To make sure that sealant has been applied between piccolo tubes and add sealant to the landing light box fasteners to prevent chafing.

- (2) Remove and keep the screws.
    - (3) Remove and keep the top doubler.
  - D. (Refer to Figure 1, Detail A and View A-A.) Inspect the 6922551-43 Left, 6922551-44 Right Inboard Piccolo Tube Assembly and 7420411-1 Left, 7420411-2 Right Tube Assembly.

- (1) If there is not excessive chafing damage between the piccolo tubes or tube assemblies, go to Step 4.
    - (2) If there is excessive chafing damage between the piccolo tubes or tube assemblies, do the steps that follow. (Refer to the Model 680A Maintenance Manual, Chapter 30, Wing Anti-Ice Piccolo Tube Assembly - Removal/Installation.)

- (5) (Refer to Figure 1, Detail, Detail B and View A-A.) Fillet seal between the replaced piccolo tubes or tube assemblies with U065012S (Type V, Class B) Sealant. (Refer to the Citation Standard Practices Manual, Chapter 20, Fuel, Weather, Pressure and High Temperature Sealing - Maintenance Practices.)

- (2) Allow the sealant to cure for 24 hours.
    - C. Go to Step 5.
5. (Refer to Figure 1, Detail A and Detail B.) Install the left and right top doubler.

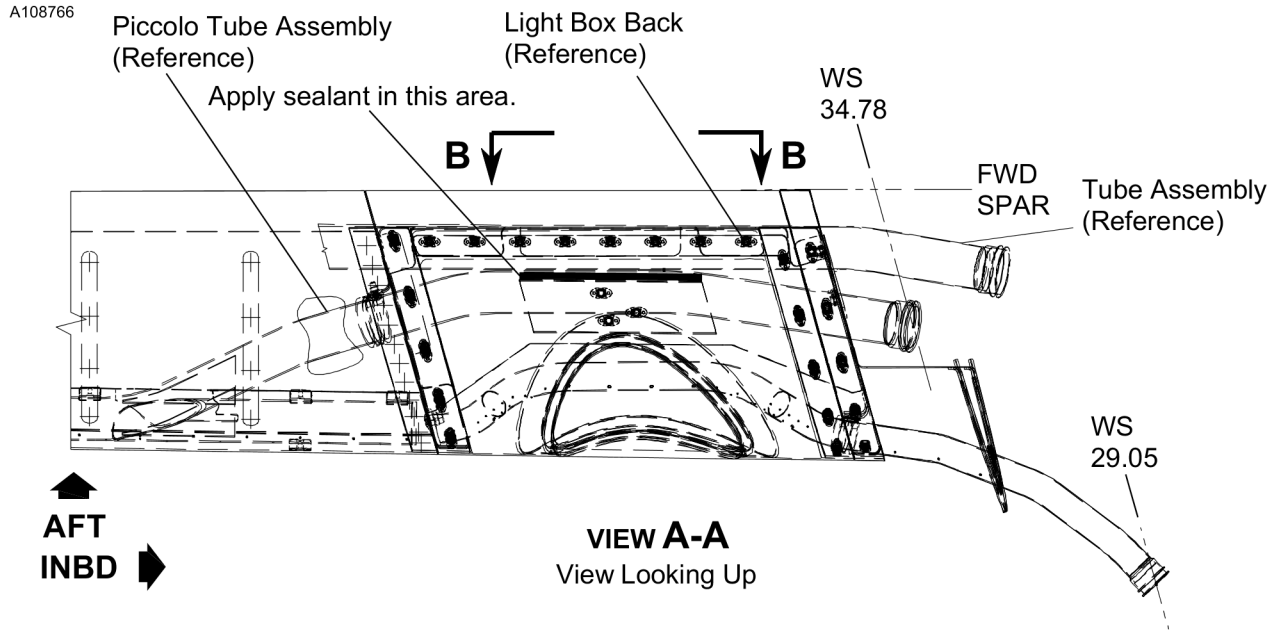
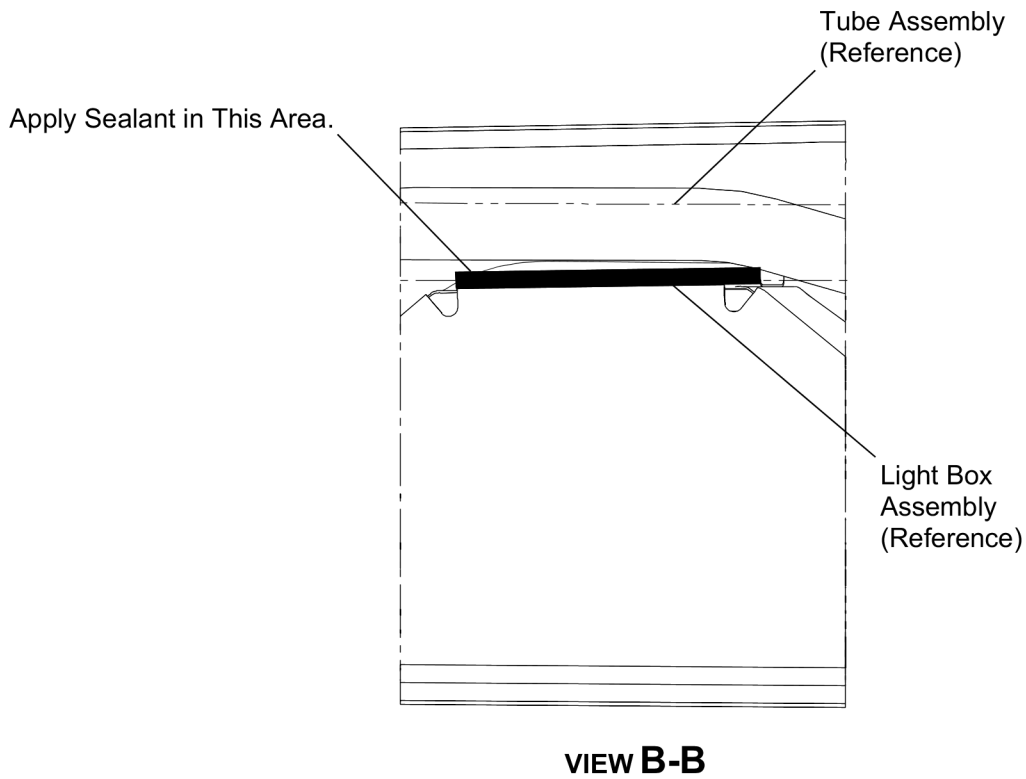
Figure 1. Piccolo Tube Sealing (Sheet 2)

- (6) Go to Step 5.
4. (Refer to Figure 1, Detail A, View A-A and View B-B.) Inspect for sealant between the 6922551-43 Left, 6922551-44 Right Inboard Piccolo Tube Assembly and the 7420411-1 Left, 7420411-2 Right Tube Assembly where the tubes come together above the light box assembly.

- B. (Refer to Figure 1, View A-A.) If there is not a fillet seal between the 6922551-43 Left, 6922551-44 Right Inboard Piccolo Tube Assembly and the 7420411-1 Left, 7420411-2 Right Tube Assembly, do the following step.

- (1) Fillet seal between the 6922551-43 Left, 6922551-44 Right Inboard Piccolo Tube Assembly and the 7420411-1 Left, 7420411-2 Right Tube Assembly with U065012S (Type V, Class B) Sealant. (Refer to the Citation Standard Practices Manual, Chapter 20, Fuel, Weather, Pressure and High Temperature Sealing - Maintenance Practices.)

6. Install the left and right landing light. (Refer the Model 680A Maintenance Manual, Chapter 33, Landing Light - Removal/Installation.)
  7. (Refer to Figure 1, Detail A, View A-A and View B-B.) Fillet seal between the fasteners on top of the 6922530-35 Left, 6922530-36 Right Light Box Back and the 7420411-1 Left and 7420411-2 Right Tube Assembly with U065013S, (Type V, Class B) Sealant. (Refer to the Citation Standard Practices Manual, Chapter 20, Fuel, Weather, Pressure and High Temperature Sealing - Maintenance Practices.)
