NAVIGATION - STALL WARNING HORN REPLACEMENT

The original stall warning horn is no longer available. If the stall warning horn needs to be replaced, a new stall warning horn is available and will require an additional bracket for installation. For some airplanes, addition of a resistor and diodes will be necessary to complete the initial installation.

SEB-34-22
Page 1 of 10

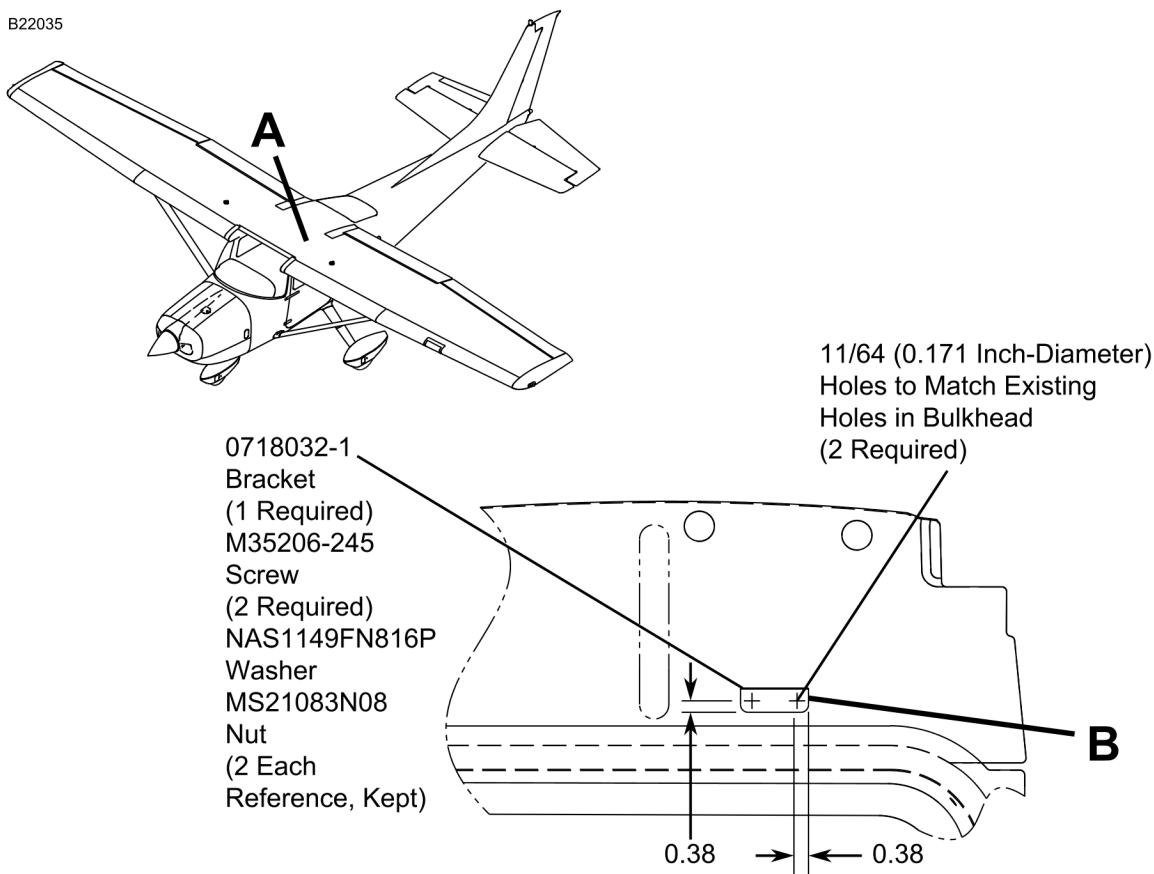
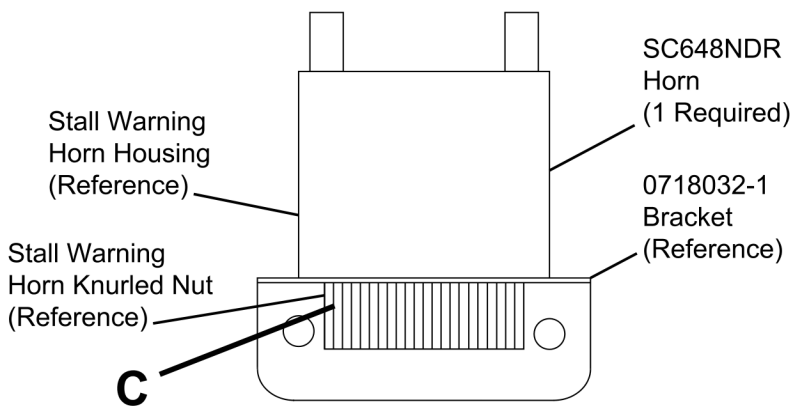
Figure 1. Warning Horn Modification (Sheet 1)

DETAIL A

View Looking Outboard at Left Side

DETAIL B

Looking Outboard at
 Stall Warning Horn

NOTE: Holes to Maintain 0.38 Minimum Edge Distance.

NOTE: Only the lower straight wing root fairing will need to be removed. The wrap around and top fairing will not need to be removed.
3. Remove headliner to access stall warning horn assembly. (Refer to Chapter 25, Interior Upholstery - Maintenance Practices.)
4. (Refer to Figure 2, Sheet 1.) Disconnect wiring connector P1 from JC030.
5. (Refer to Figure 1, Sheets 1 and 2.) Remove two MS21083N08 Nuts and NAS1149FN816P Washers that attach the stall warning horn assembly to the bulkhead. Keep the nuts and washers.
6. (Refer to Figure 2, Sheet 2.) Remove the stall warning horn from airplane.
7. (Refer to Figure 1, Sheets 1 and 2.) Install the 0718032-1 Bracket as follows:

NOTE: The bracket will be installed with the short leg fastened to the bulkhead. The long leg will be above the short leg and extend inboard from the bulkhead.

- A. Position and center the 0718032-1 Bracket over the two holes in the bulkhead where the stall warning horn was removed.

NOTE: Position the bracket so there is a minimum of 0.38-inch edge distance for the hole locations.

- B. Match drill two 11/64 (0.171-Inch Diameter) holes in the 0718032-1 Bracket.

NOTE: The removed horn can be disassembled and the two holes from the outer plastic housing can be used as a guide to identify the hole locations. Be sure to center the holes and maintain minimum of 0.38-inch edge distance.

- C. Debur the drilled holes.

- D. Install the 0718032-1 Bracket with two M35206-245 Screws, the kept washers and nuts.

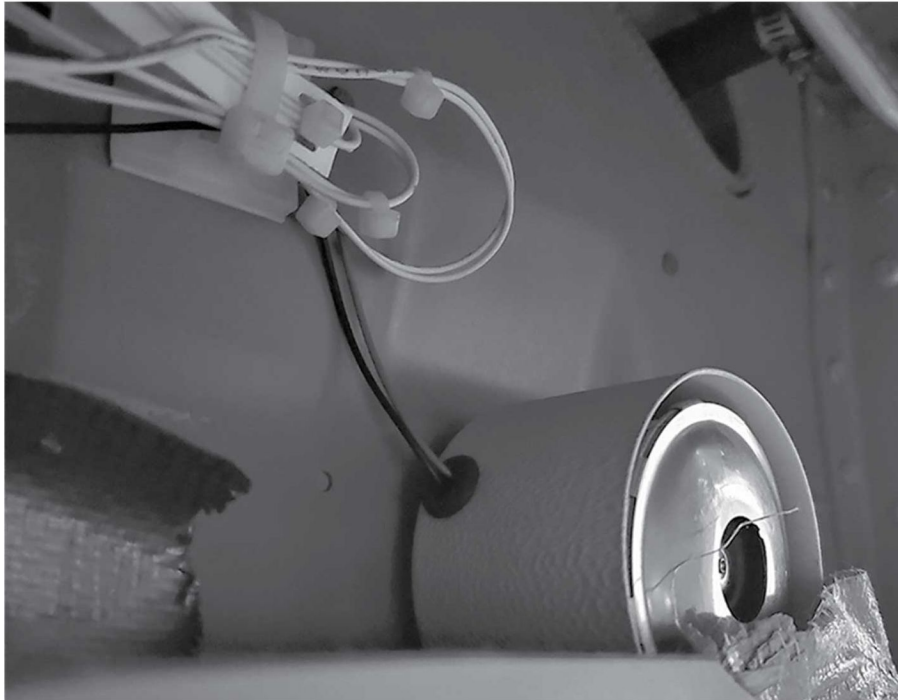
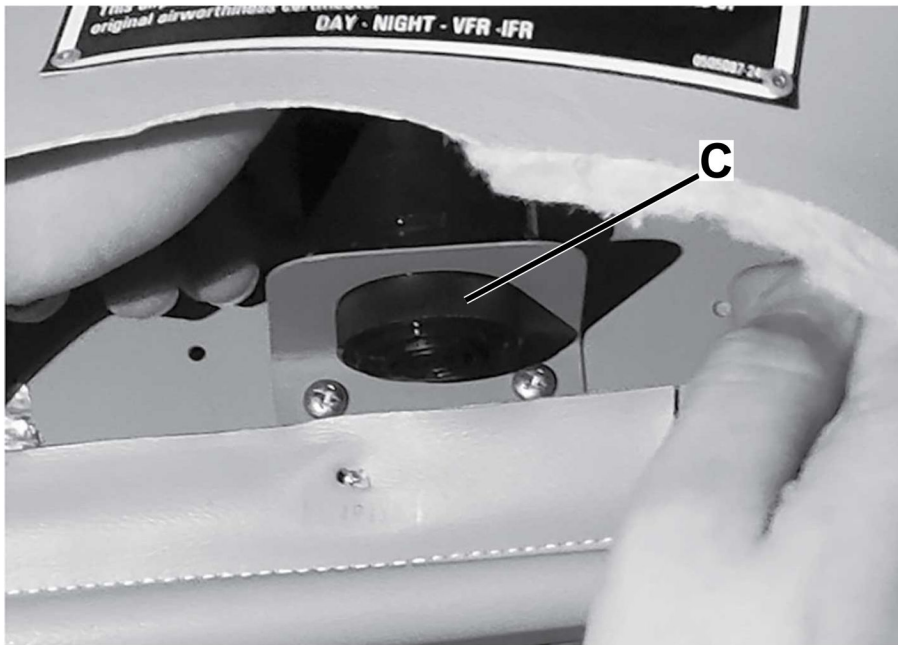
Figure 1. Warning Horn Modification (Sheet 2)

DETAIL A

Before Modification, Old Horn

After Modification, New Horn

8. (Refer to Figure 1, Sheets 1 thru 3.) Install the SC648NDR Horn as follows:

- A. Remove the knurled nut from the SC648NDR Horn.
B. Put the SC648NDR Horn into the 0718032-1 Bracket.
C. Install the knurled nut on the SC648NDR Horn and hand tighten.

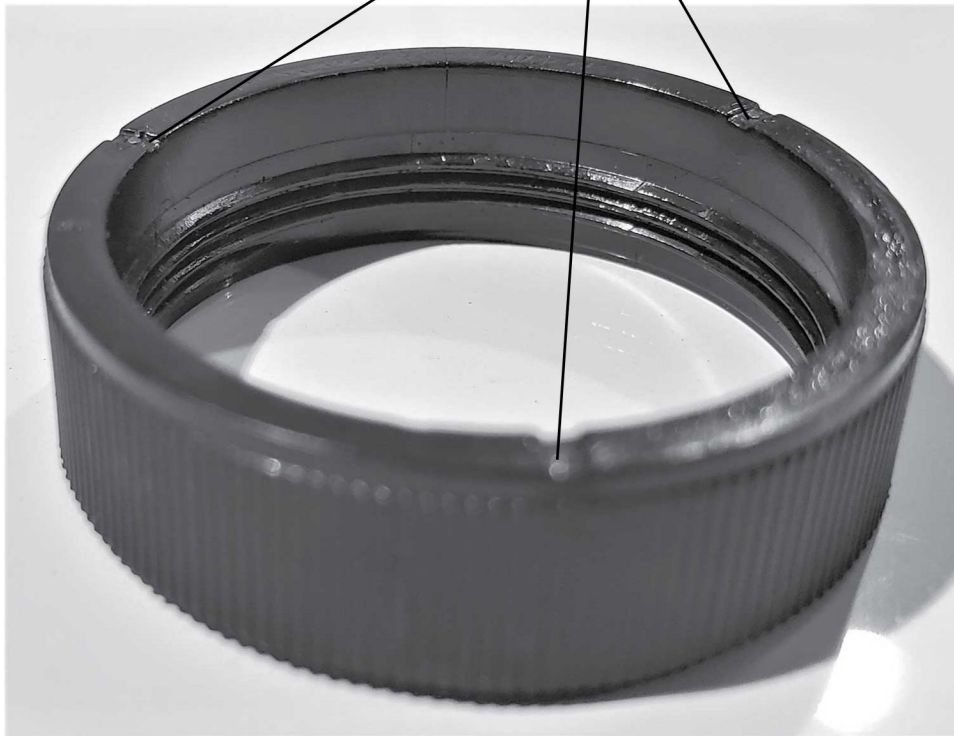
Figure 1. Warning Horn Modification (Sheet 3)

Install with three detents first.
Detents go toward bracket and horn.

DETAIL C
Knurled Nut Install Direction

NOTE: (Refer to Figure 1, Sheet 3.) The plastic knurled nut must be installed with the three indents toward the bracket and horn assembly. On the internal circumference, the smooth side without threads is installed first, towards the bracket and horn. This technique of installation will make sure the nut fully seats against the bracket and not bottom-out on the threads. If not installed correctly the knurled nut will bottom-out on the threads and the horn assembly will not be fully tightened in the bracket.

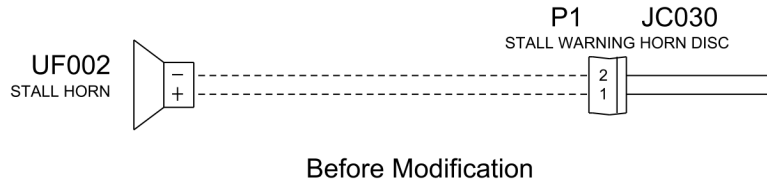
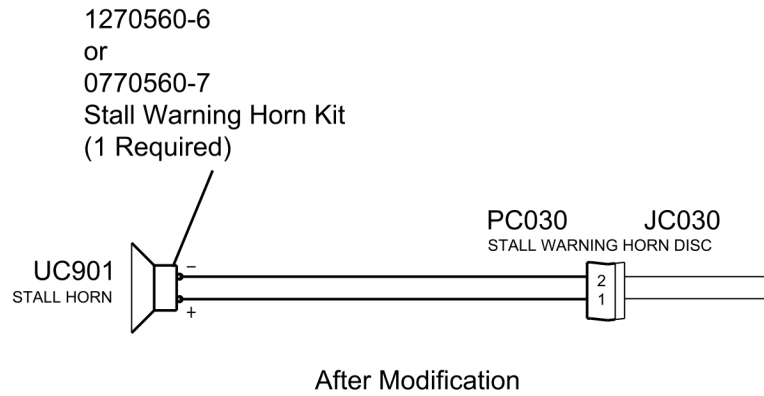
Figure 2. Wiring Modifications (Sheet 1)

LEGEND	
-----	Removed
—————	New

9. (Refer to Figure 2, Sheet 1.) Connect wiring connector PC030 to JC030.
