Service Bulletin

SEB95-3

FLAP SUPPORT INSPECTION AND ROLLER WASHER INSTALLATION

TITLE FLAP SUPPORT AND ROLLER BEARING INSPECTION/FLAP ROLLER WASHER
INSTALLATION

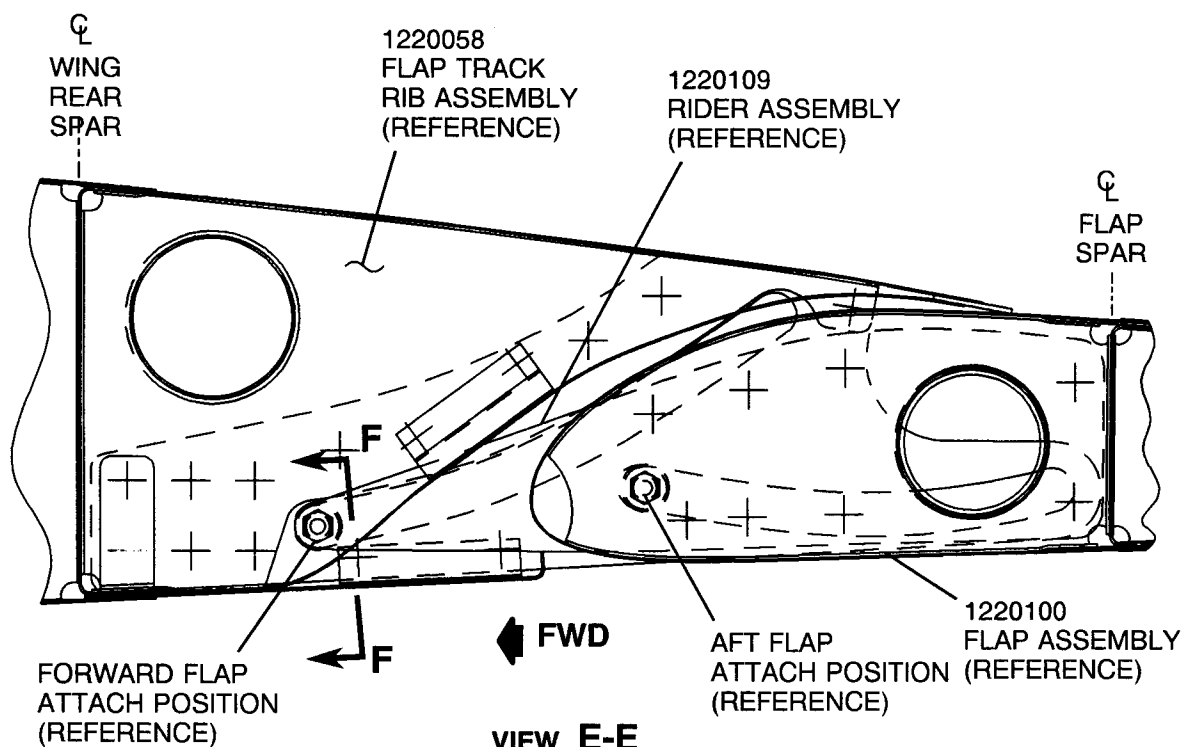
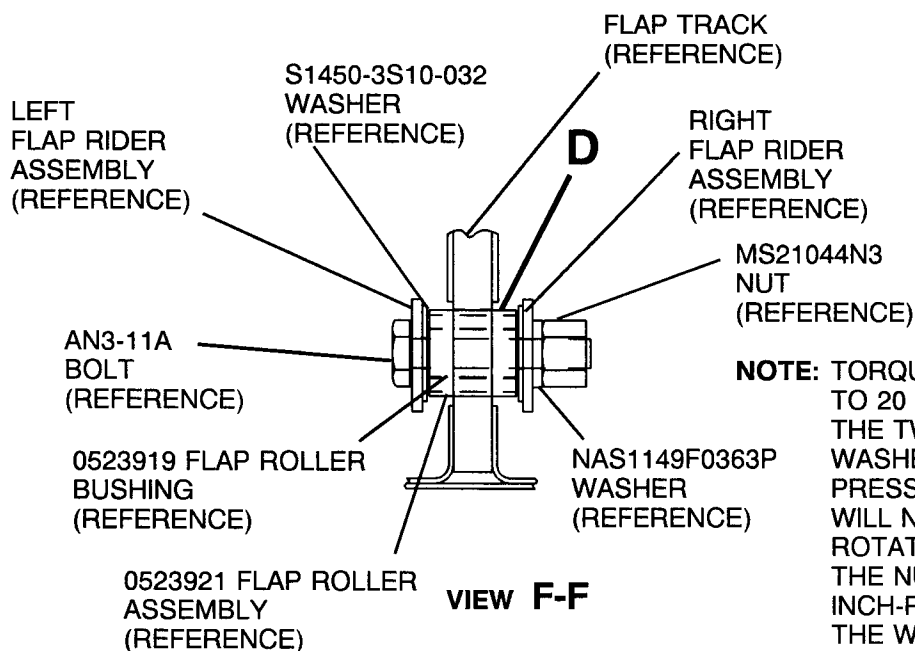
VIEW E-E
AIRPLANES WITH
EXTENDED FLAPS

NOTE: DO NOT INSTALL
 S1450-3S10-032 WASHERS ON
 THE AFT ROLLER ASSEMBLY

NOTE: TORQUE THE MS21044N3 NUT
 TO 20 INCH-POUNDS. CHECK
 THE TWO (2) S1450-3S10-032
 WASHERS WITH FINGER
 PRESSURE TO ASSURE THEY
 WILL NOT ROTATE. IF
 ROTATION IS FELT, LOOSEN
 THE NUT, RETORQUE TO 25
 INCH-POUNDS, AND VERIFY
 THE WASHER CANNOT BE
 TURNED WITH FINGER
 PRESSURE
