LANDING GEAR - INSPECTION OF THE NOSE LANDING GEAR STRUT ASSEMBLY INTERNAL ORIFICE ASSEMBLY FOR CORRECT INSTALLATION

700 (Citation Longitude)

SL700-32-01
Page 1 of 7

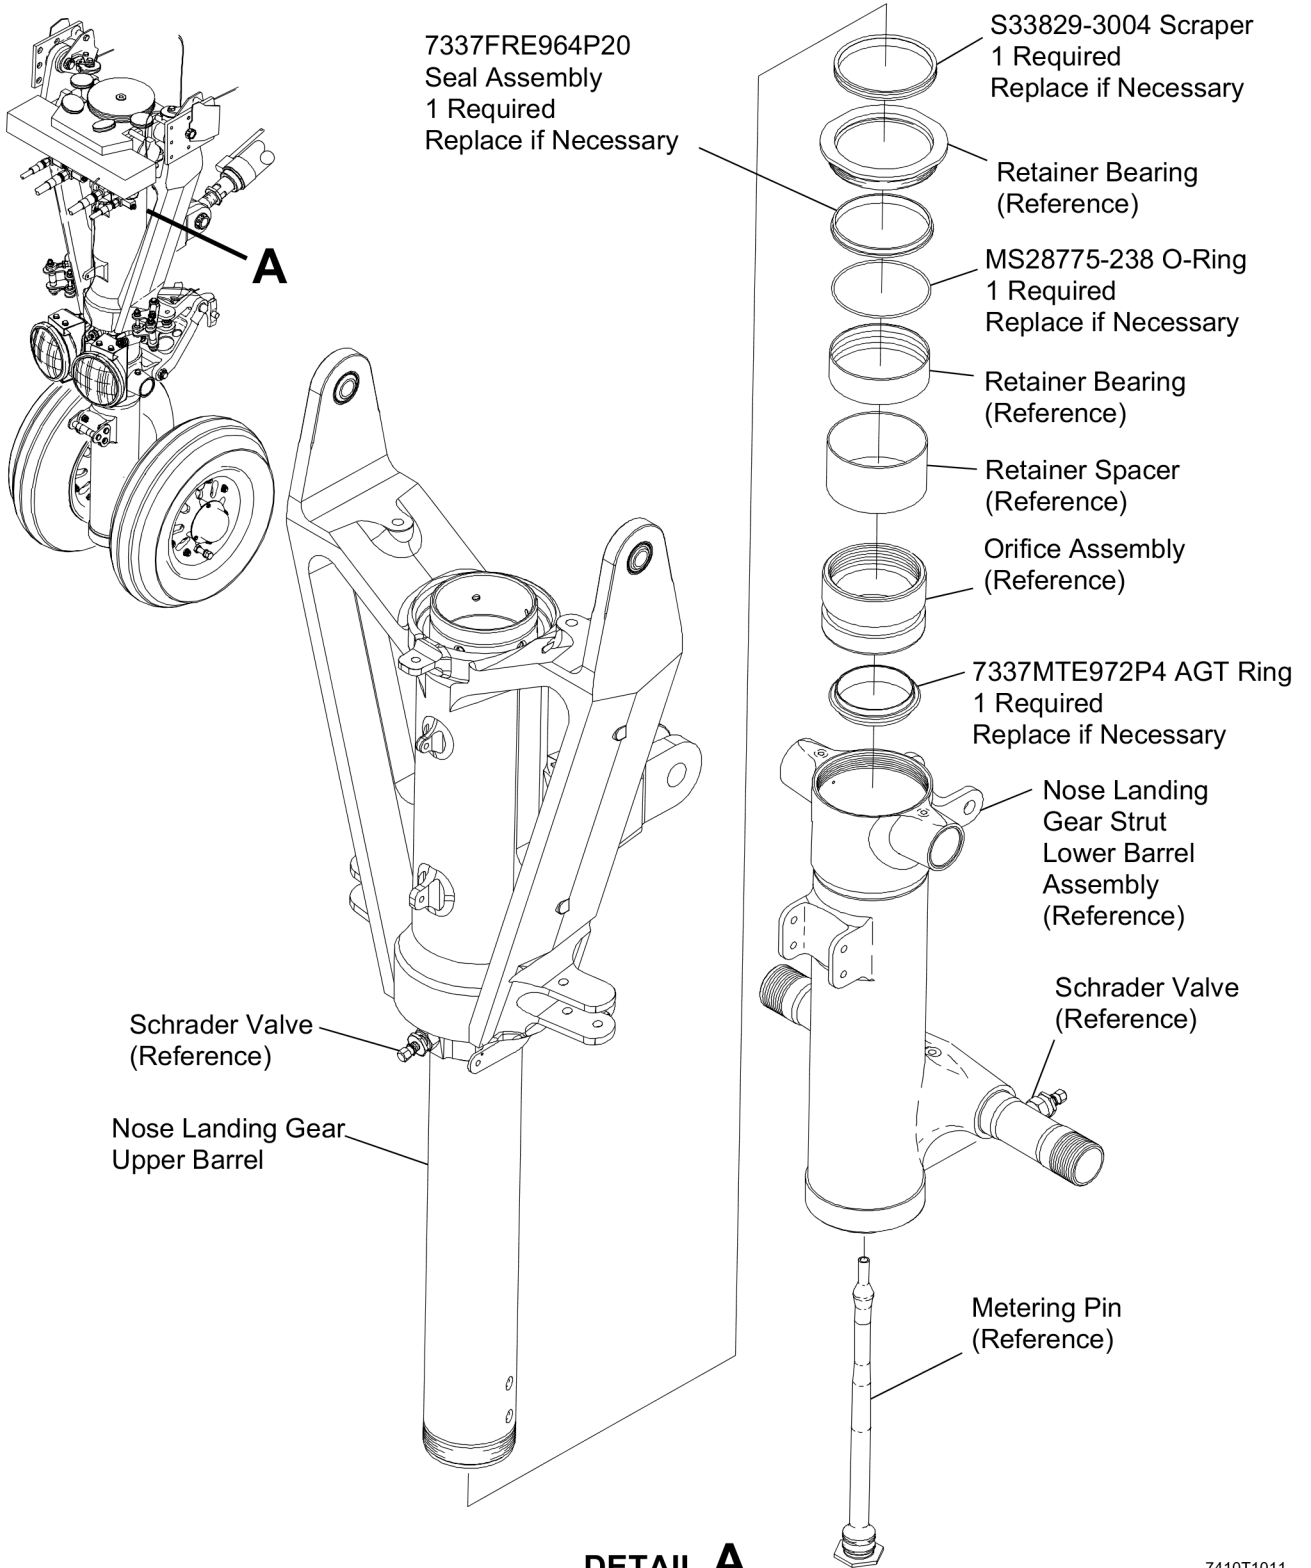
Figure 1. Nose Landing Gear Shock Strut Orifice Assembly for Correct Installation (Sheet 1)

- (7) (Refer to Figure 1, Detail A.) Remove the orifice assembly from the nose landing gear upper barrel assembly.
NOTE: If the orifice assembly will not come loose, it is permissible to apply heat not to exceed 300° F (148.88° C) for 20.0 minutes maximum while applying force. If heat exceeds the maximum value and time limit, it will be necessary to replace the orifice assembly.

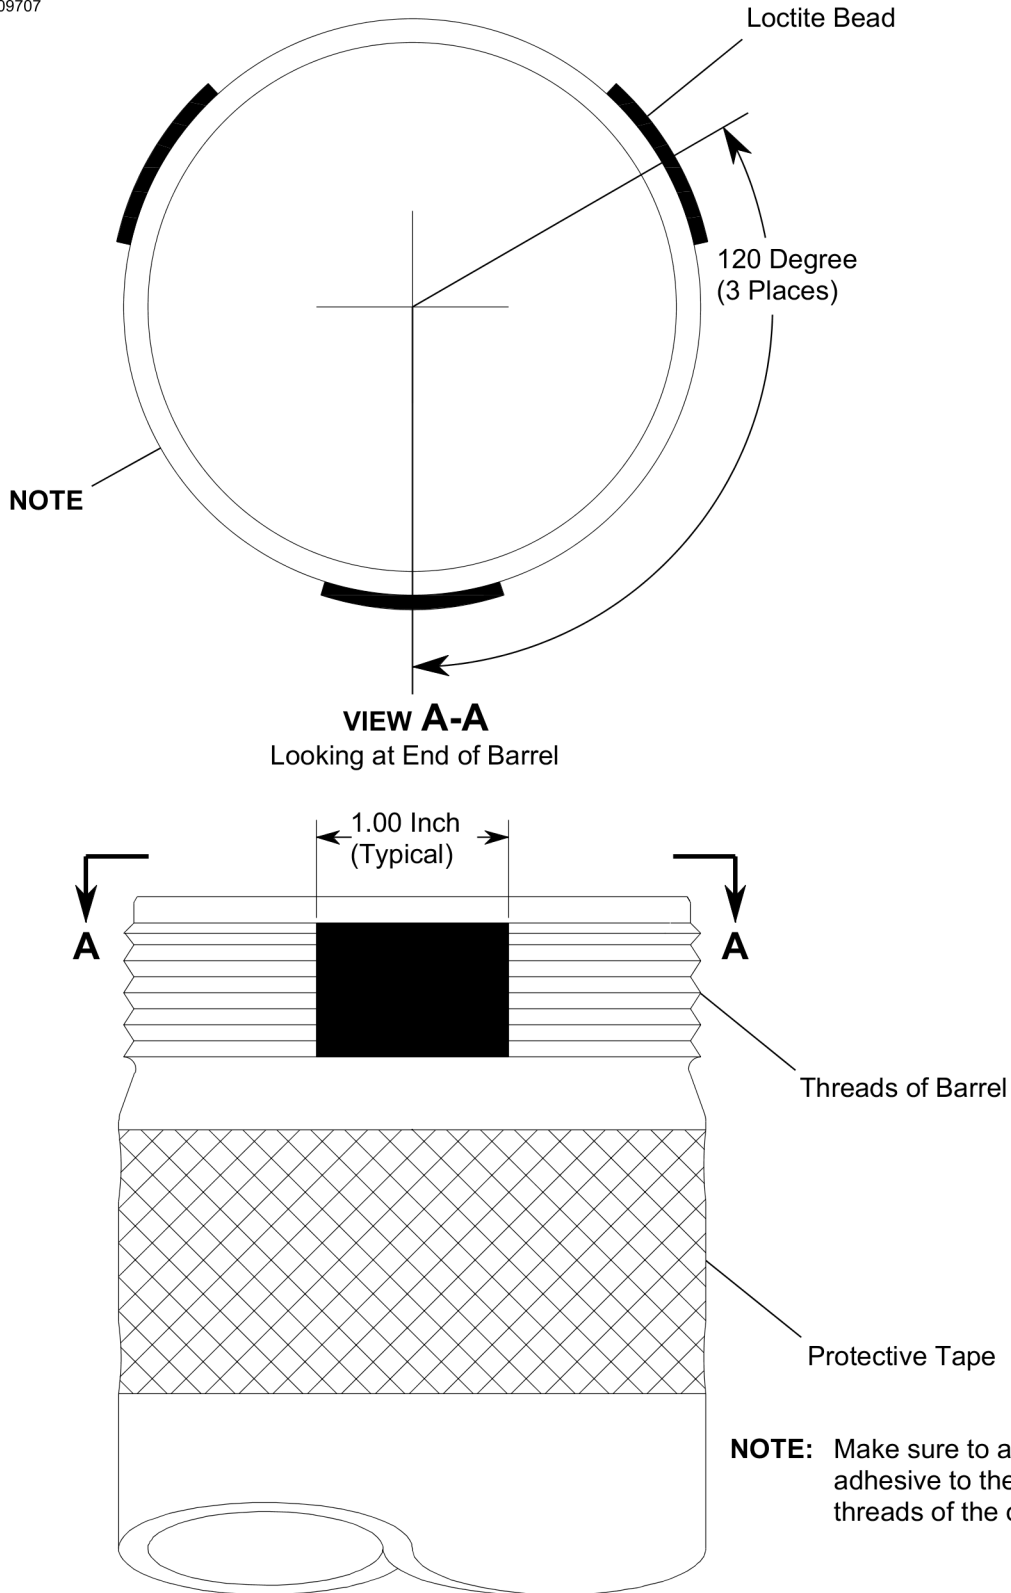
Figure 2. Loctite Promoter and Anaerobic Compound Application Area (Sheet 1)

- (11) Remove the orifice assembly from the upper barrel assembly.
- (12) (Refer to Figure 2, Sheet 1.) Apply a strip of protective tape around the circumference of the upper barrel to prevent contact with the adhesion promoter.

- (14) (See Figure 2, Sheet 1.) Apply U064072 anaerobic adhesive to the threads of the orifice assembly and the upper barrel at three locations.
NOTE: Each band should be approximately 1.0 inch (25.40 mm) long, spaced 120 degrees apart. Make sure each band completely fills the thread channels it's applied to.
